GSA Great Lakes Region

214 State Street Evaluation Report

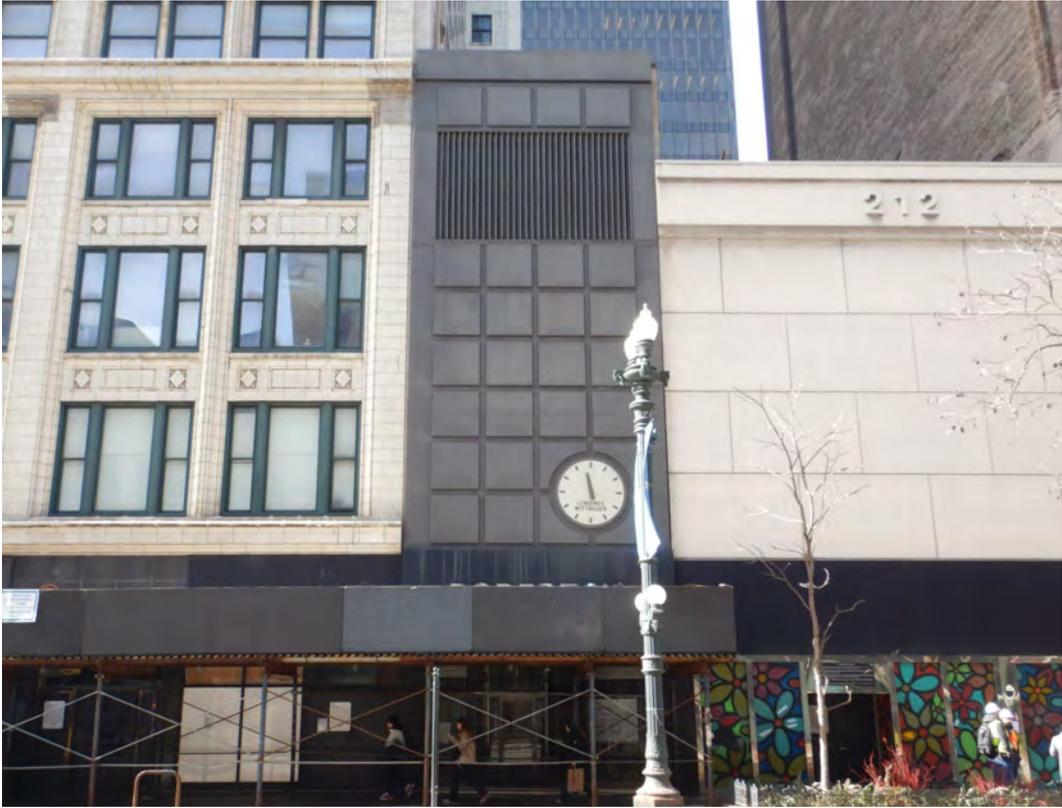
Exterior East elevation

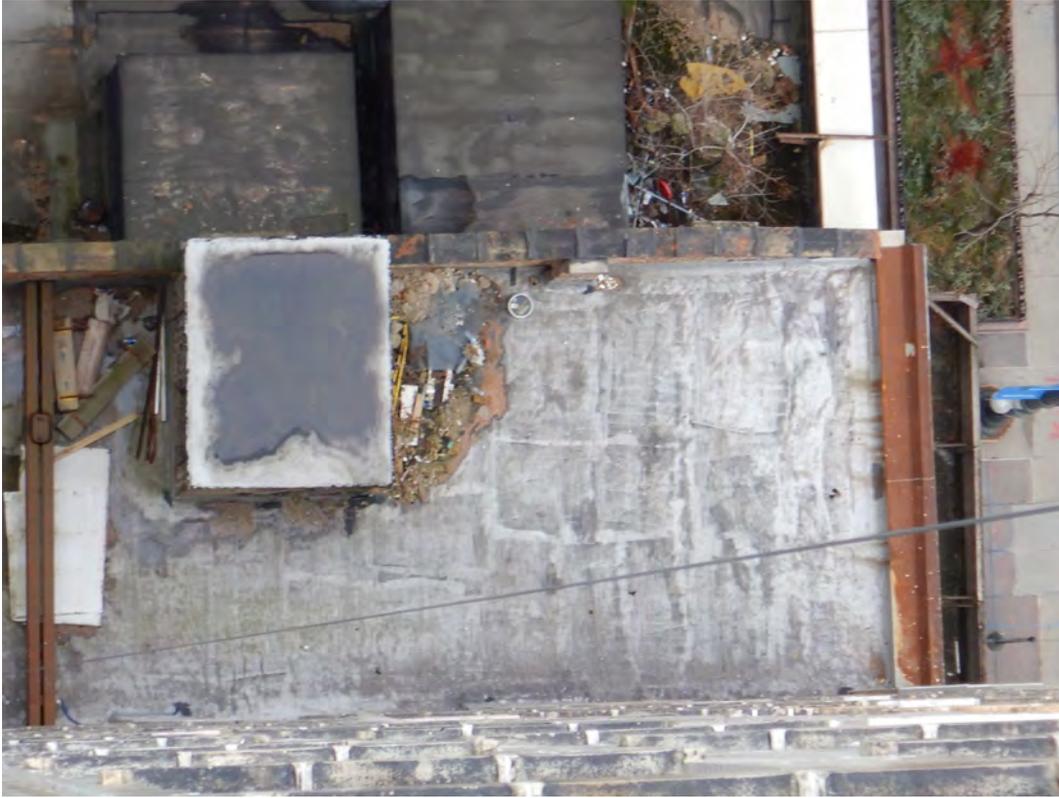
East section of the roof with elevator overrun

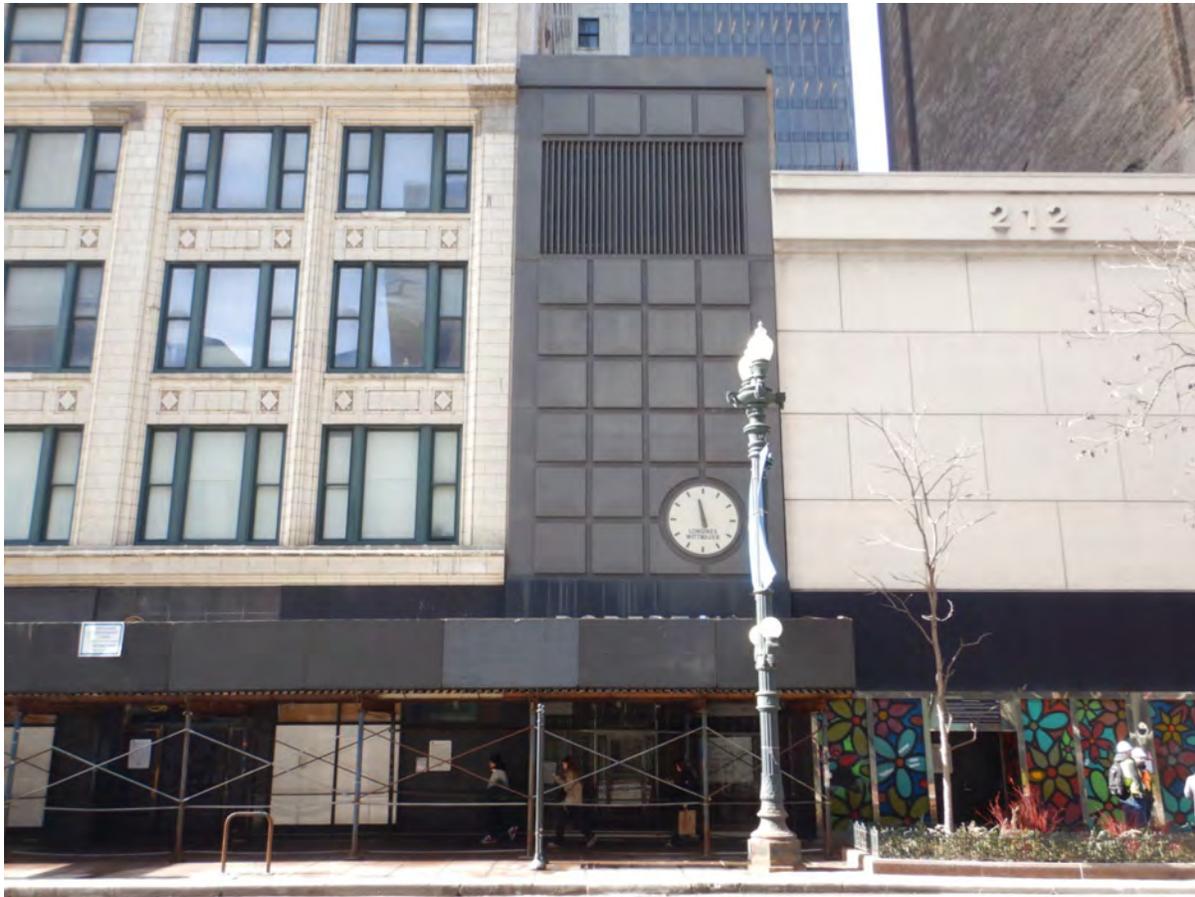
East elevation of 214 South State Street, center

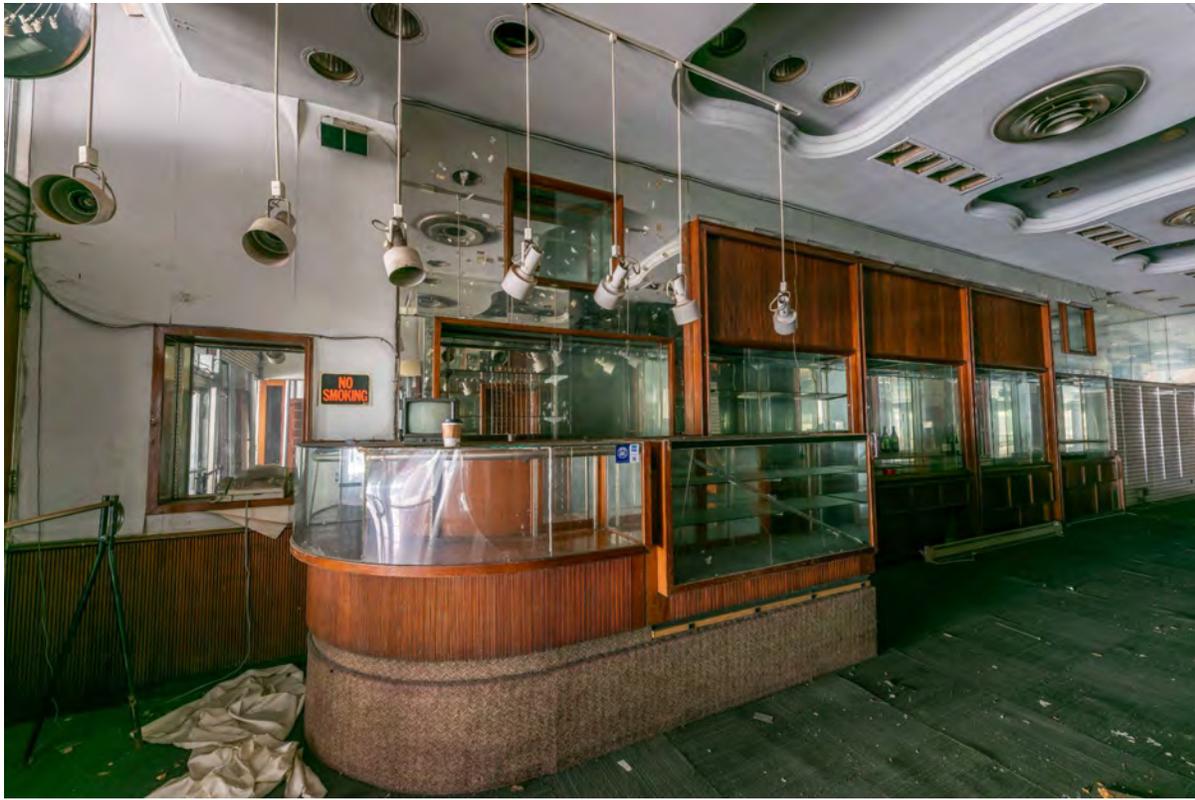
First Floor Retail Counter
