Thornton Tomasetti

Building Solutions

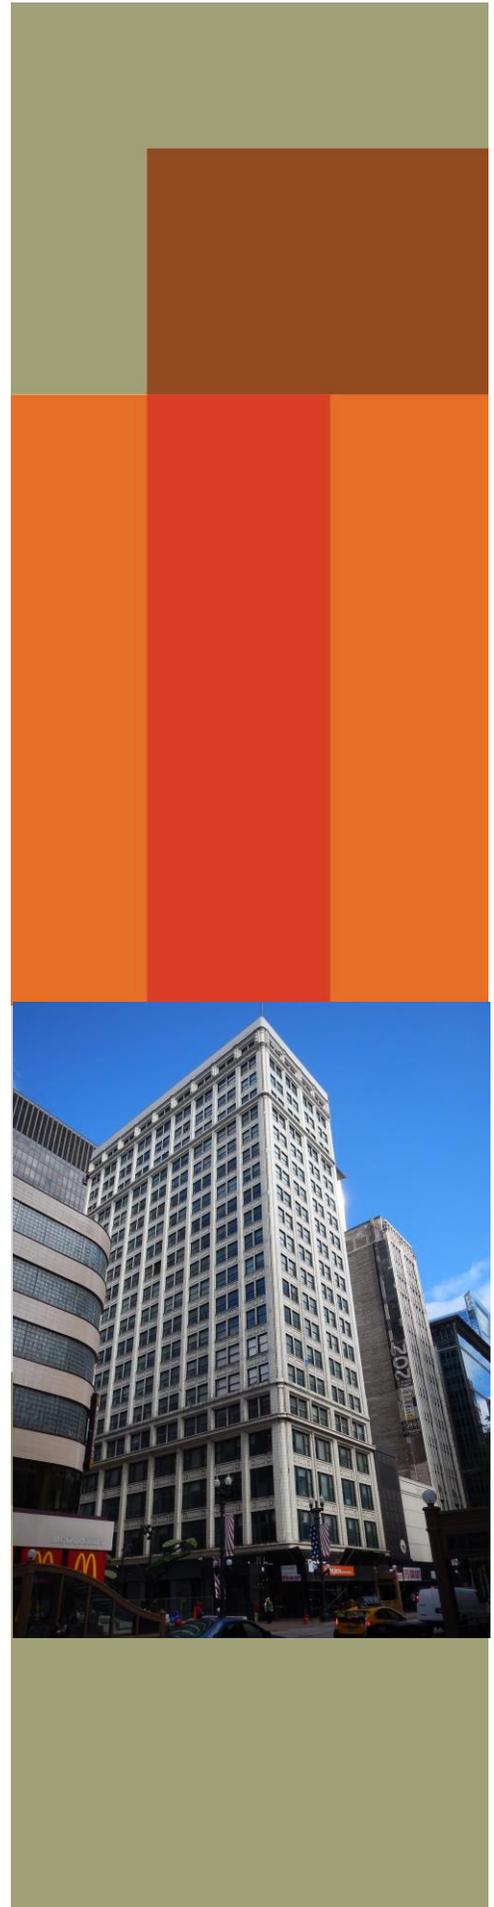
Submission Date
February 23, 2022

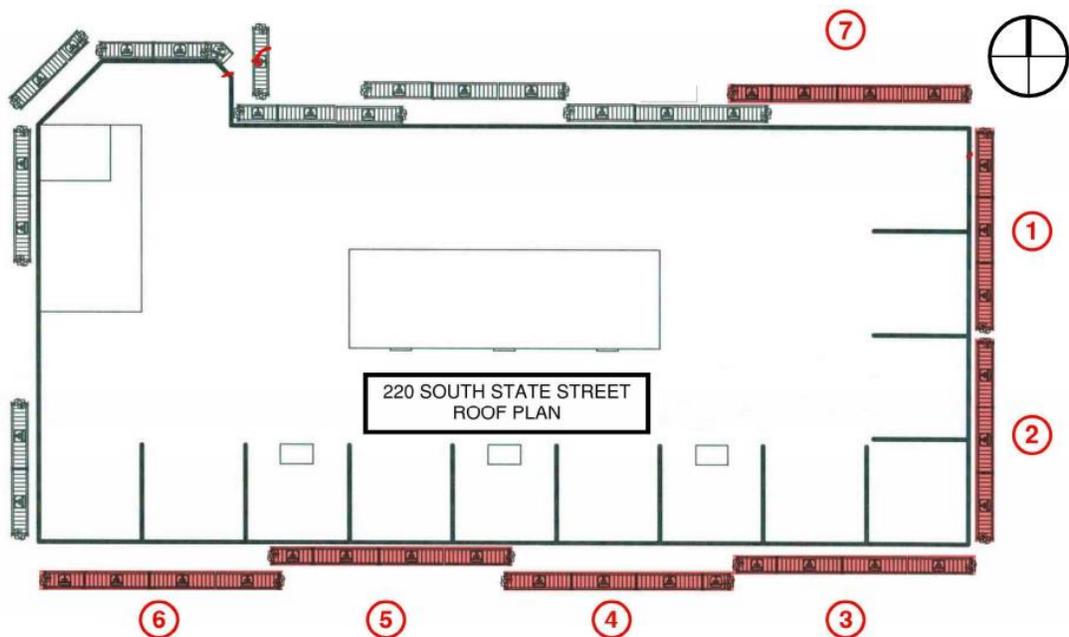
Thornton Tomasetti's observations were limited to up-close visual examinations performed at arm's length with the aid of hammer or mallet devices utilized for sounding terra cotta and glazed brick. No destructive material testing was performed.

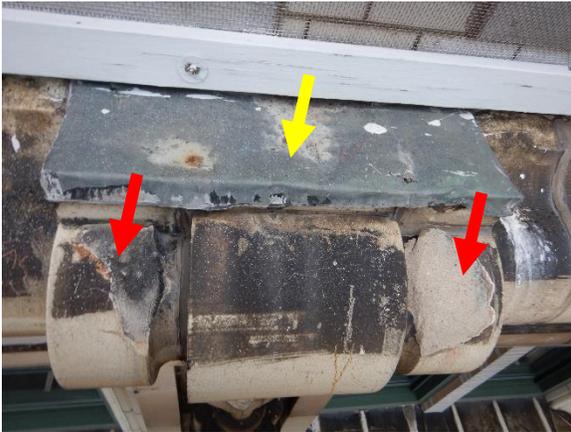
Photo 5. Medium sized spalls (red arrows) and loose metal flashing (yellow arrow) at cornice.

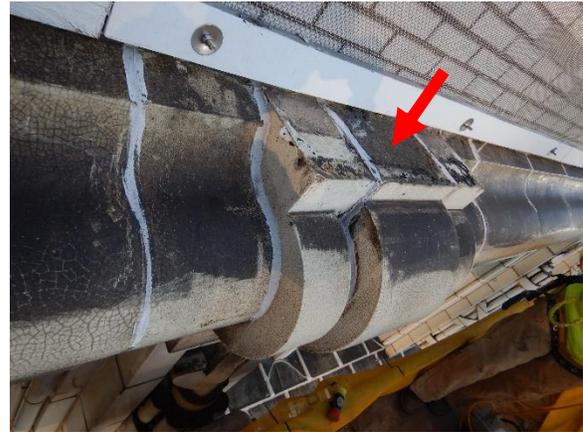
Photo 6. Typical missing metal flashing cap over column terra cotta unit.

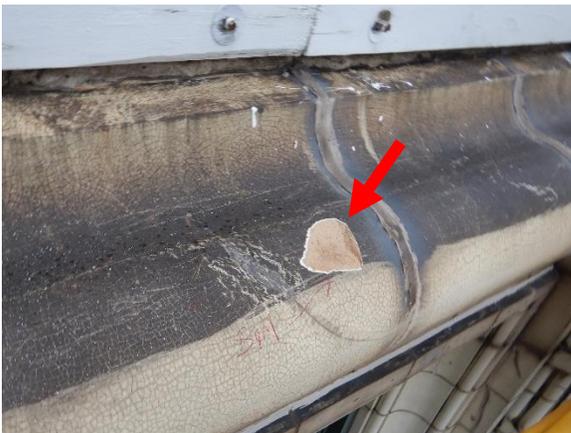
Photo 7. Recent spalls typically observed throughout half round profile units of cornice.

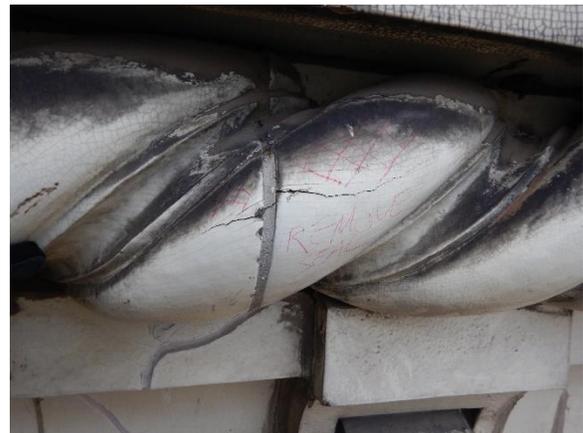
Photo 8. Terra cotta torsade with loose material at 21st floor water table.

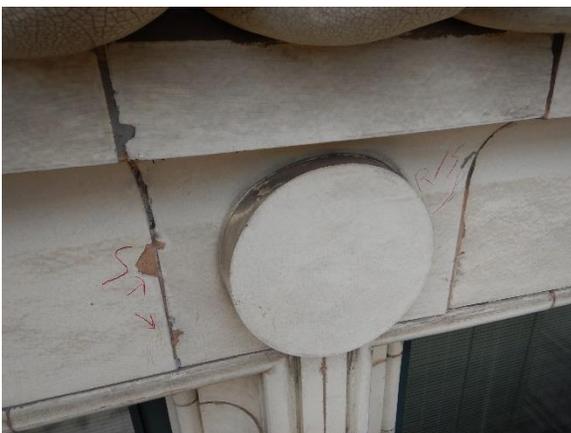
Photo 9. Terra cotta capping (with new crack) at columns below 21st floor water table.

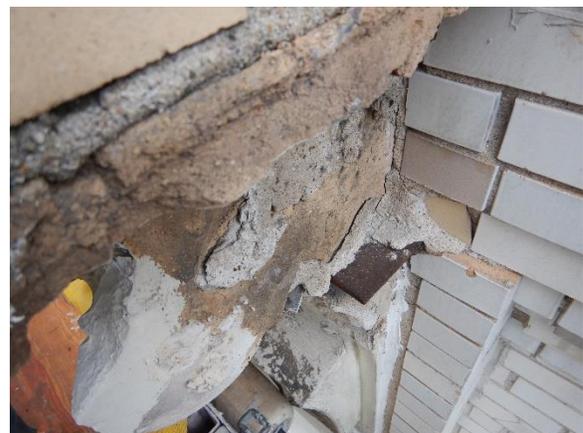
Photo 10. Previously removed portion at end of 21st floor water table.

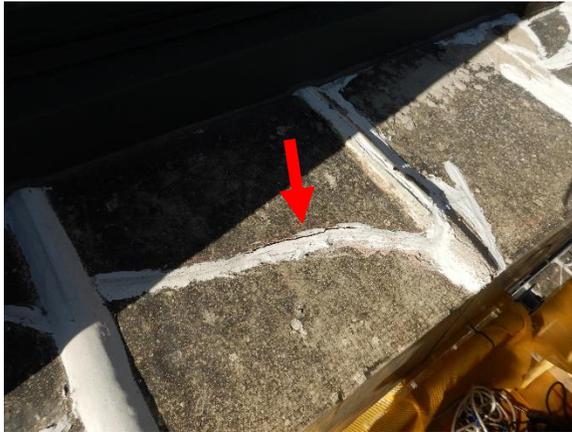
Photo 11. Widespread cracking observed throughout topside of south and east elevation water tables.

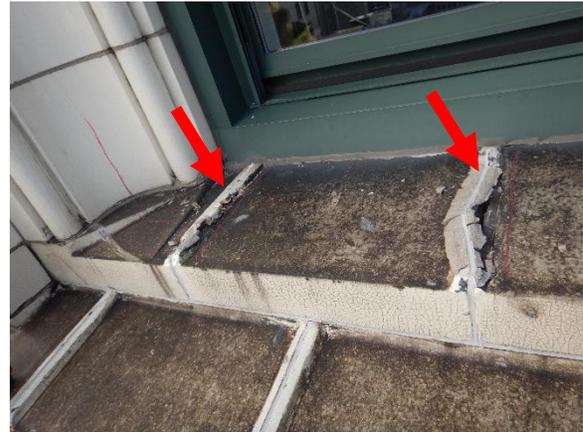
Photo 12. Failed previous mortar repairs at water table skyward facing joints.

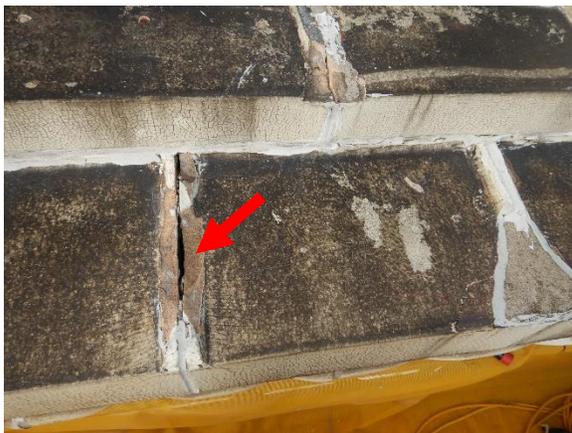
Photo 13. Removed loose terra cotta material at water table skyward facing joints.

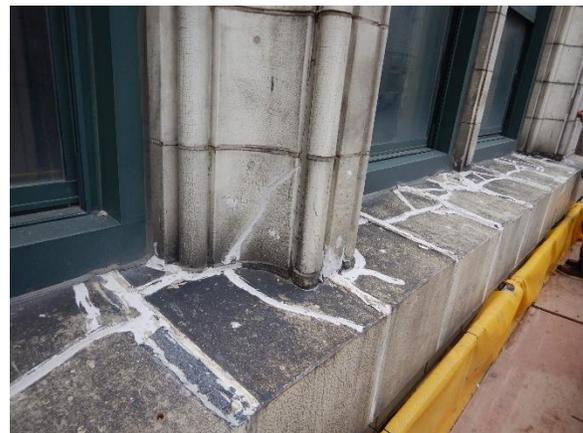
Photo 14. Extensive cracking along 5th floor belt course and 6th floor water table.

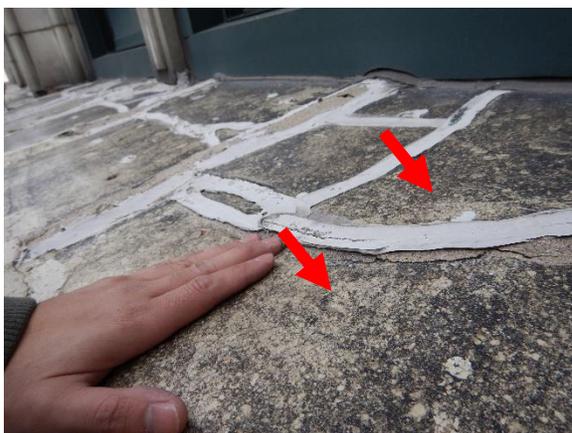
Photo 15. Slight vertical displacement at projecting sill units noted at top of 6th floor water table.

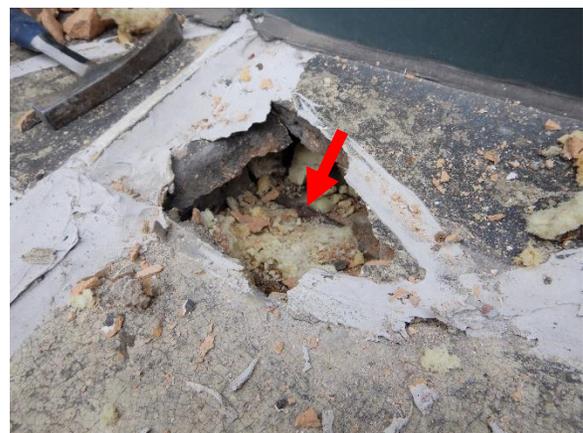
Photo 16. Foam-filler material observed under removed loose material. Note corroded steel rod.

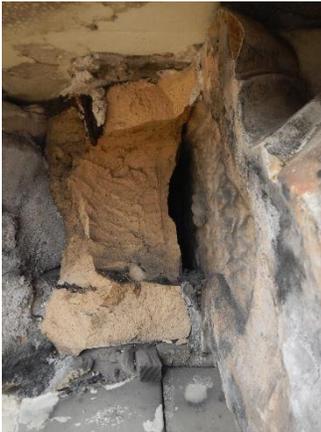
Photo 17. 21st floor water table with missing terra cotta portion.

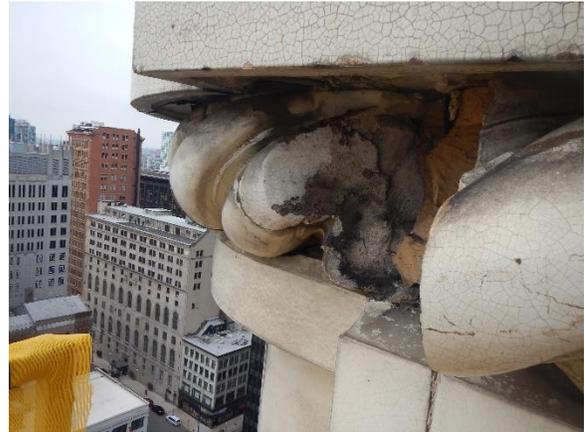
Photo 18. 21st floor water table with missing terra cotta portion.

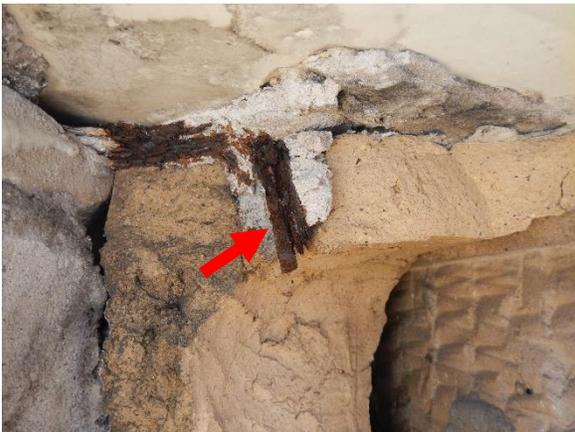
Photo 19. Corroded steel tie observed behind missing terra cotta portion.

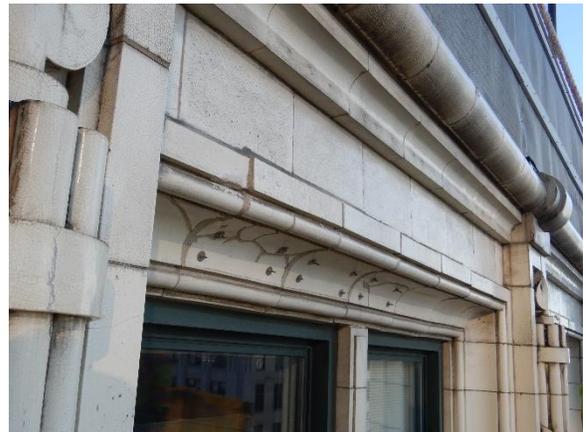
Photo 20. Previous crack repairs at window heads.

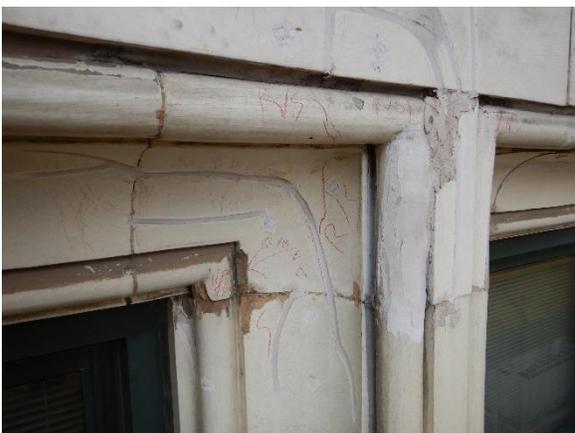
Photo 21. Typical new cracks observed at window heads.

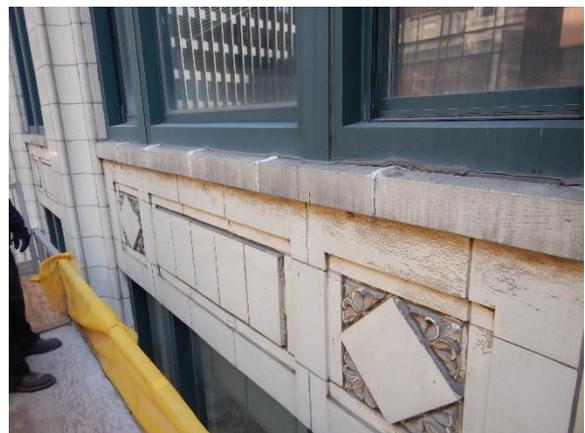
Photo 22. Typical decorated spandrels.

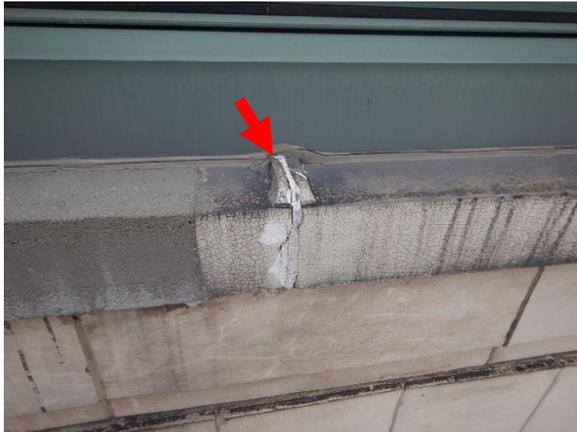
Photo 23. Cracked terra cotta "nose" joint at window sills.

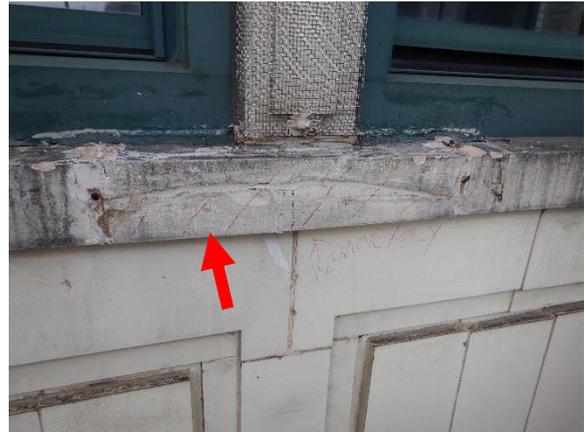
Photo 24. Terra cotta window sill unit to be removed due to deterioration observed.

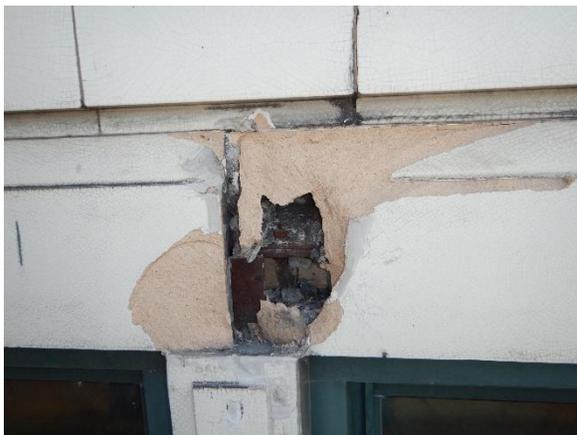
Photo 25. Severely spalled terra cotta spandrel unit (loose material removed prior to when photo was taken).

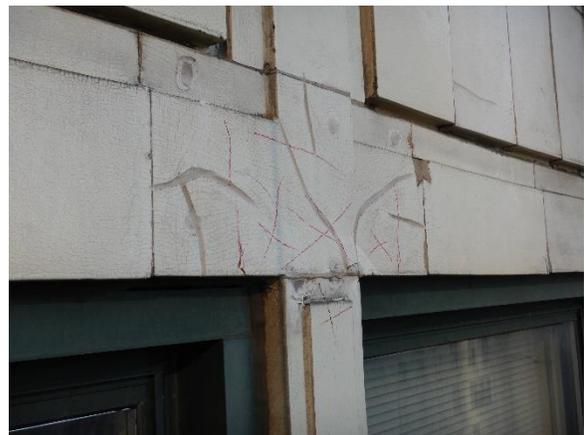
Photo 26. Typical terra cotta window head unit observed in poor condition.

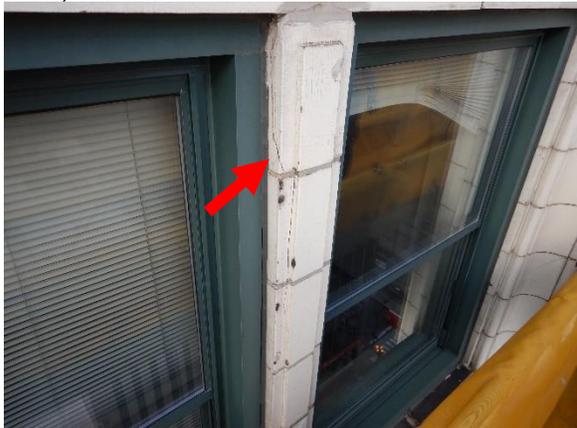
Photo 27. Typical terra cotta mullion, with crack noted by red arrow.

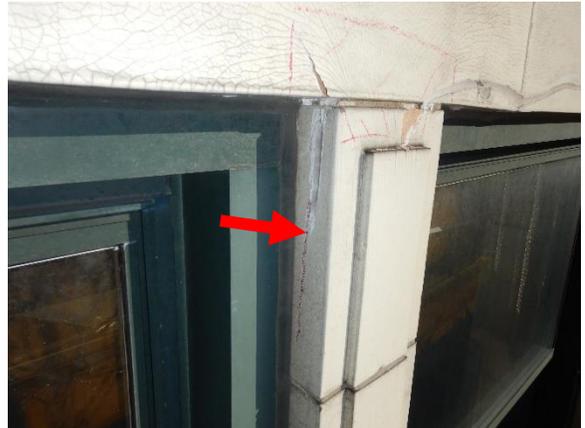
Photo 28. Typical cracked terra cotta mullion units.

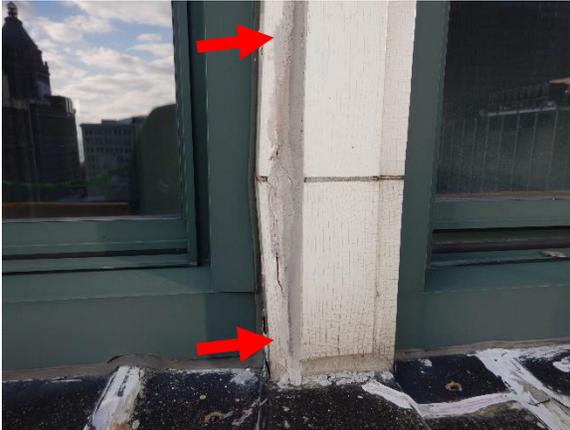
Photo 29. Crack passing through previous pinning repairs, existing pins noted by red arrows.

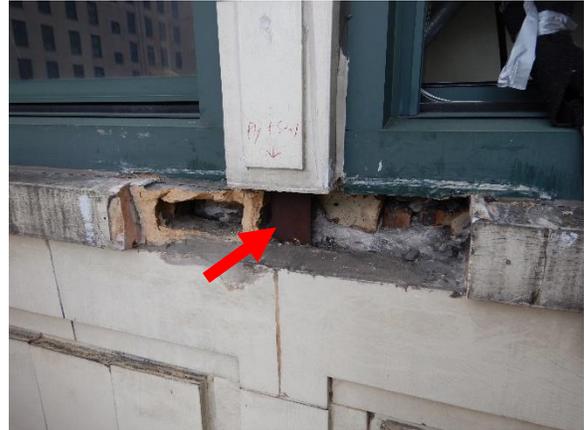
Photo 30. Existing steel observed with surface corrosion at bottom of mullion.

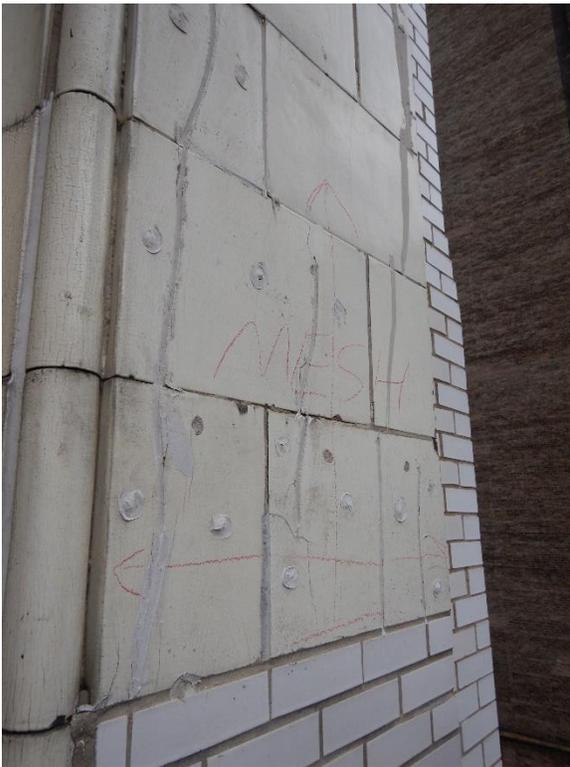
Photo 31. Previous terra cotta repairs at column units in poor condition.

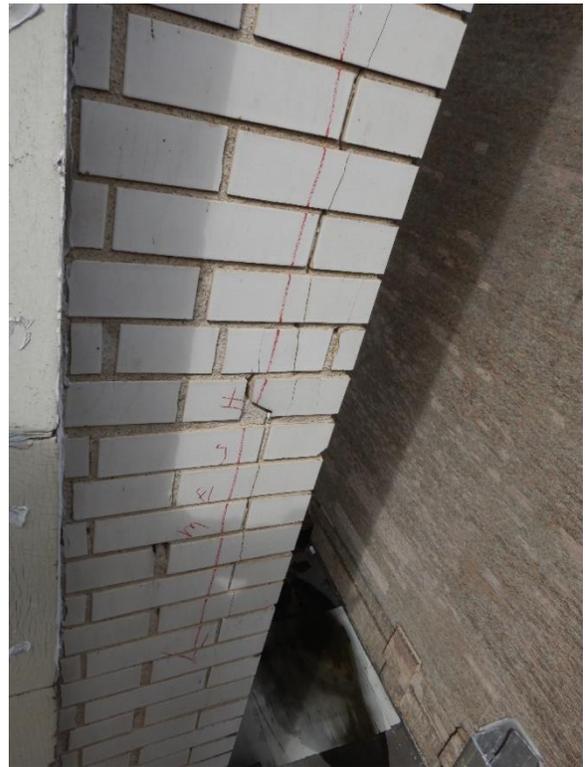
Photo 32. Cracked brick at replaced terra cotta column units.

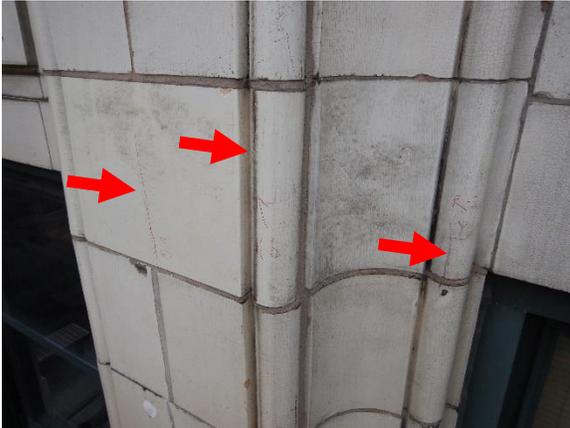
Photo 33. Typical cracked recessed joints and terra cotta column units.

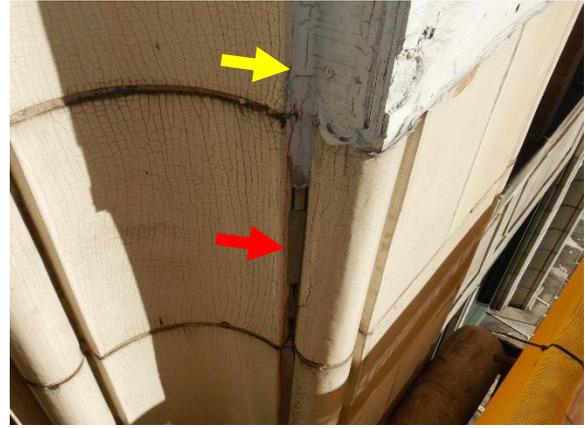
Photo 34. Typical deteriorated sealant (yellow arrow) and mortar joint (red arrow) observed.

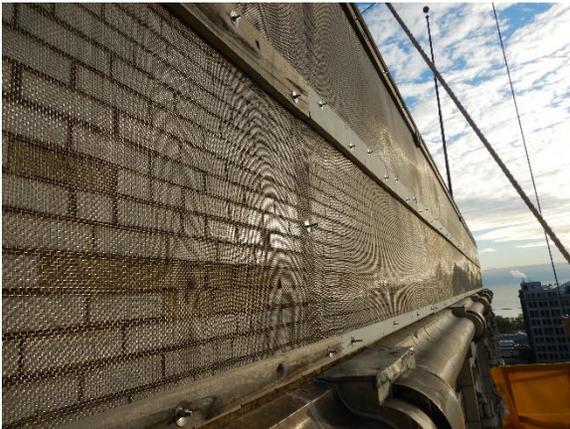
Photo 35. Existing condition of stainless steel mesh and wood shoring at parapet wall.

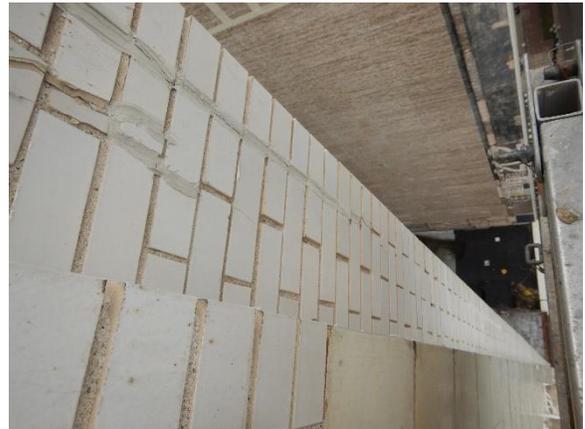
Photo 36. Reconstructed glazed brick masonry at northeast building corner.

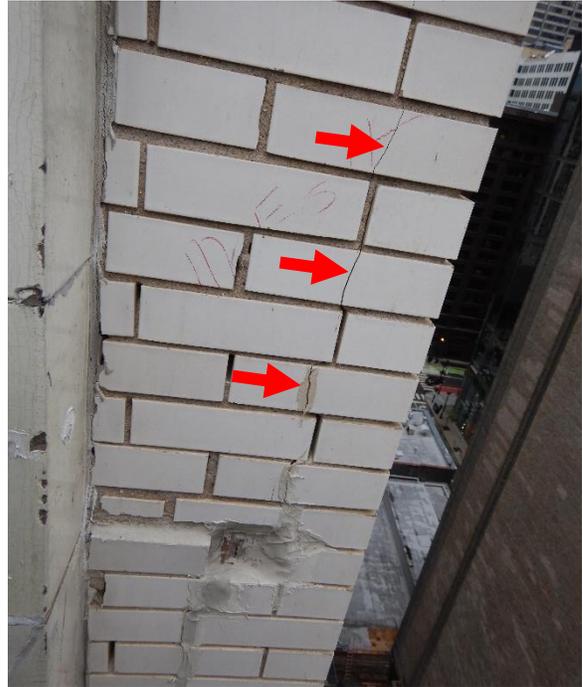
Photo 38. Typical new cracks throughout north edge of northeast building corner

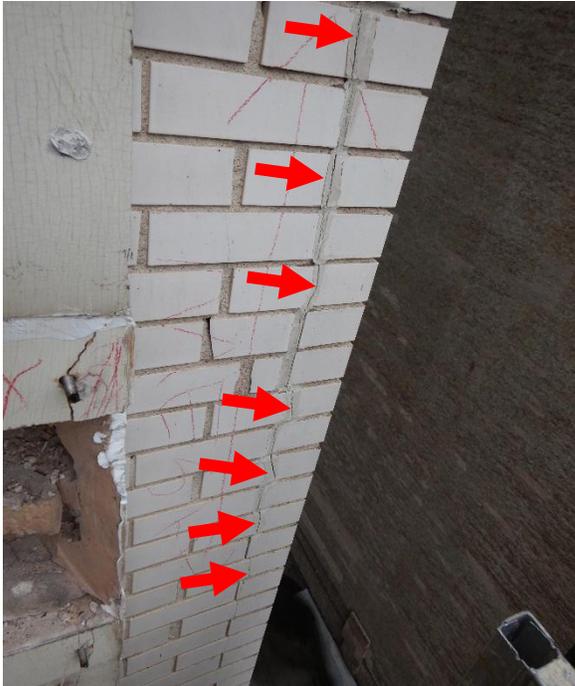
Photo 39. Typical new cracks through previous crack repair at northeast building corner.

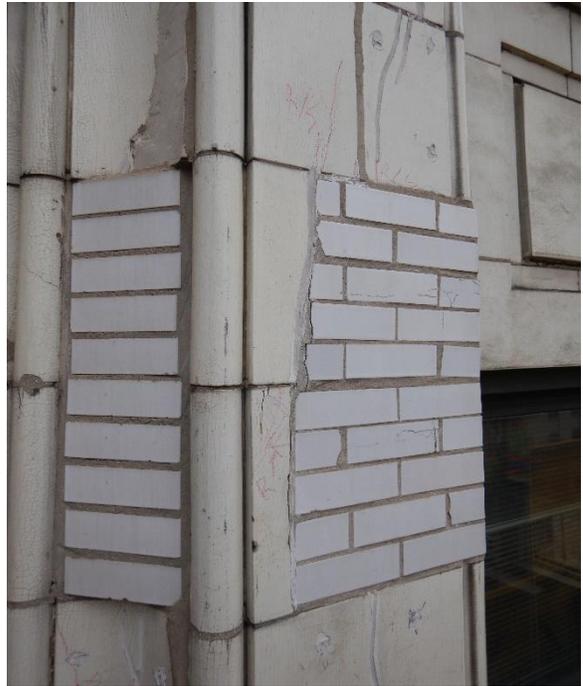
Photo 40. Typical condition of previous glazed brick infills.

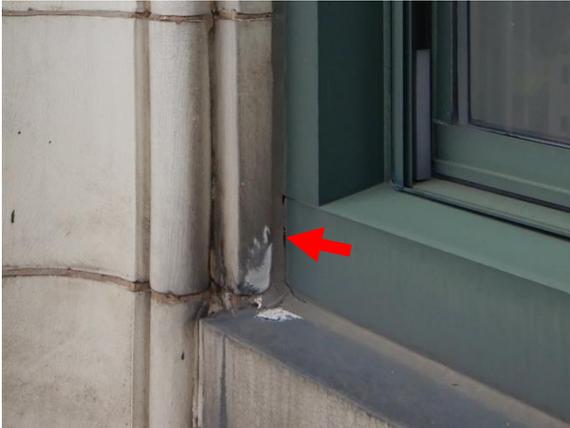
Photo 41. Typical failed sealant noted at perimeter of windows.

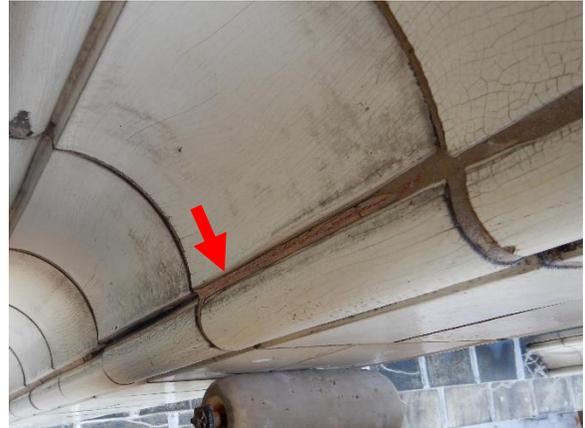
Photo 42. Typical cracked and missing mortar joint.

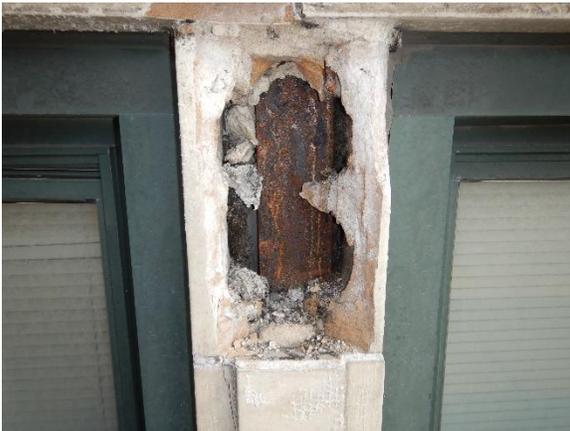
Photo 43. Mullion steel member with extensive surface corrosion.

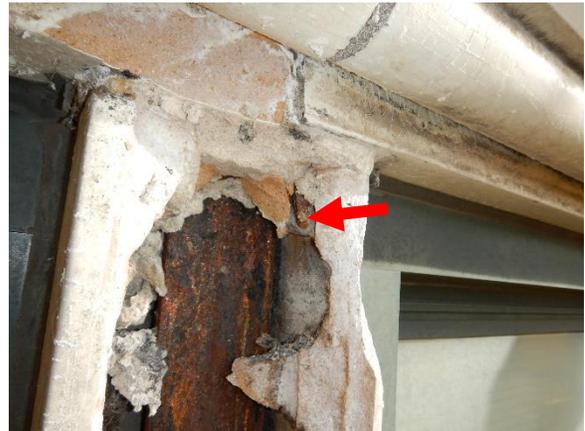
Photo 44. Corroded steel rod (red arrow) observed at surface of spalled mullion terra cotta.

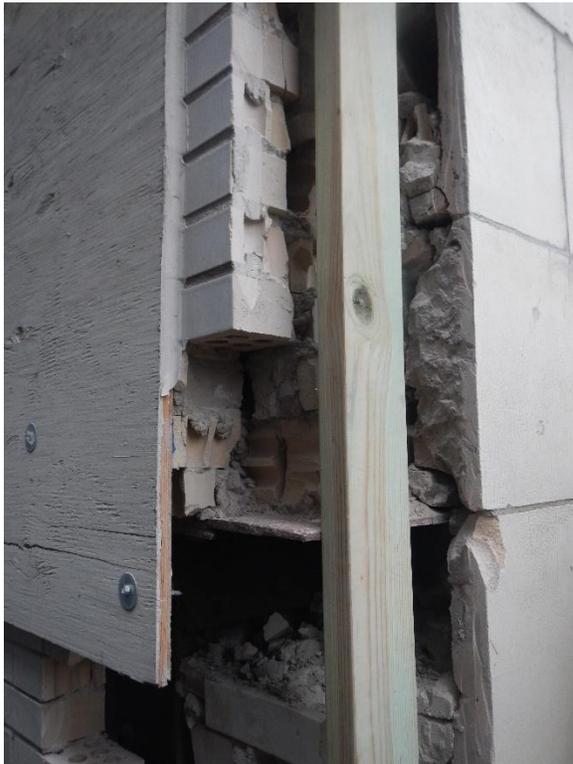
Photo 45. Exploratory opening at cracked glazed brick on the 14th floor, south elevation.

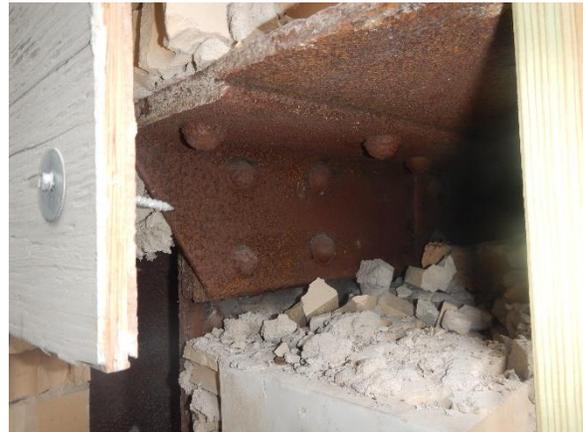
Photo 46. Steel connection member at column observed with extensive surface corrosion and pitting.

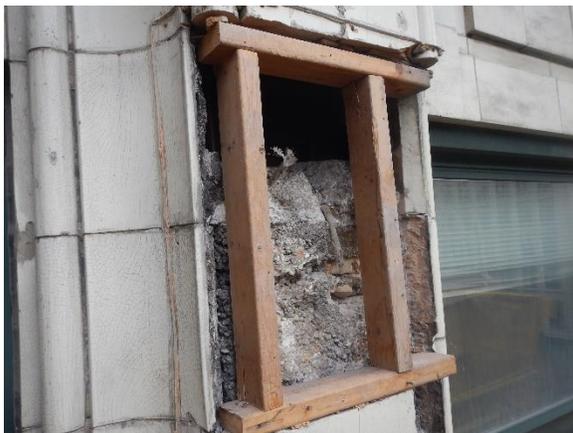
Photo 47. Exploratory opening at existing plywood covering over column at 8th floor, south elevation.

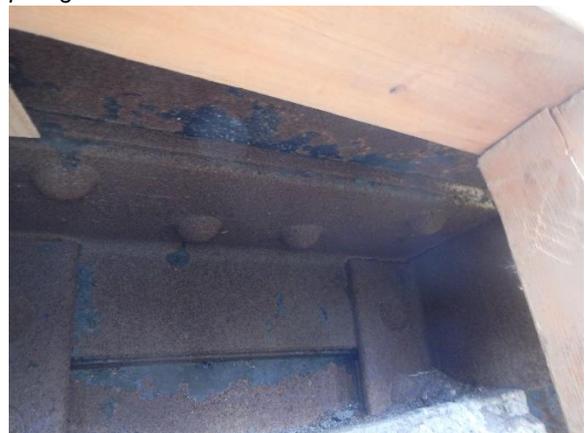
Photo 48. Steel built-up column observed with surface corrosion and some pitting.

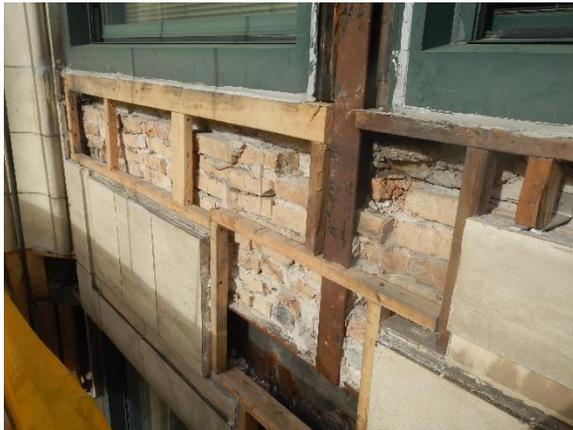
Photo 49. Exploratory opening at existing plywood covering over spandrel beam and mullion at 8th floor, south elevation.

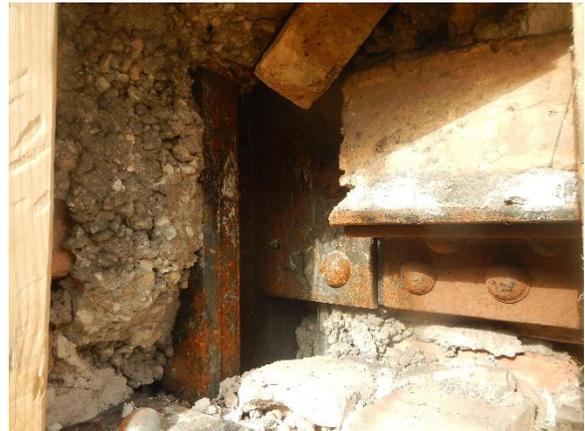
Photo 52. Existing connection of spandrel beam to built-up column, surface corrosion noted throughout.

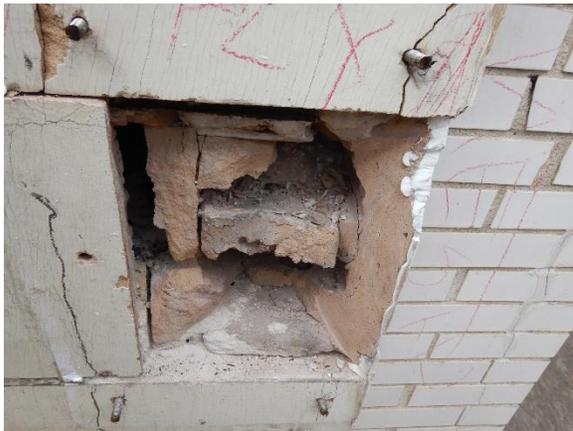
Photo 53. Exploratory opening at existing plywood covering over column at 14th floor, east elevation.

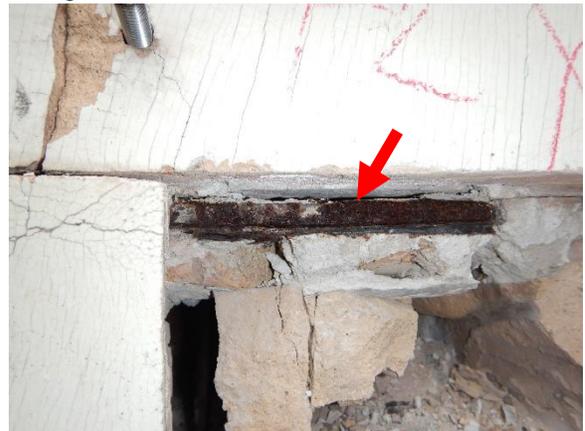
Photo 54. Steel bracket observed with severe corrosion.

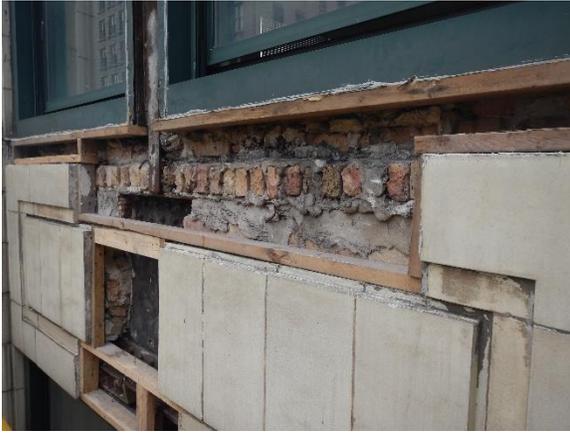
Photo 55. Exploratory opening at existing plywood covering over spandrel beam, mullion, and column at 7th floor, east elevation.

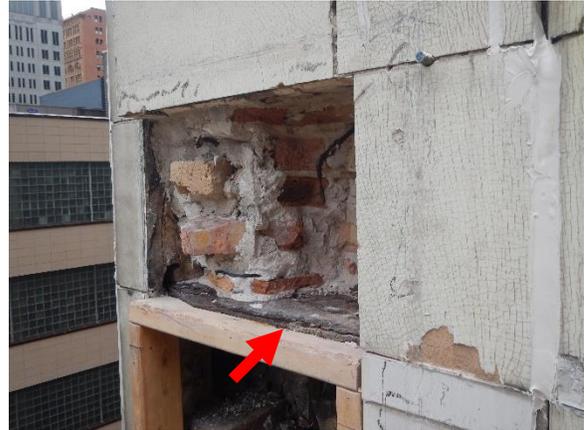
Photo 56. Significant rust jacking observed at existing steel bracket.

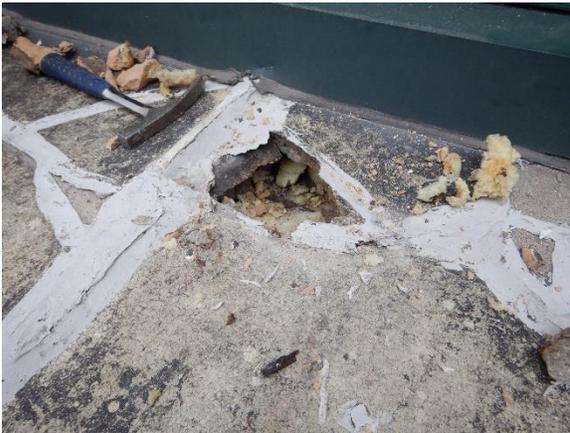
Photo 57. Exploratory opening at spalled terra cotta sill unit of the 6th floor water table, east elevation.

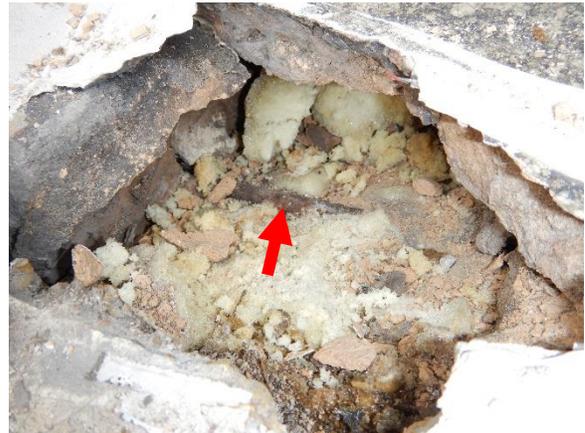
Photo 58. Existing steel rod with section loss due to corrosion and foam material observed underneath spalled terra cotta sill unit.

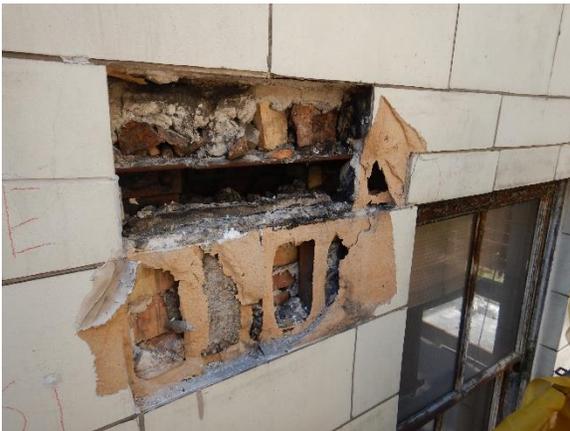
Photo 59. Exploratory opening at spalled terra cotta units over spandrel beam flange at 13th floor, north elevation.

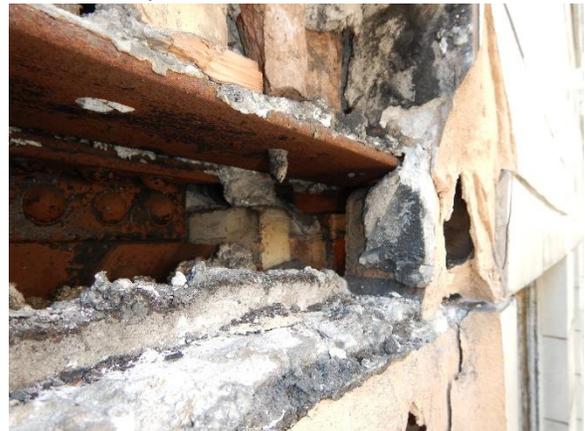
Photo 60. Extensive surface corrosion observed at top flange of steel built-up spandrel beam.

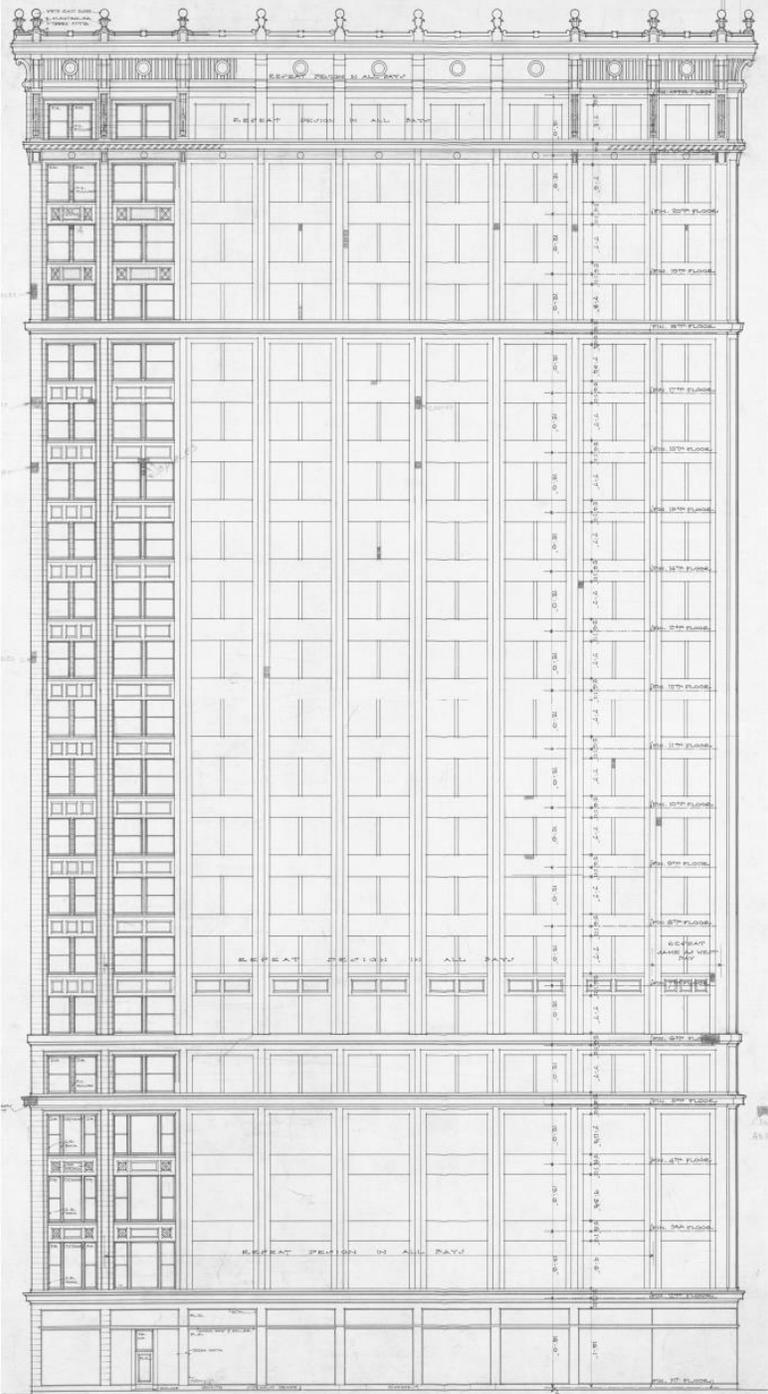
Figure 1 - South Elevation
