GSA Great Lakes Region

# **202 State Street Evaluation Report**

**202 S State Street**

Report Issuance 6.1.23

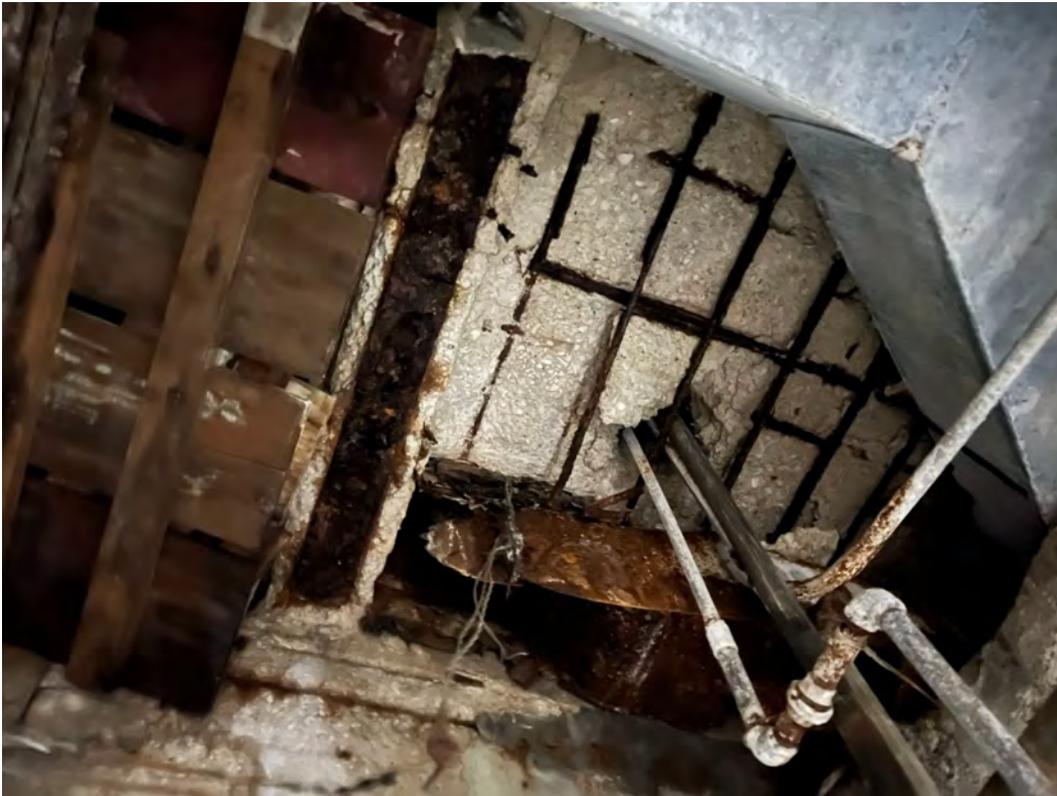
In the sub-basement, water was observed leaking through the first basement slab in the westernmost bay. Spalling of the underside of the slabs were observed as was exposed and corroded reinforcing bars. Water was also observed leaking at an abandoned elevator shaft adjacent to the north basement wall. Corrosion was observed on overhead exposed steel framing and on embedded rolled shapes cast into the basement wall. The elevator pit at this location is full of water. A tunnel connection to the tunnel below Adams Street is indicated below the sub-basement level; however it is unknown if this connection remains due to the presence of standing water.

Upper basement slab from below: Area with exposed and corroded rebar and steel

1. Perform repairs ranging from partial depth patches to full depth replacement of concrete slab at the basement and sub-basement level slabs. It is estimated that approximately 25% of the slab supporting these levels requires repair or replacement.

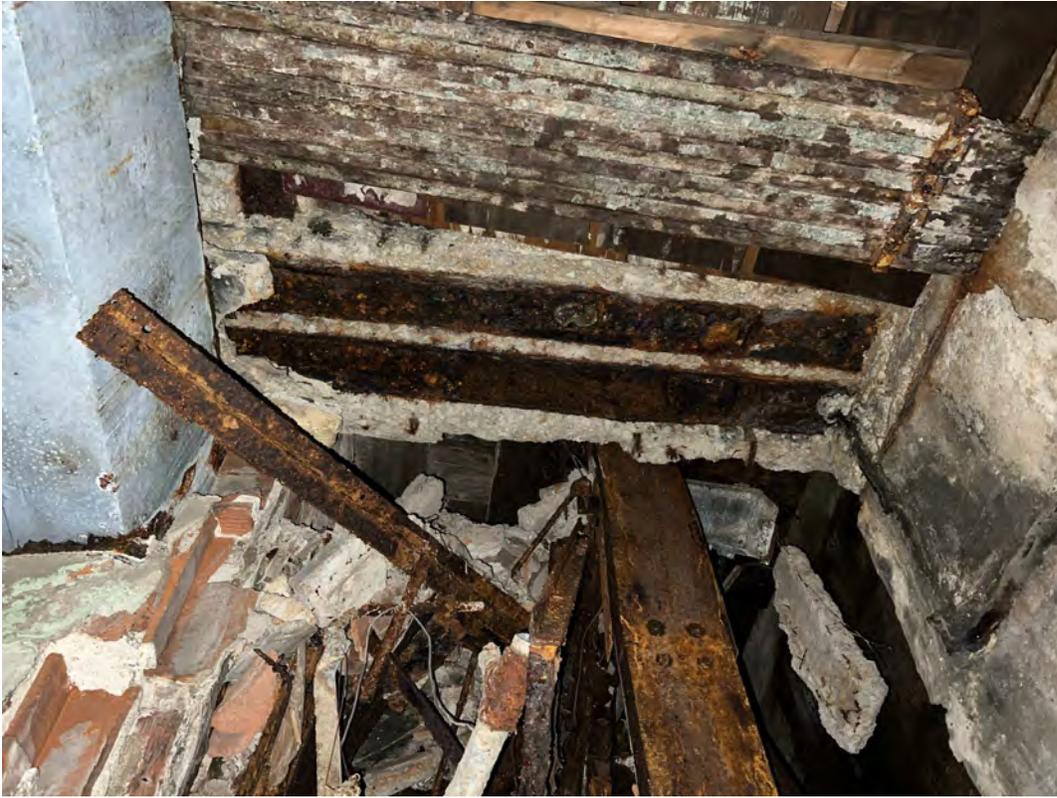
Repair of missing encasement (fireproofing) around existing steel framing members is also anticipated which will include cleaning and coating of the exposed steel member and replacement of fireproofing. TT estimates approximately 20% of the steel framing supporting the basement and ground levels will require repair of encasement and cleaning of steel. A small percentage of steel beams may require reinforcement due to section loss caused by corrosion.

Upper basement slab from below: Corroded steel beams with missing cover above elevator pit

2. Perform repairs to approximately 10% of the footprint area of the ground level clay tile arch floor system.
3. Perform steel cleaning and coating and replacement of fireproofing at the basement levels where concrete or clay tile arch cover on existing steel is missing. It is estimated that approximately 20% of existing steel on the lower levels will require this.

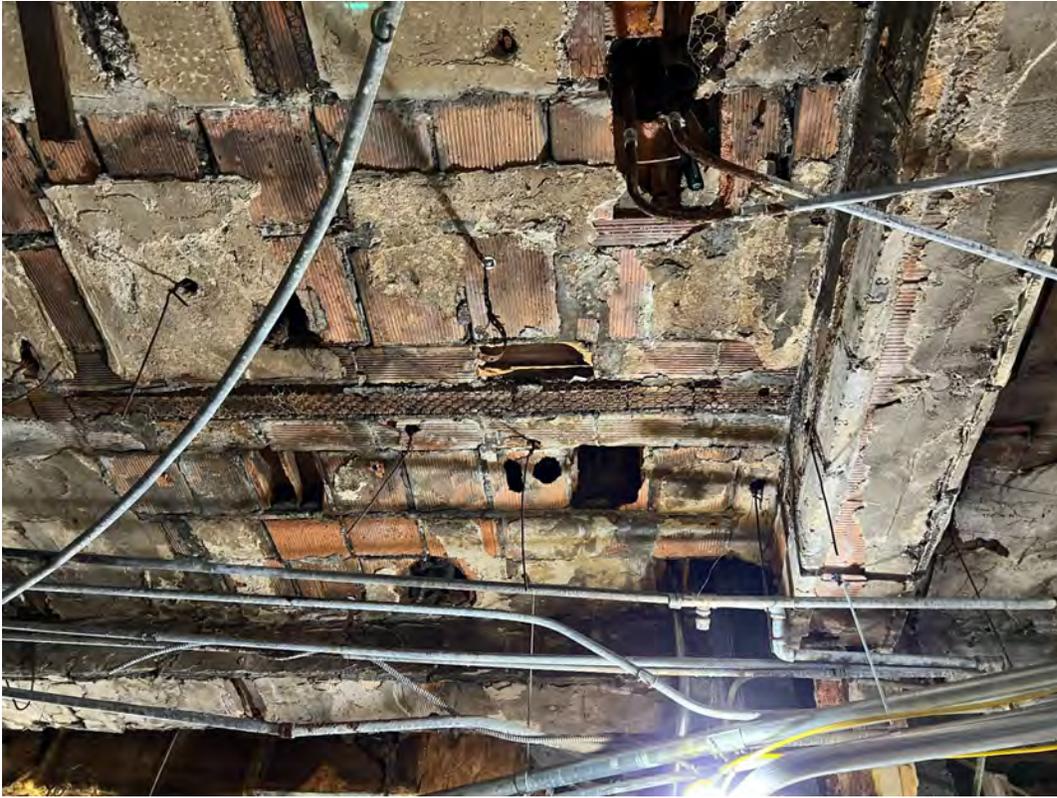
The underside of the ground level clay tile arch slab has localized areas of damage in the tiles across the building footprint. Approximately 10% of the ground level clay tile will require repair.

Ground Level floor from below: Isolated damage to clay tile floor system

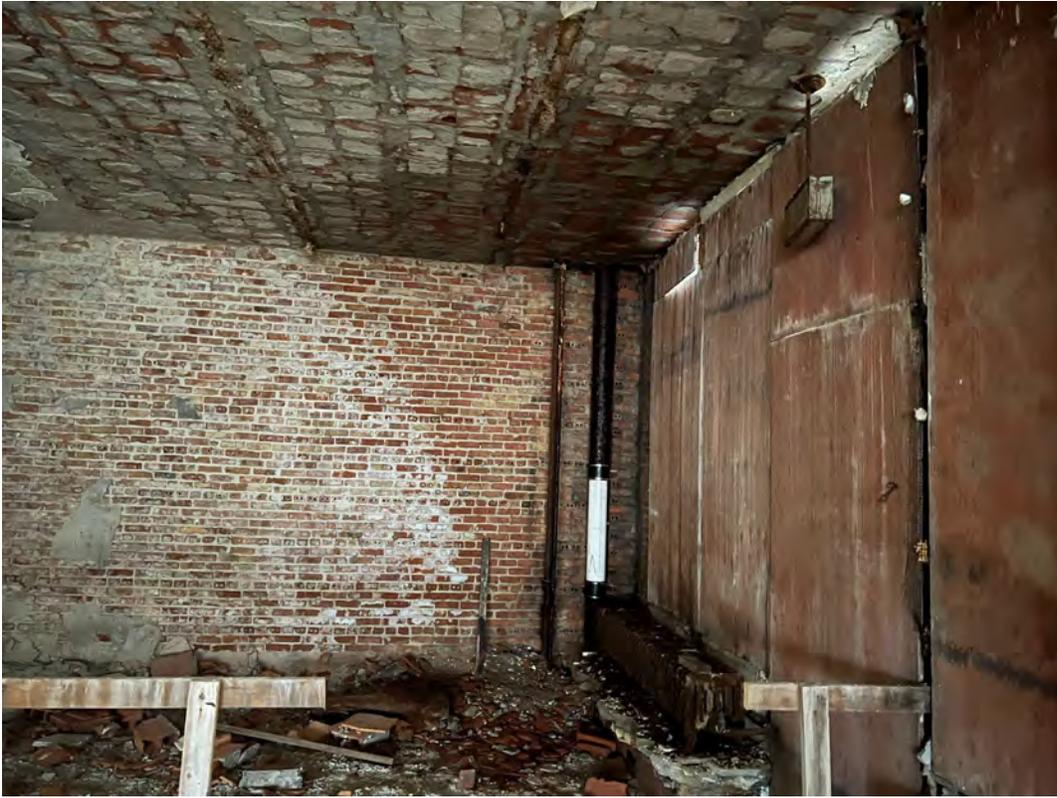
Active leaks were observed at multiple locations at the roof level, with higher concentrations at the northwest corner and the flat portion of the roof adjacent to the elevator penthouse. At these locations, water is migrating down several floors through the clay tile system. In the northwest corner, the roof drain pipe allows water to migrate further down the building. Saturated areas of the clay tile floor system were observed down to the 7th floor. Water was observed running over the surface of the drain pipe, from the roof level to the first basement level.

The saturated areas of clay tile will need to be evaluated for possible damage due to freeze thaw and those areas may require replacement of the tile system with slab on metal deck. Similarly, these

Superstructure: Observed water infiltration at northwest corner of slab typical Levels 7 - Roof

7. Evaluate the clay tile arch and steel tie rods in the northwest corner of Levels 7 through the Roof level for additional deterioration due to freeze thaw cycles from observed water infiltration in these areas. Repair clay tile arch and tie rods as necessary.

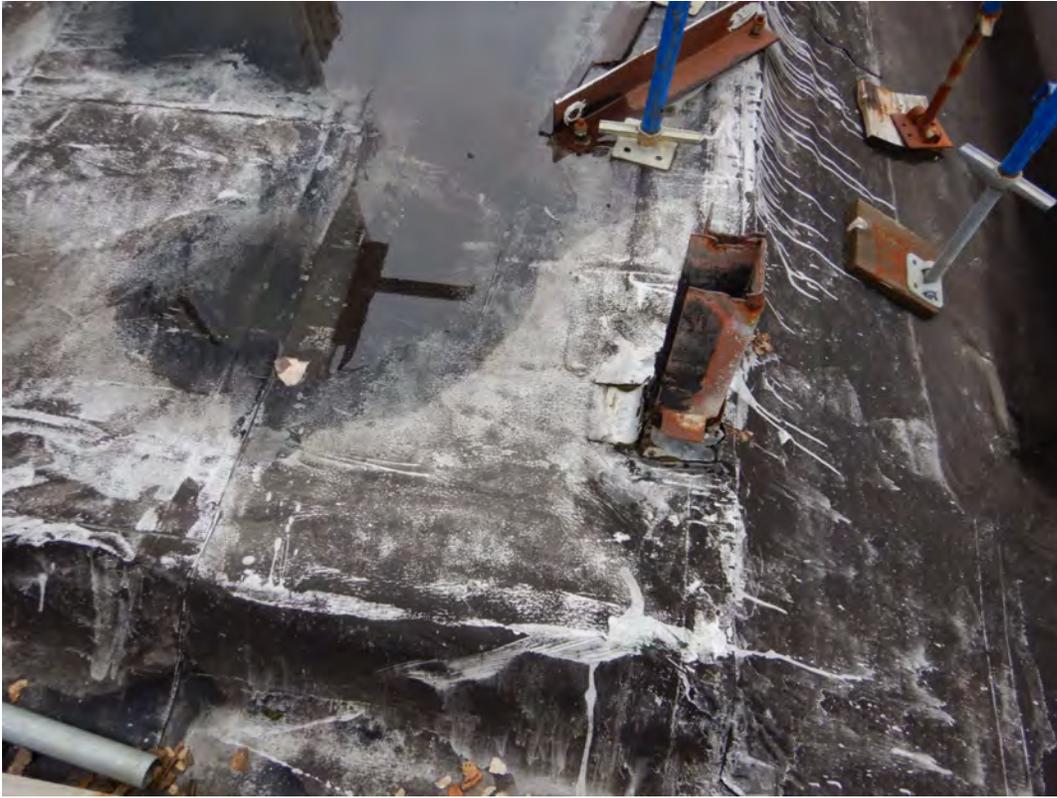
The main roof's upper portion is flat and has standing water. Vegetation is growing out of the roof. The sloped portion has abandoned skylights that are roofed over. The low flat perimeter slopes from a high point at the southeast corner down to the north and then to the low point at the northwest corner near the fire escape. Only one roof drain drains the entire roof, and it was clogged with debris. The roof membrane terminates on the inside brick parapet with a termination bar along the north and east elevations. The termination bar sealant is failing while the brick parapet wall is deteriorated. The roof membrane is severely deteriorated and membrane details at parapets, and penetrations are failed. Corroded metal coping covers the top of the remaining brick and terra cotta parapet wall, after a portion of the parapet was previously removed. Terra cotta coping caps the south and west parapet walls with the pieces temporarily anchored to prevent dislodgement.

Failed roofing membrane and ponding water on upper flat roof

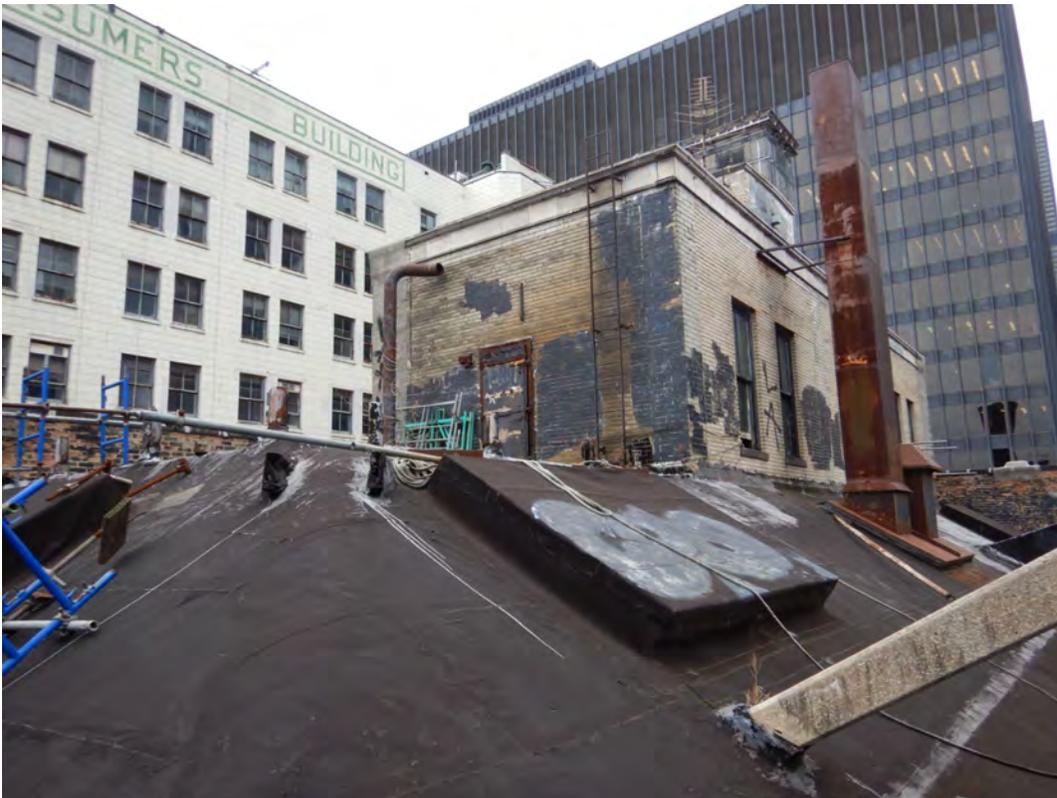
Sloped section of roof with roof covered skylight, penthouse in background

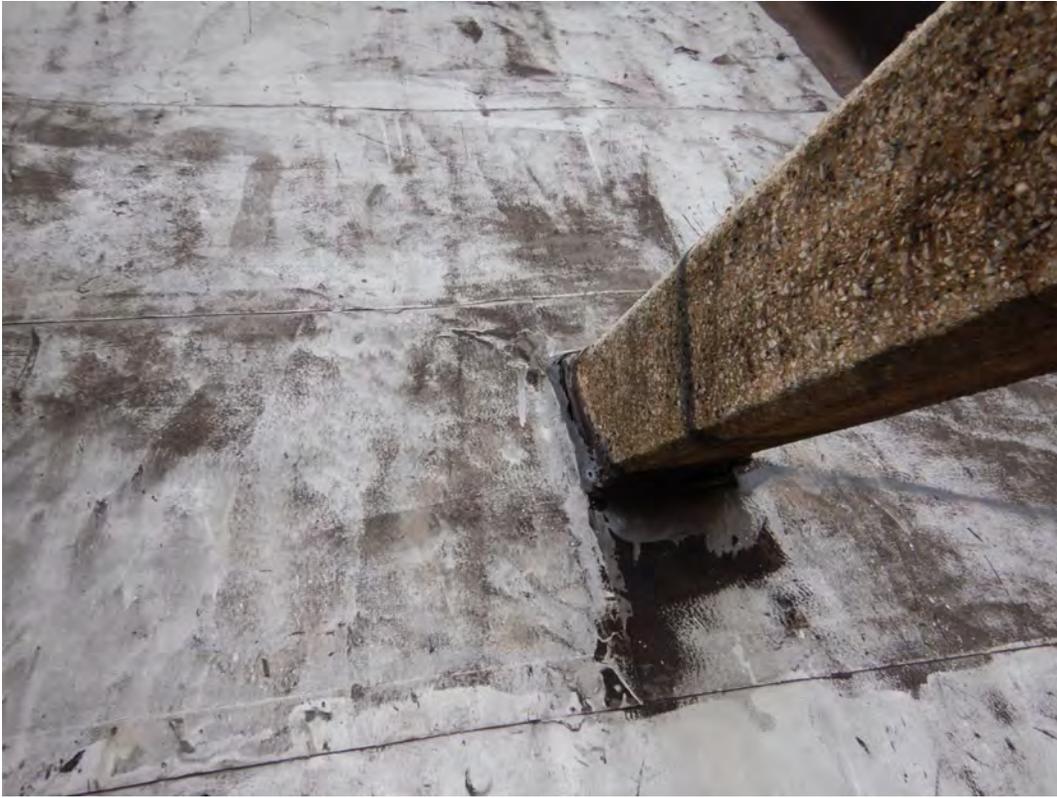
The diagonal steel bracing encased in concrete that supports the tall parapet wall penetrates the roof membrane. The braces as well as the interface with the roof are deteriorated. Plant growth occurs at the roof intersections.

Failed roof membrane at parapet brace

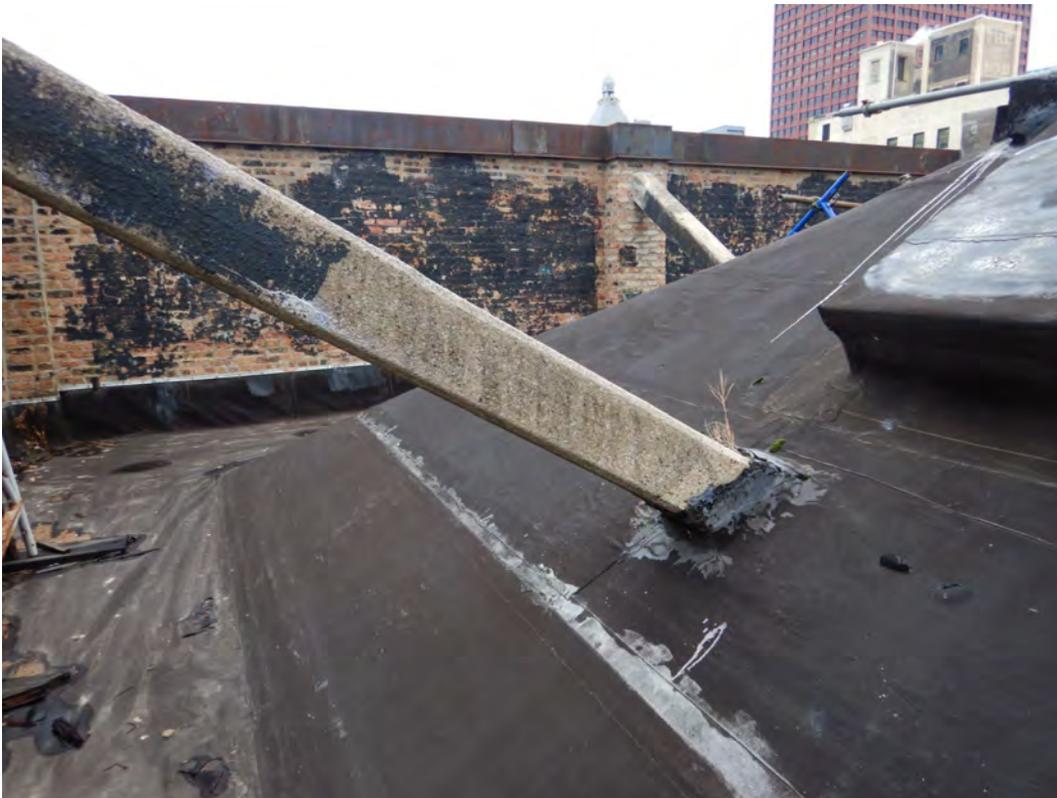
Vegetation growing out of diagonal brace to roof membrane juncture

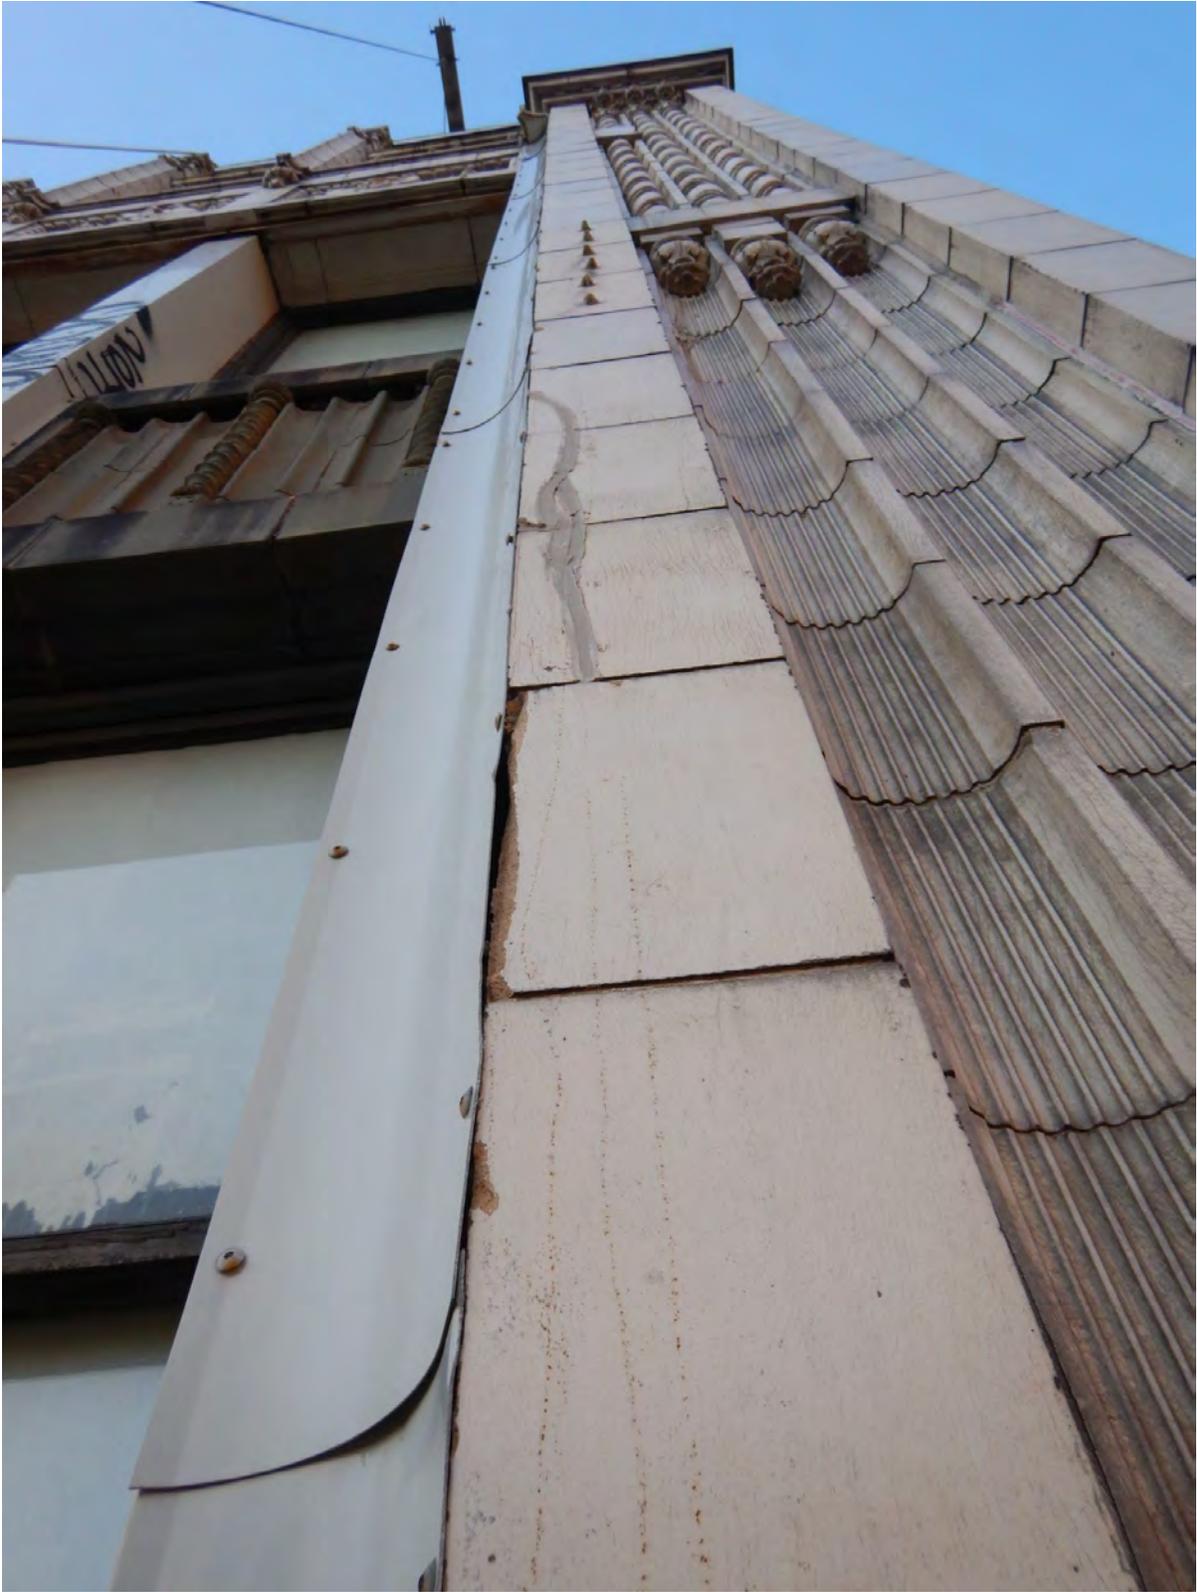
The columns are clad with fluted terra cotta units. The quarter-round units at the edge of the columns have been removed and the gap covered with aluminum sheeting. Terra cotta column units are generally in fair condition with localized cracking and glazing spalls. Terra cotta units adjacent to the fire escape show signs of extensive cracks and spalls due to corroded metal embedments for the fire escape. Previous repair efforts appear to be temporary in nature, including stabilization pins and crack repairs. The aluminum sheeting appeared to be in place and intact. Mortar joints generally appeared aged and weathered. Sealants are typically in poor condition and beyond their service life.

Terra cotta column with cracked units

- e. At locations of terra cotta units with minor deterioration (e.g., minimal cracks), terra cotta units are recommended to be removed, repaired and reinstalled.

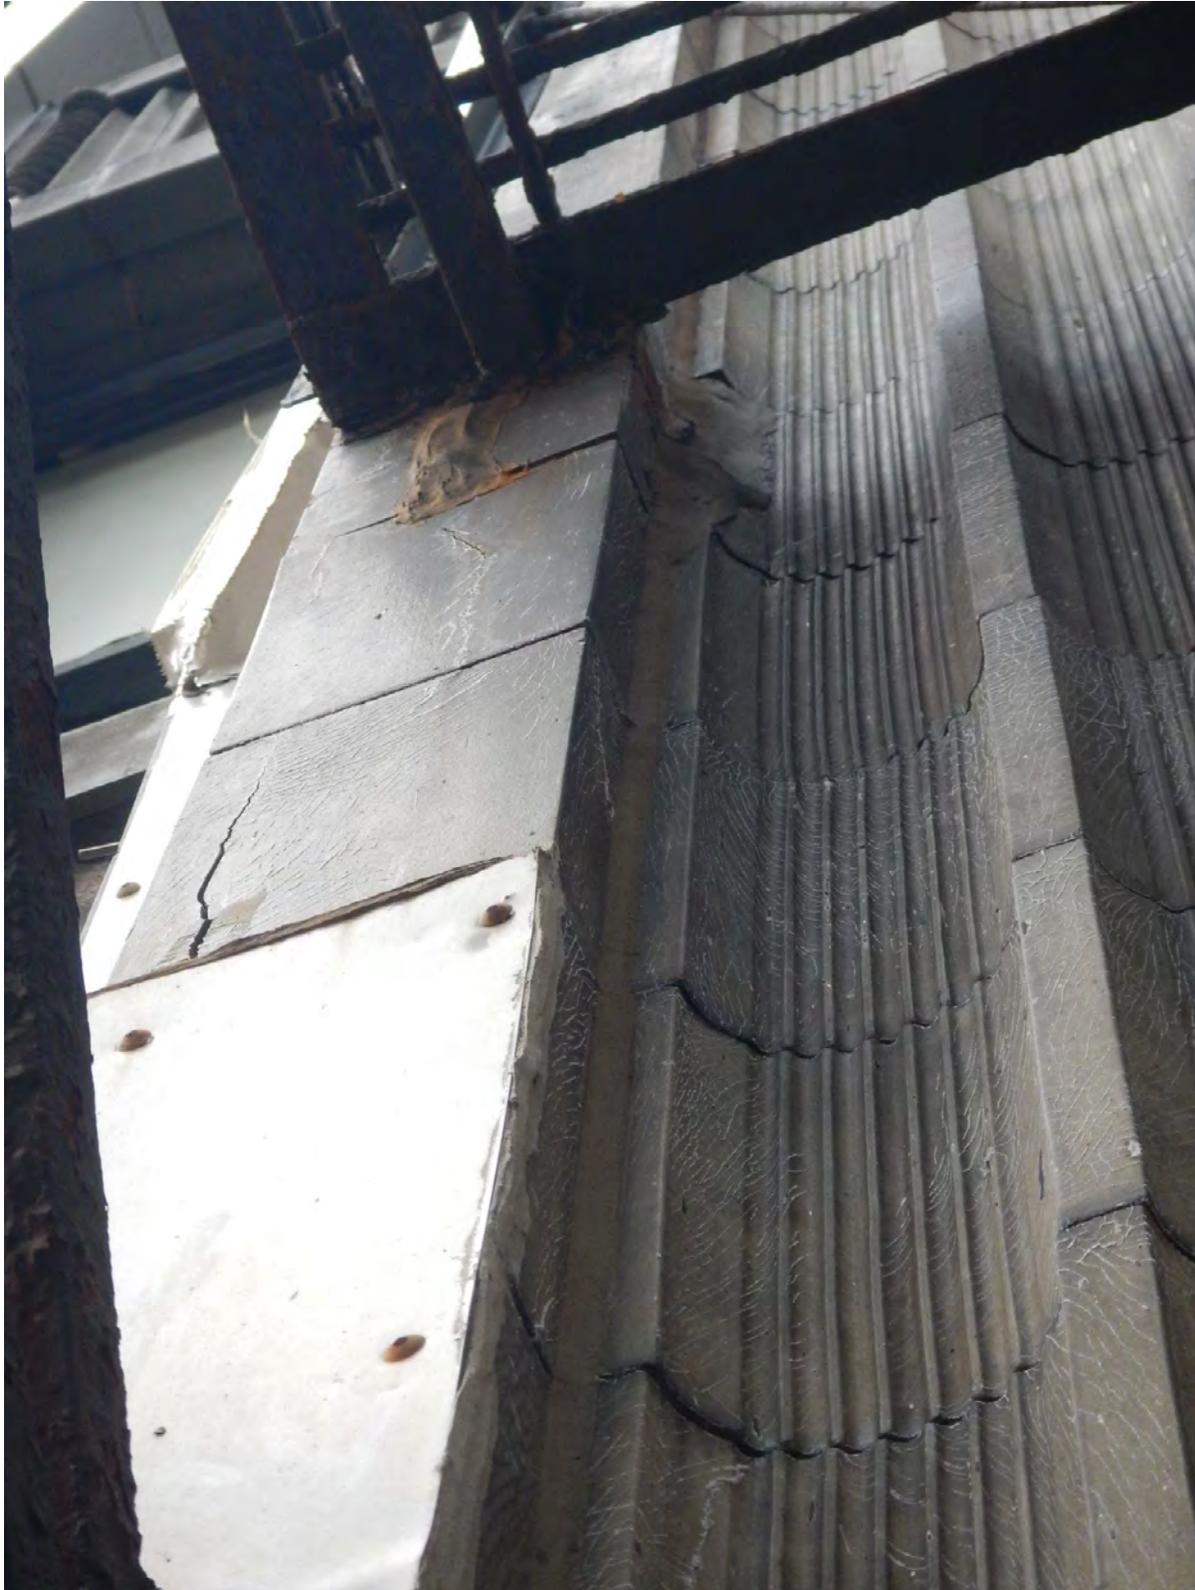
Terra cotta column with cracked units adjacent to steel fire escape embedments

- f. At locations of localized severely deteriorated terra cotta units (e.g., adjacent to the fire escape), new individual terra cotta units are recommended to be installed to maintain the original aesthetic.

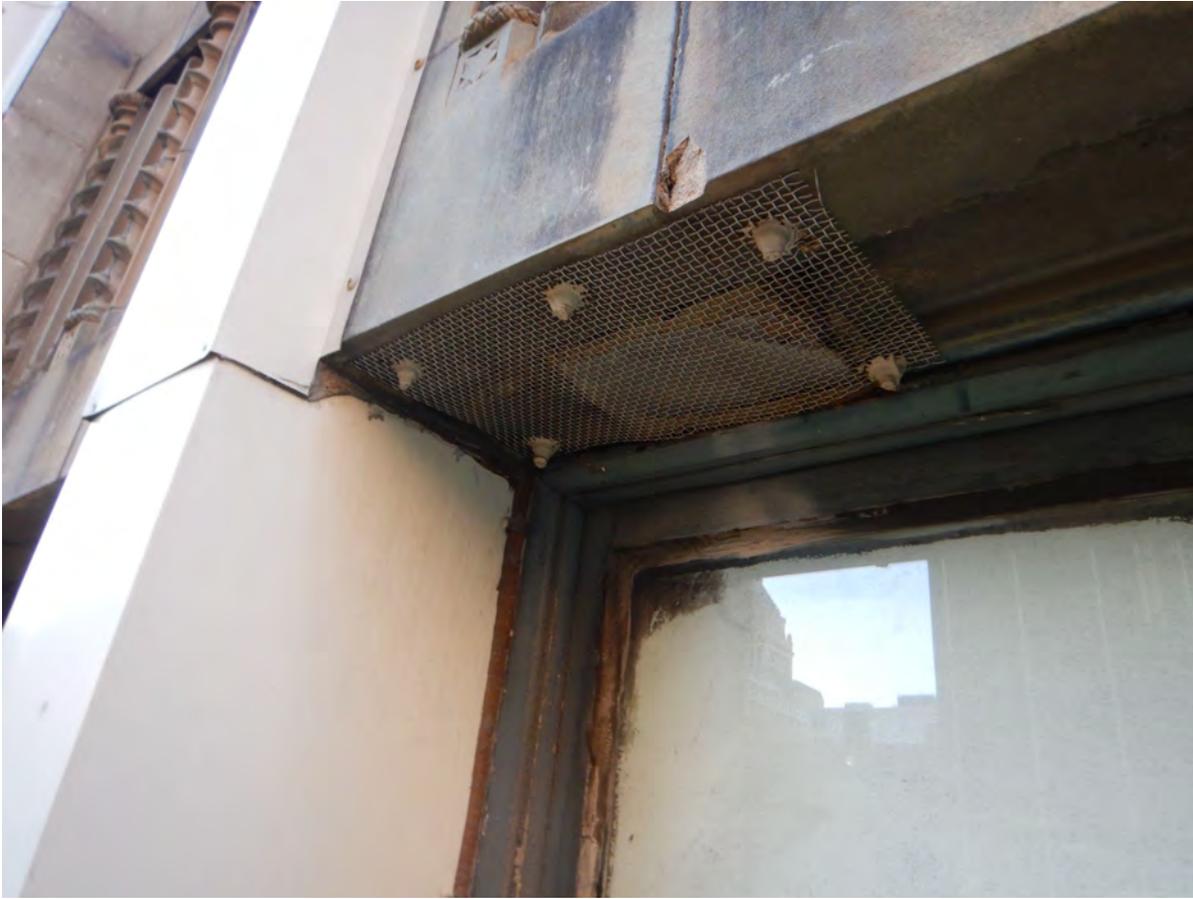
Continuous mullions extend from the third floor window sill to the top of the 15th floor window. Most of the terra cotta mullion units have been removed and the gap covered with aluminum sheeting. The aluminum sheeting appeared to be intact and in place. Where the original terra cotta mullion units are in situ, mainly at the 3rd floor, the terra cotta is typically cracked. Mortar joints generally appeared aged and weathered. Sealants are typically in poor condition and beyond their service life.

Continuous mullion clad in aluminum sheeting and spandrel unit

- b. Repointing all mortar joints is recommended.
  - c. Replacement of all sealants is recommended.
  - d. At locations where all or a significant portion of a terra cotta element is missing (e.g., quarter rounds at columns, continuous mullions), the units could be reconstructed either with new terra cotta replacement units or a new panelized glass fiber reinforced concrete (GFRC) system designed to mimic the original aesthetic. GFRC is much lighter and easier to install than traditional terra cotta but does have maintenance requirements.

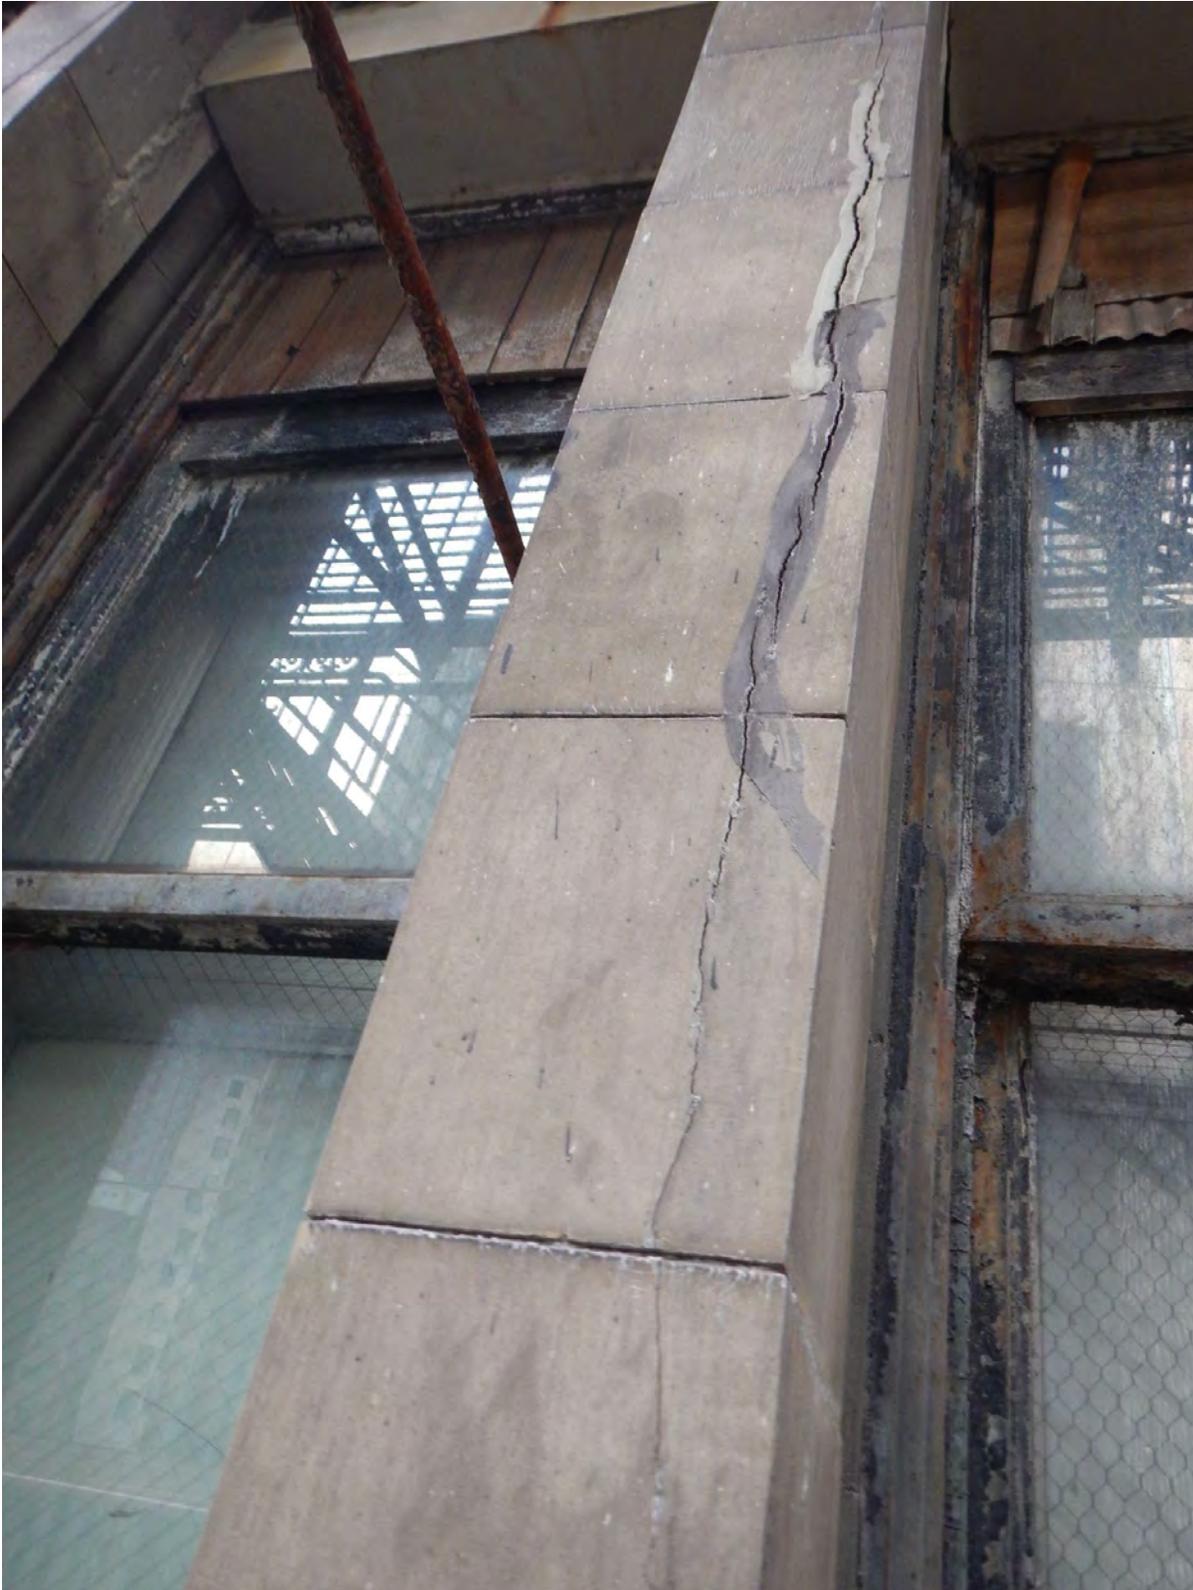
Terra cotta mullion with cracked units adjacent to steel fire escape fire escape embedments and steel framed window with wire glass

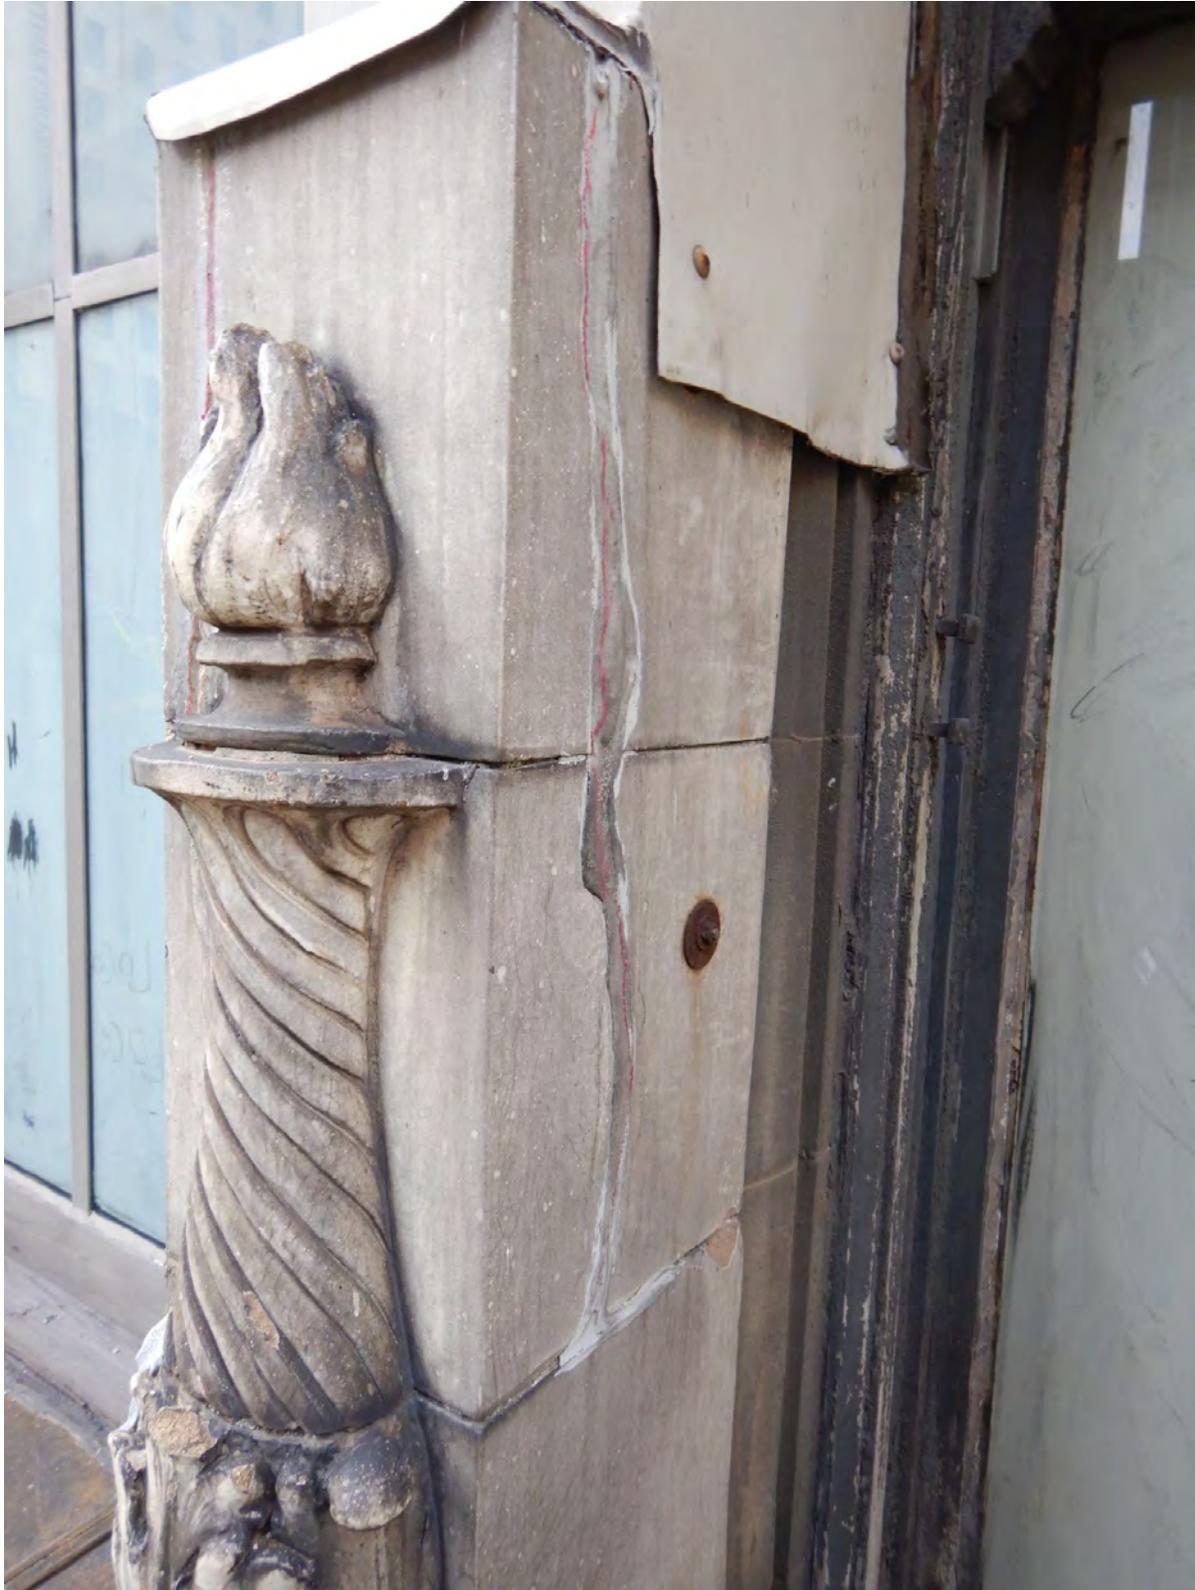
Terra cotta mullion with cracked units

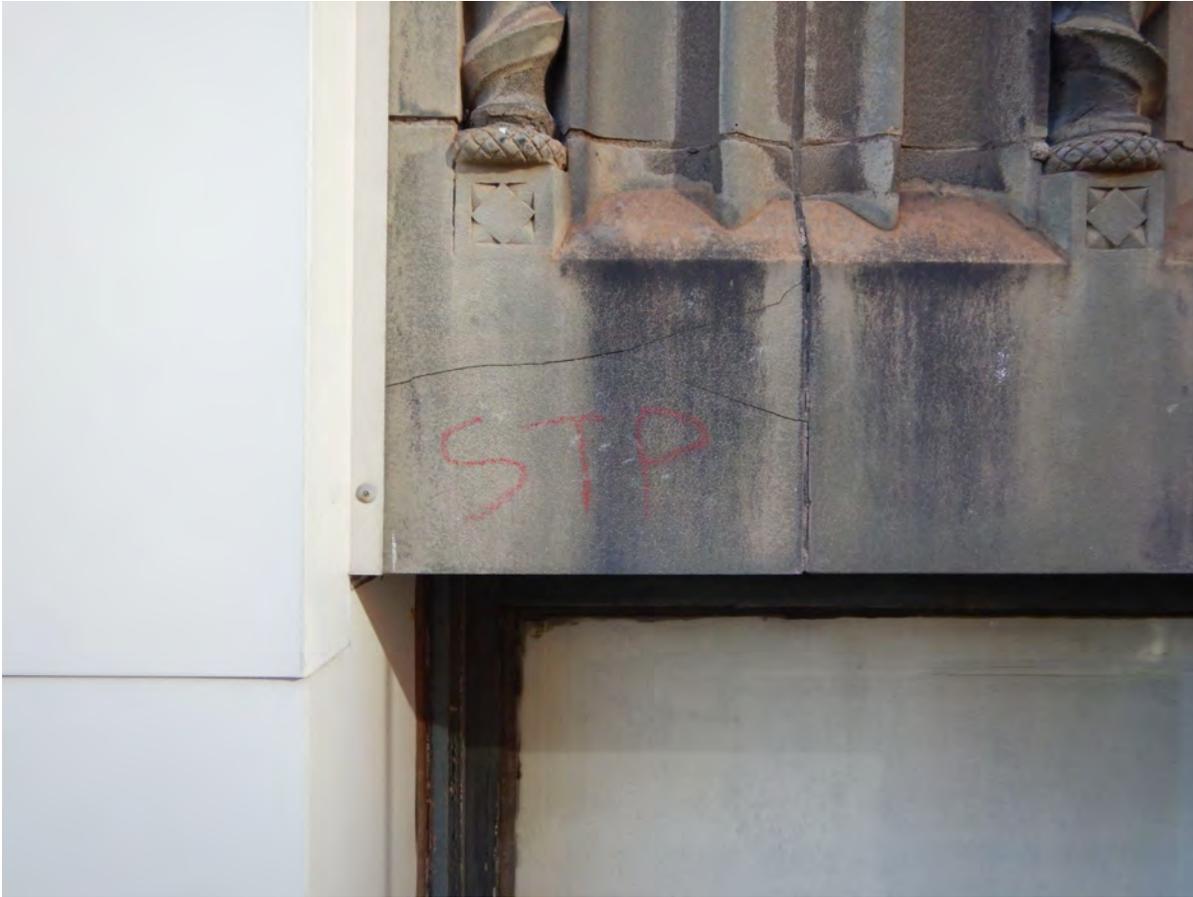
The sill and middle courses are generally in good to fair condition, while the window head course tends to have varying degrees of cracking due to corrosion of embedded steel elements. A number of previous repair efforts were observed. Metal support channels exist at the window head course of floors 14 and 15. These metal channels have begun to corrode. Steel straps and steel mesh were noted at several window head locations across the north and east elevations. Terra cotta surface glaze spalls were noted intermittently. Numerous previous crack repairs, as well as some newer cracks, were observed at several window head locations across both facades. A few units appeared to be slightly displaced. Mortar joints generally appeared aged and weathered. Sealants are typically in poor condition and beyond their service life.

Terra cotta spandrel with cracked window head unit

- g. At locations of steel lintel units, it is recommended to fully expose the steel elements, clean and paint the steel, install flashings, and reinstall the terra cotta.

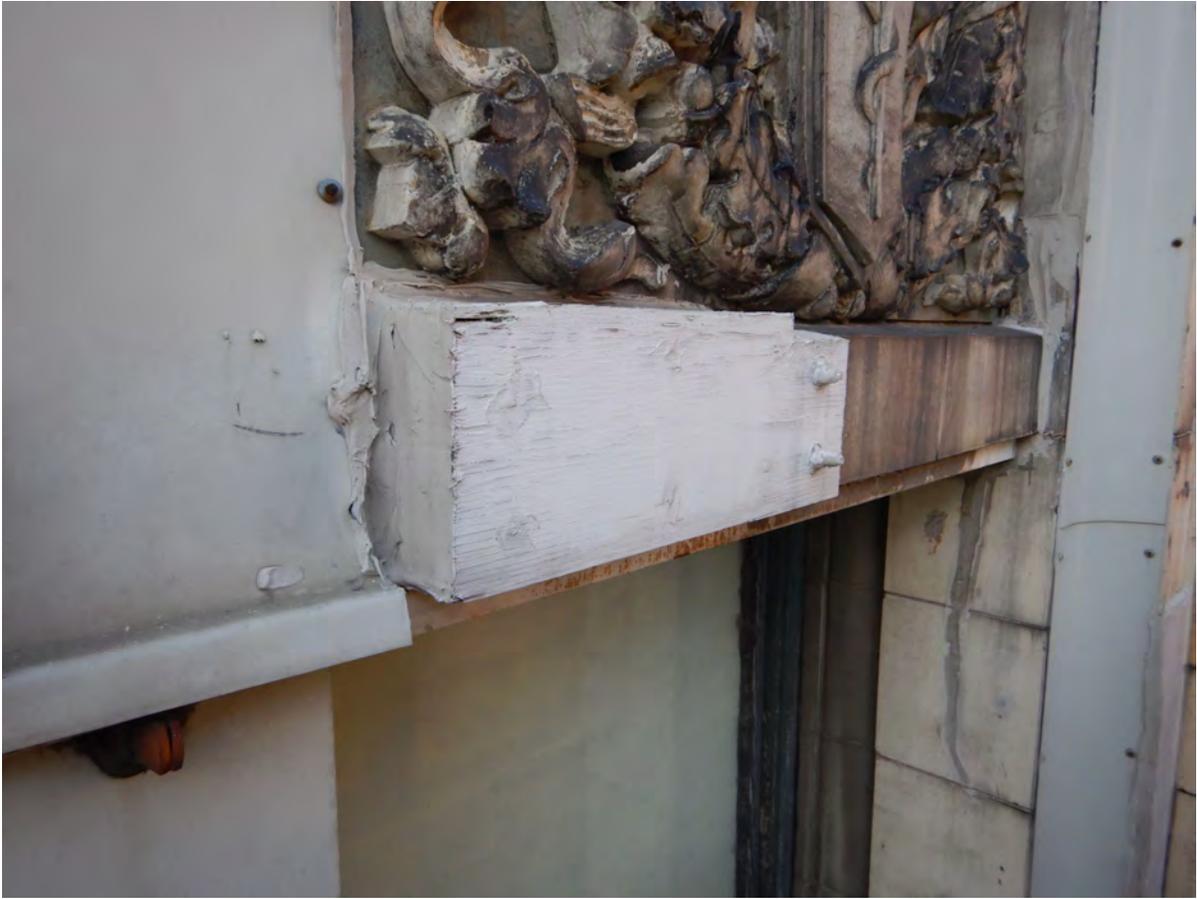
Terra cotta spandrel unit with channel beneath and cracked terra cotta jamb units

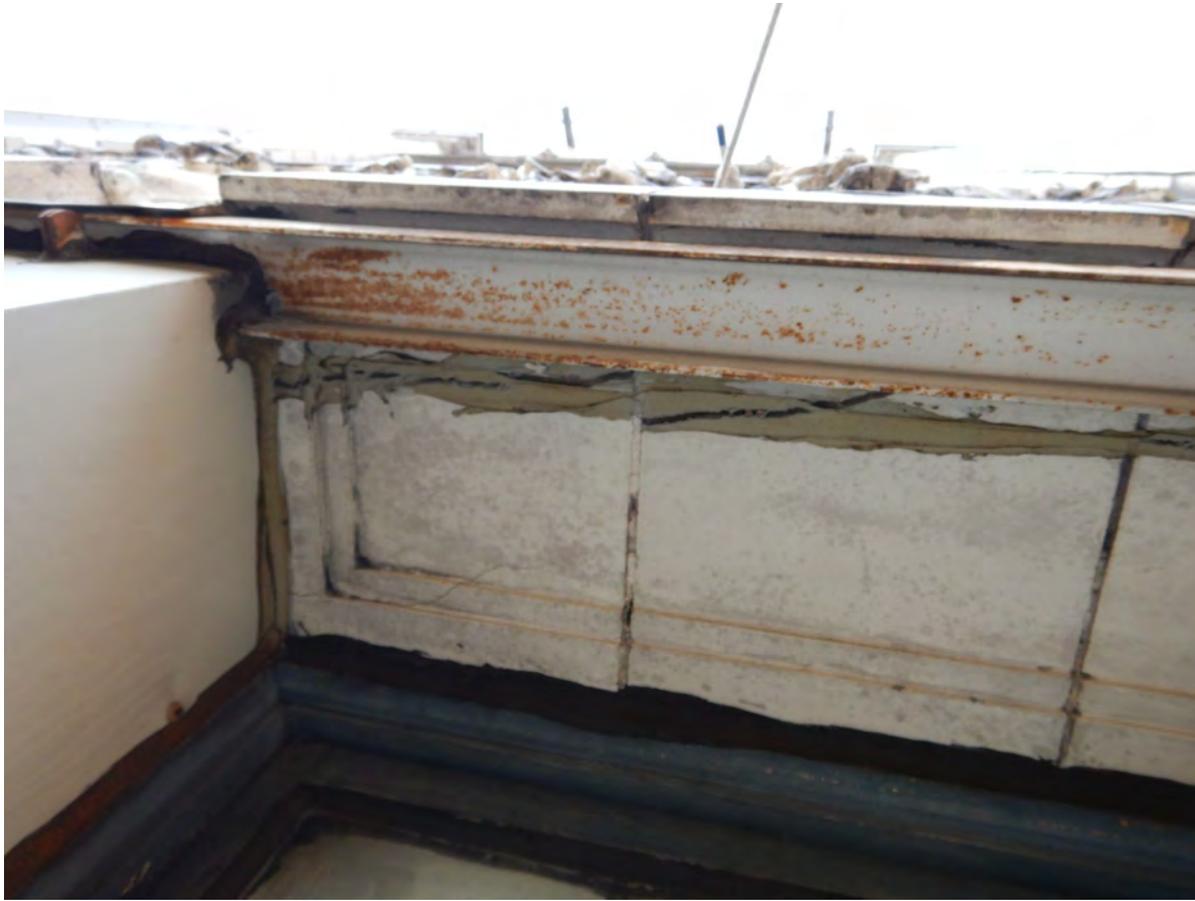
Terra cotta spandrel unit with channel beneath and cracked terra cotta units

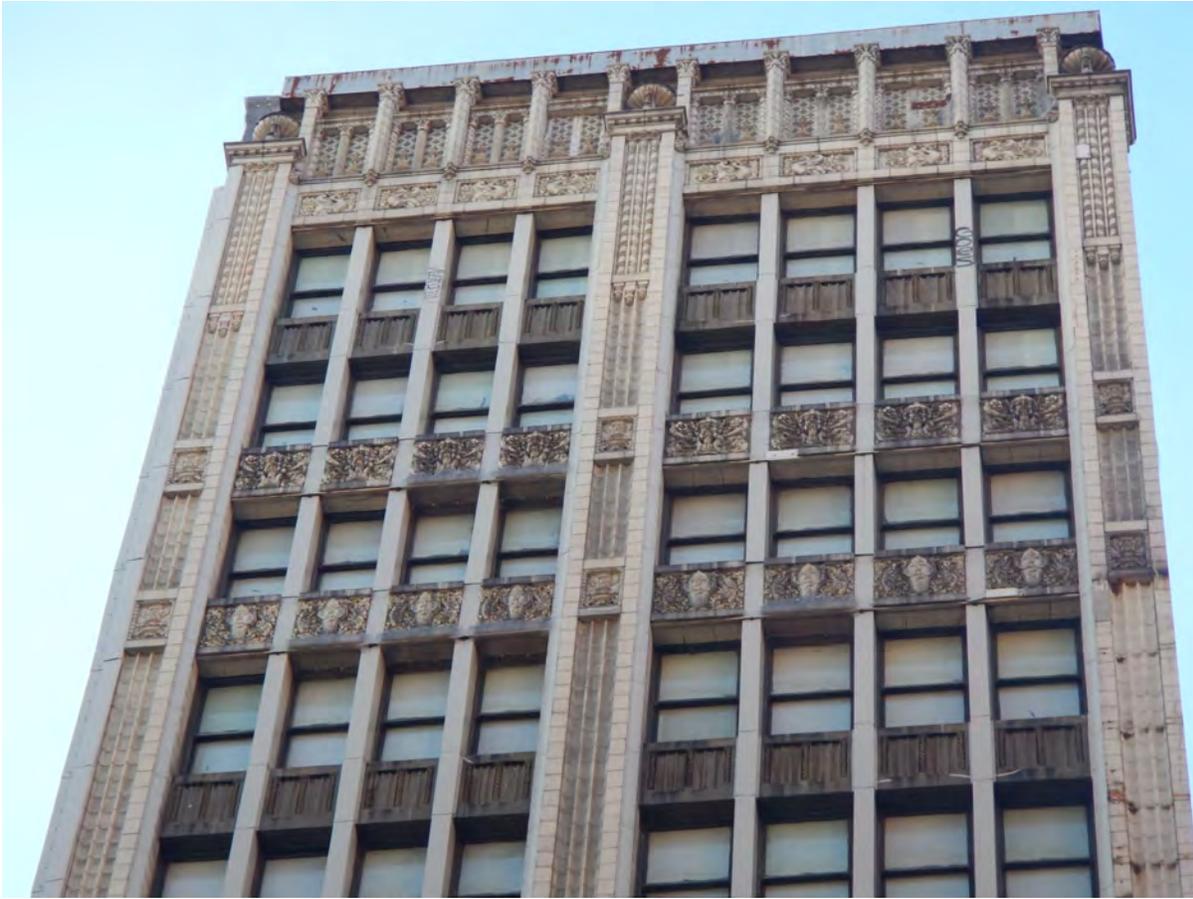
The parapet construction is generally in poor condition. Several of the projecting terra cotta units have been removed and the gap covered with metal sheeting or a parge material, which is typically in poor condition. Previous repair efforts include stabilization pins, strapping, steel mesh and crack repair. New open cracks and glazing spalls were noted across the parapet walls. The large terra cotta urns that cap each column have been strapped with wire cables. Displacement and cracking of terra cotta units was observed across the parapets. Widened or open joints were noted at the majority of the joints. Sealants have failed and beyond their service life.

Overview of parapet and upper floors of east elevation

- h. Parapet Walls – Due to the extent of distress, the existing parapet walls are recommended to be dis-assembled and terra cotta units salvaged and
