GSA Great Lakes Region

# **202 State Street Evaluation Report**

**202 S State Street**

Report Issuance 6.1.23

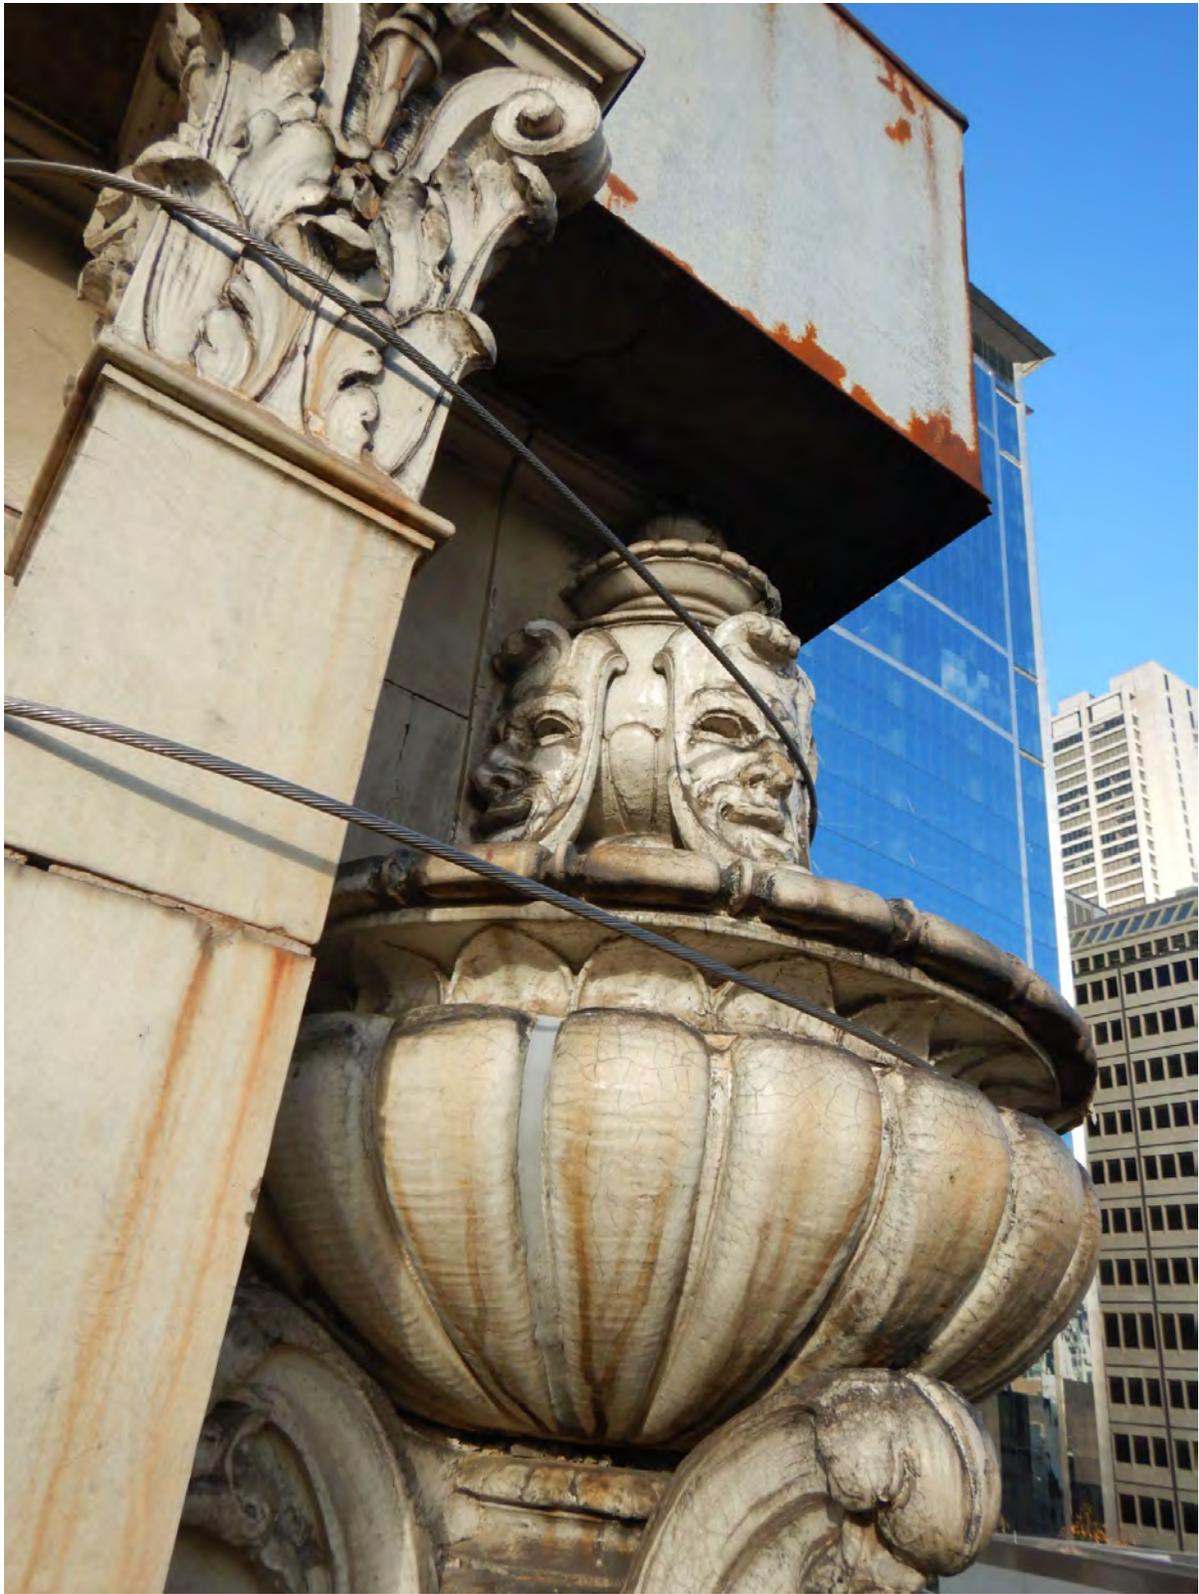
Strapped terra cotta urn at parapet wall

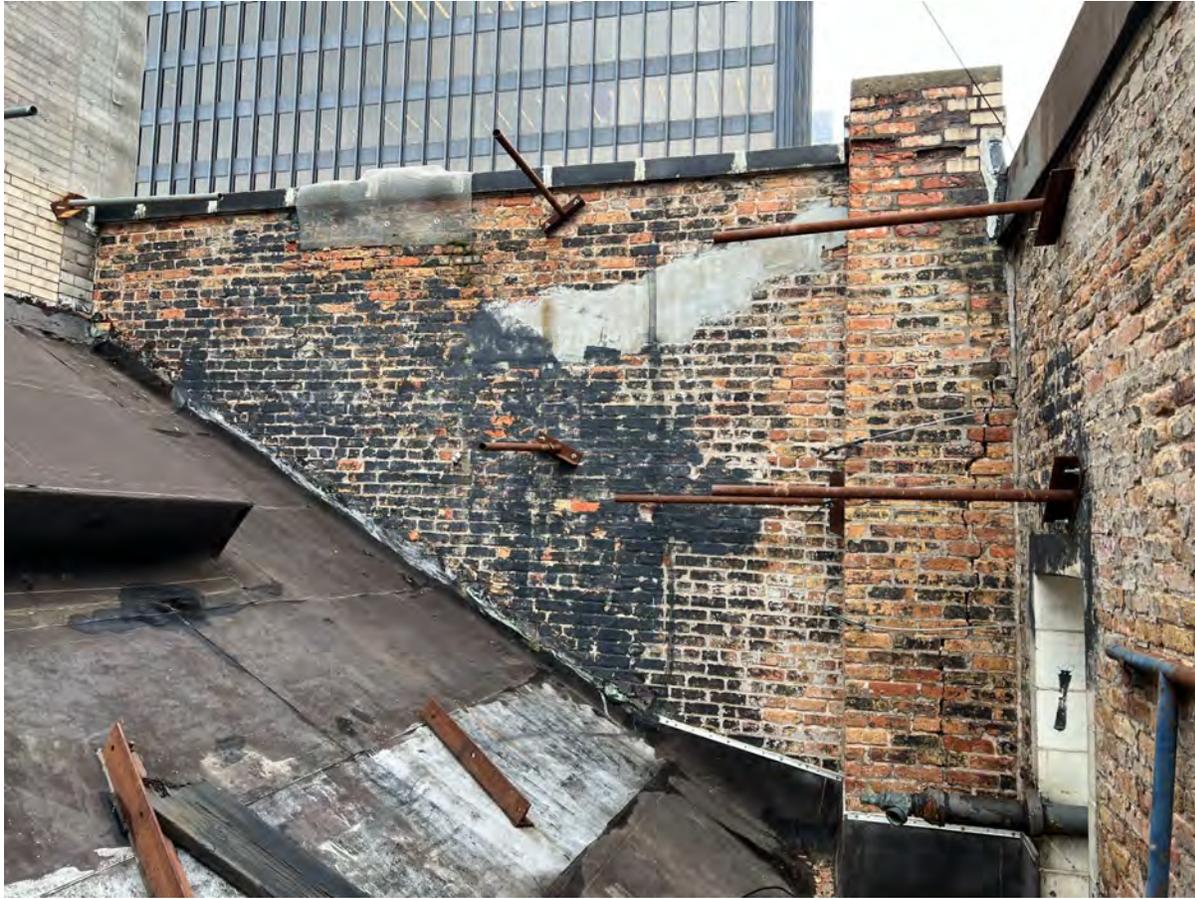
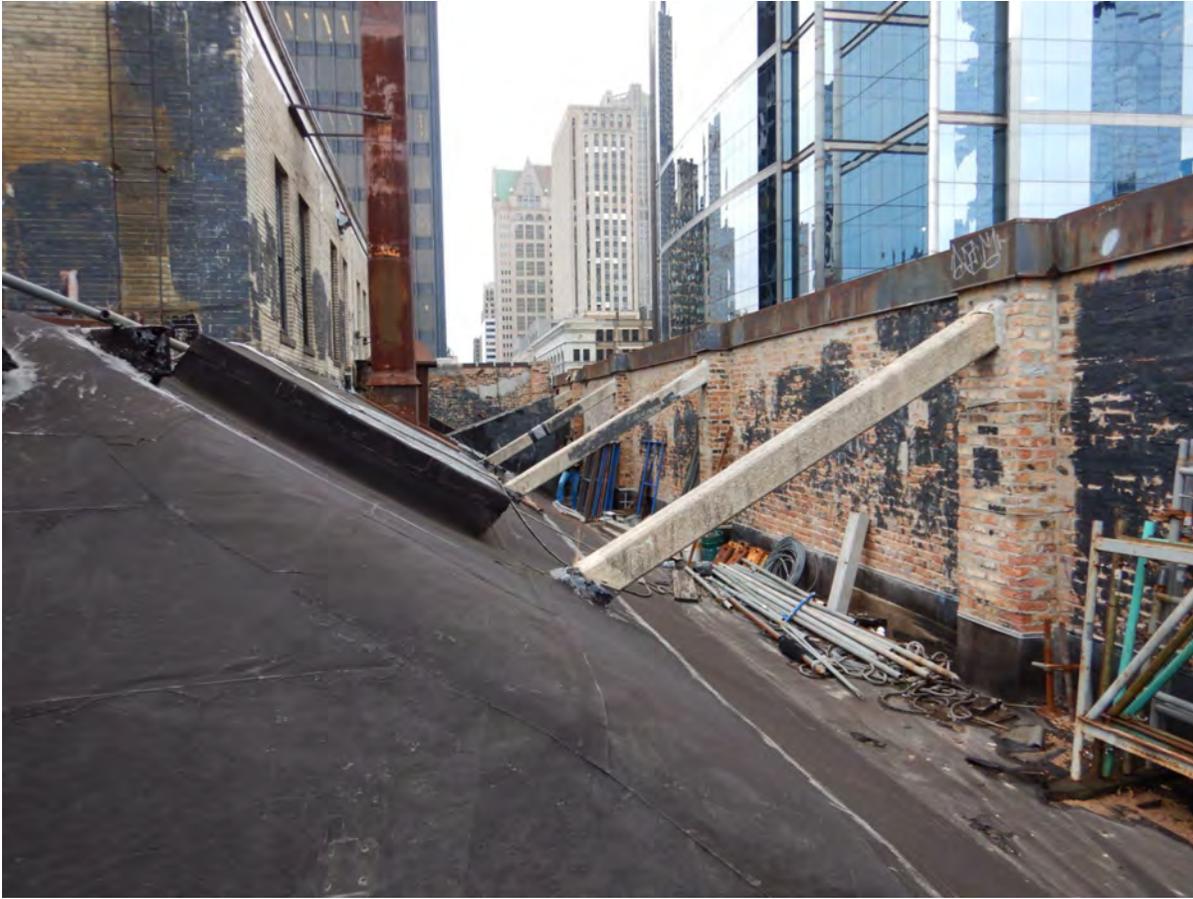
The roof side of the north and east parapet walls are one-story high common brick masonry, supported by steel columns embedded in the brick masonry. Steel kickers support the tops of the columns and are encased in concrete. The roof side brick masonry of the parapets is extremely deteriorated. The brick masonry and mortar joints are severely weathered. The concrete encasements are cracked. Exposed steel components have begun to corrode.

Roof side of parapet wall

- h. Parapet Walls – Due to the extent of distress, the existing parapet walls are recommended to be dis-assembled and terra cotta units salvaged and

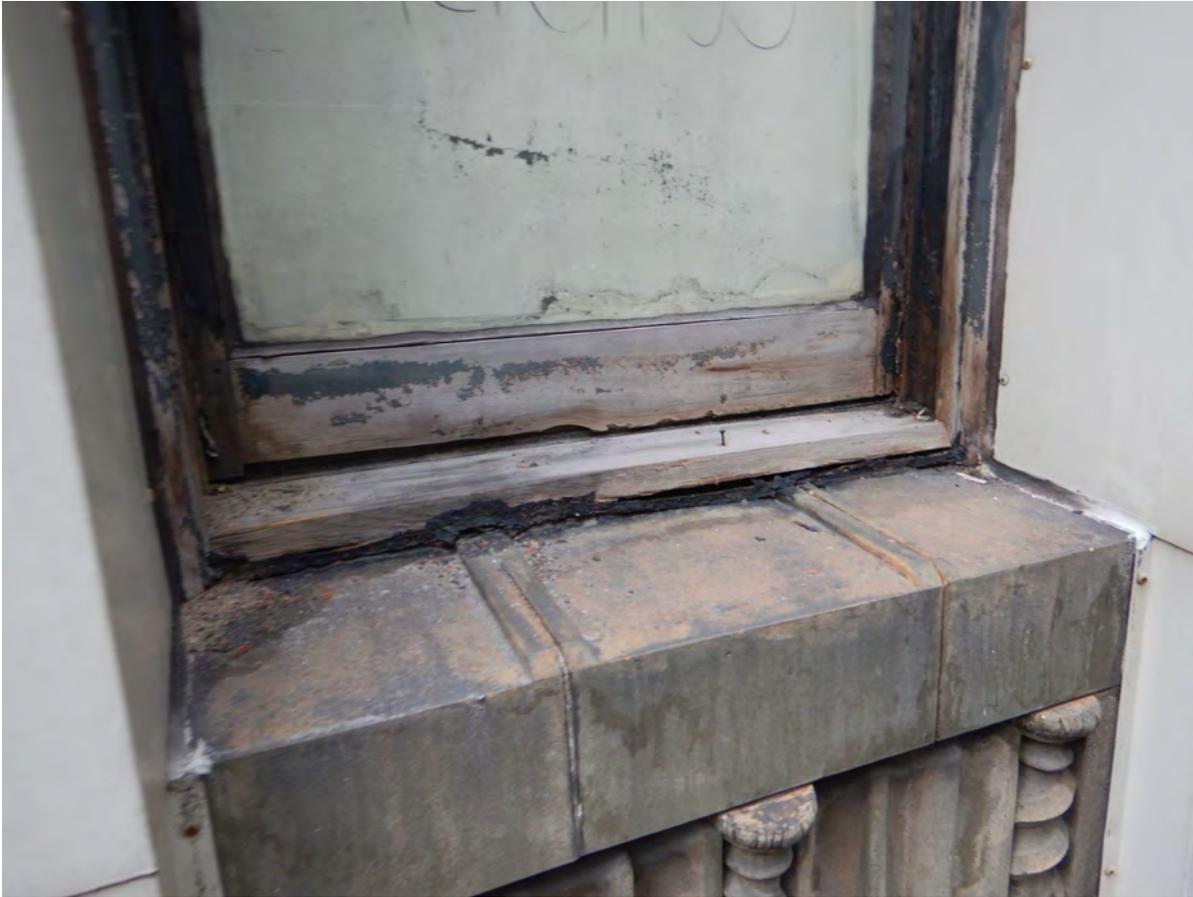
Windows and doors are in poor condition. The coating has worn away leaving the wood and steel exposed to the weather. The wood windows, including the glazing putty, are in very poor condition. Steel windows and doors have begun to corrode and are not operable. Sealants have failed and are beyond their service life.

Typical deteriorated wood window with failed coatings, sealants and glazing

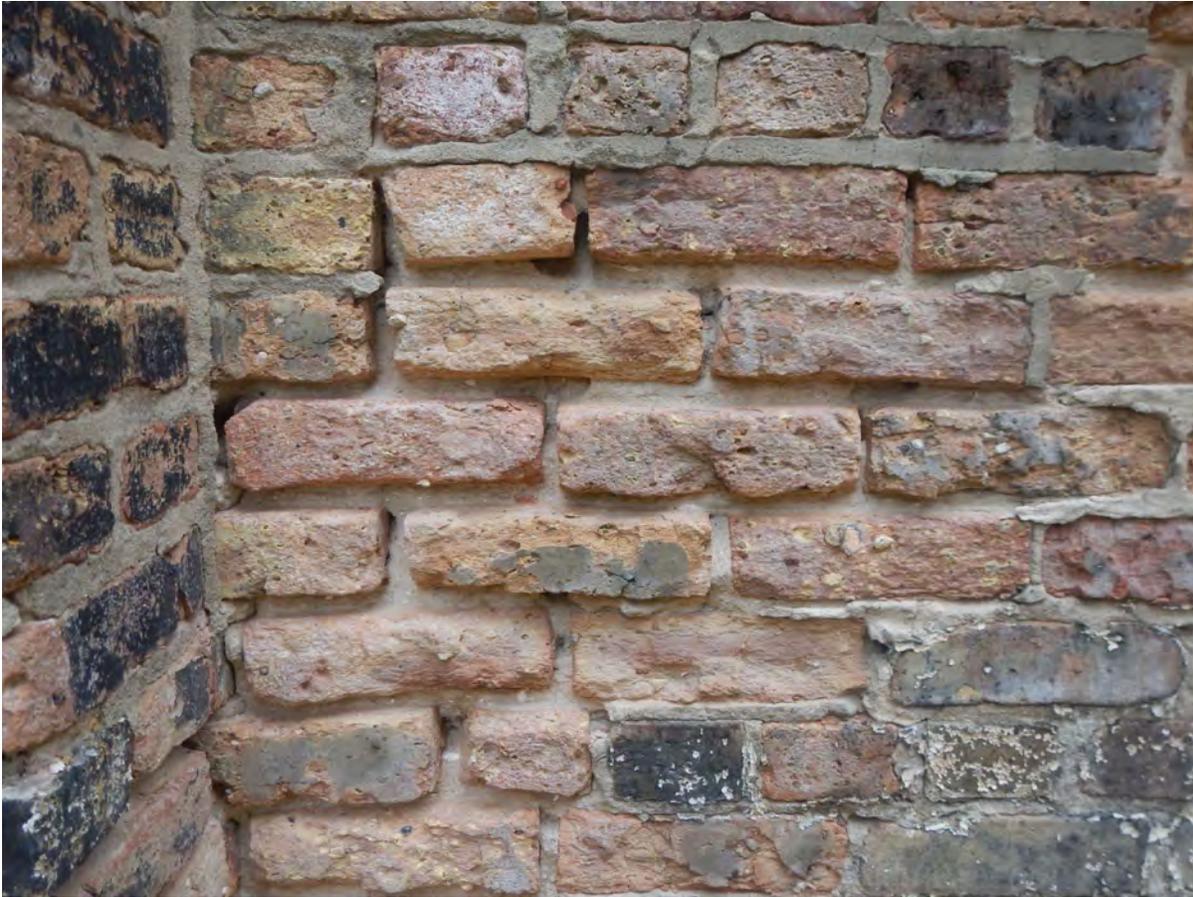
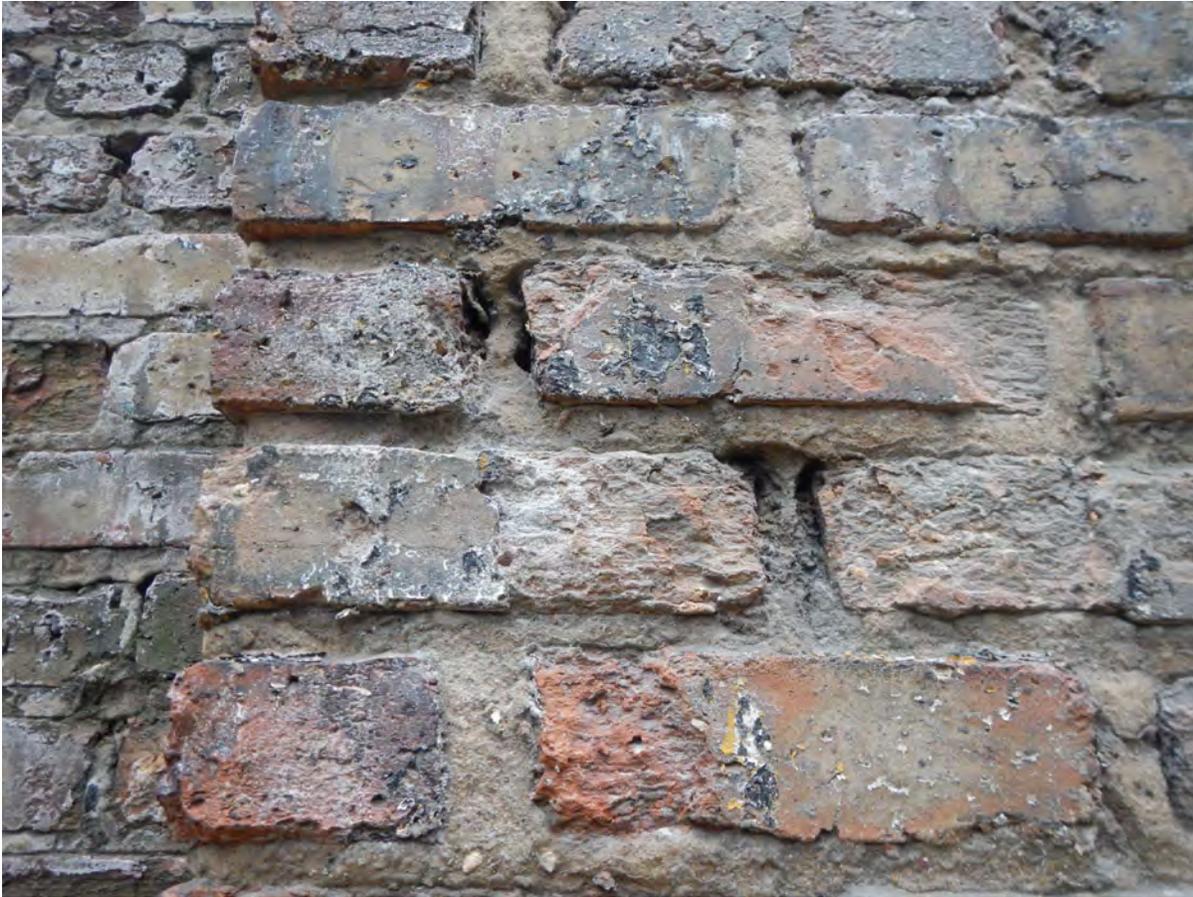
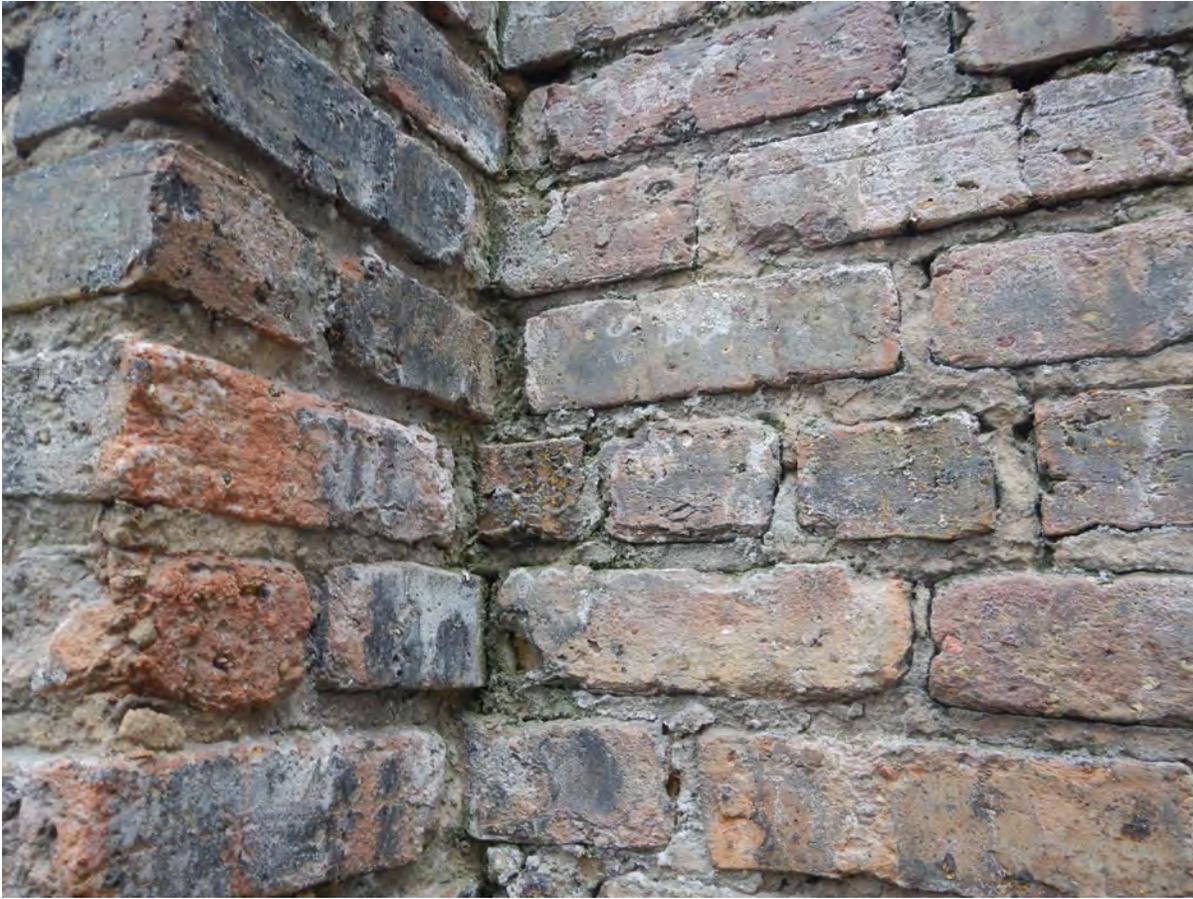
The west elevation is in generally fair to poor condition. Mortar joints were completely repointed at several floors, but large areas of eroded brick masonry and mortar joints still exist across the facade.

Weathered brick masonry and mortar joints

c. Repointing all mortar joints is recommended.

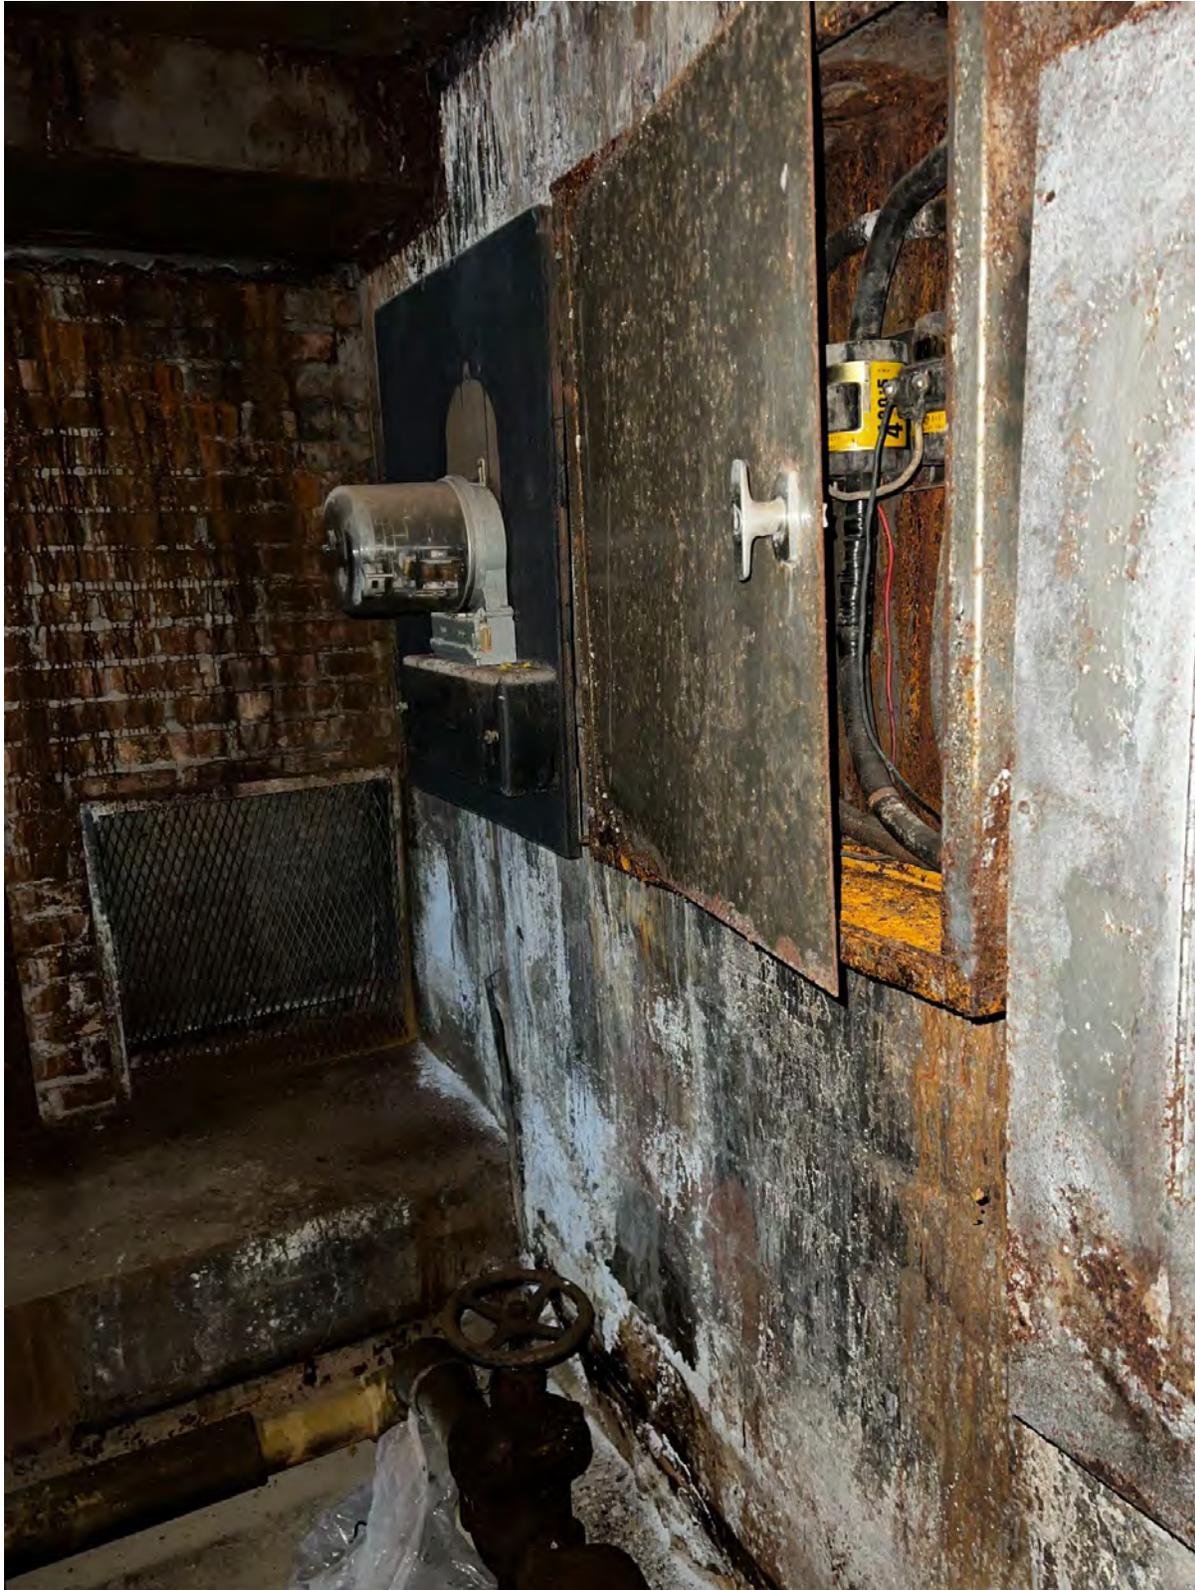
Sub Basement: Existing meter and incoming wire feeds degraded by water damage

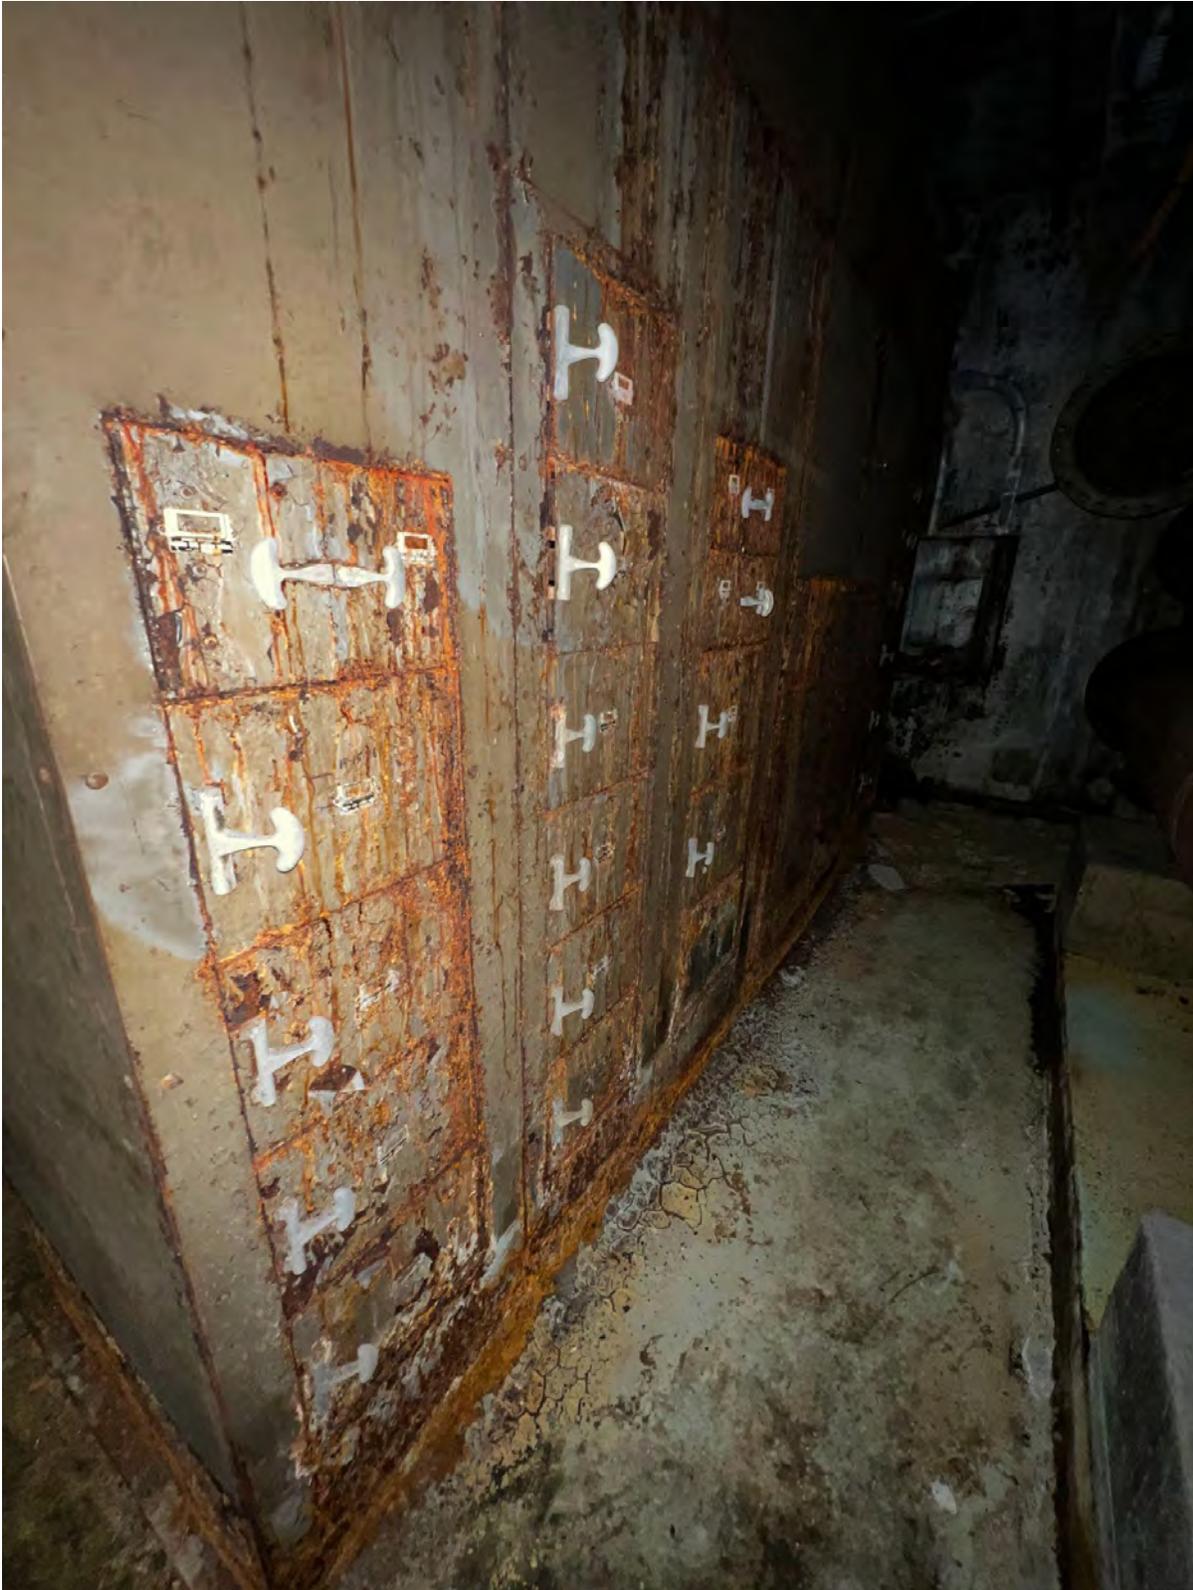
Sub-Basement: Existing switchboard - Degraded due to water damage

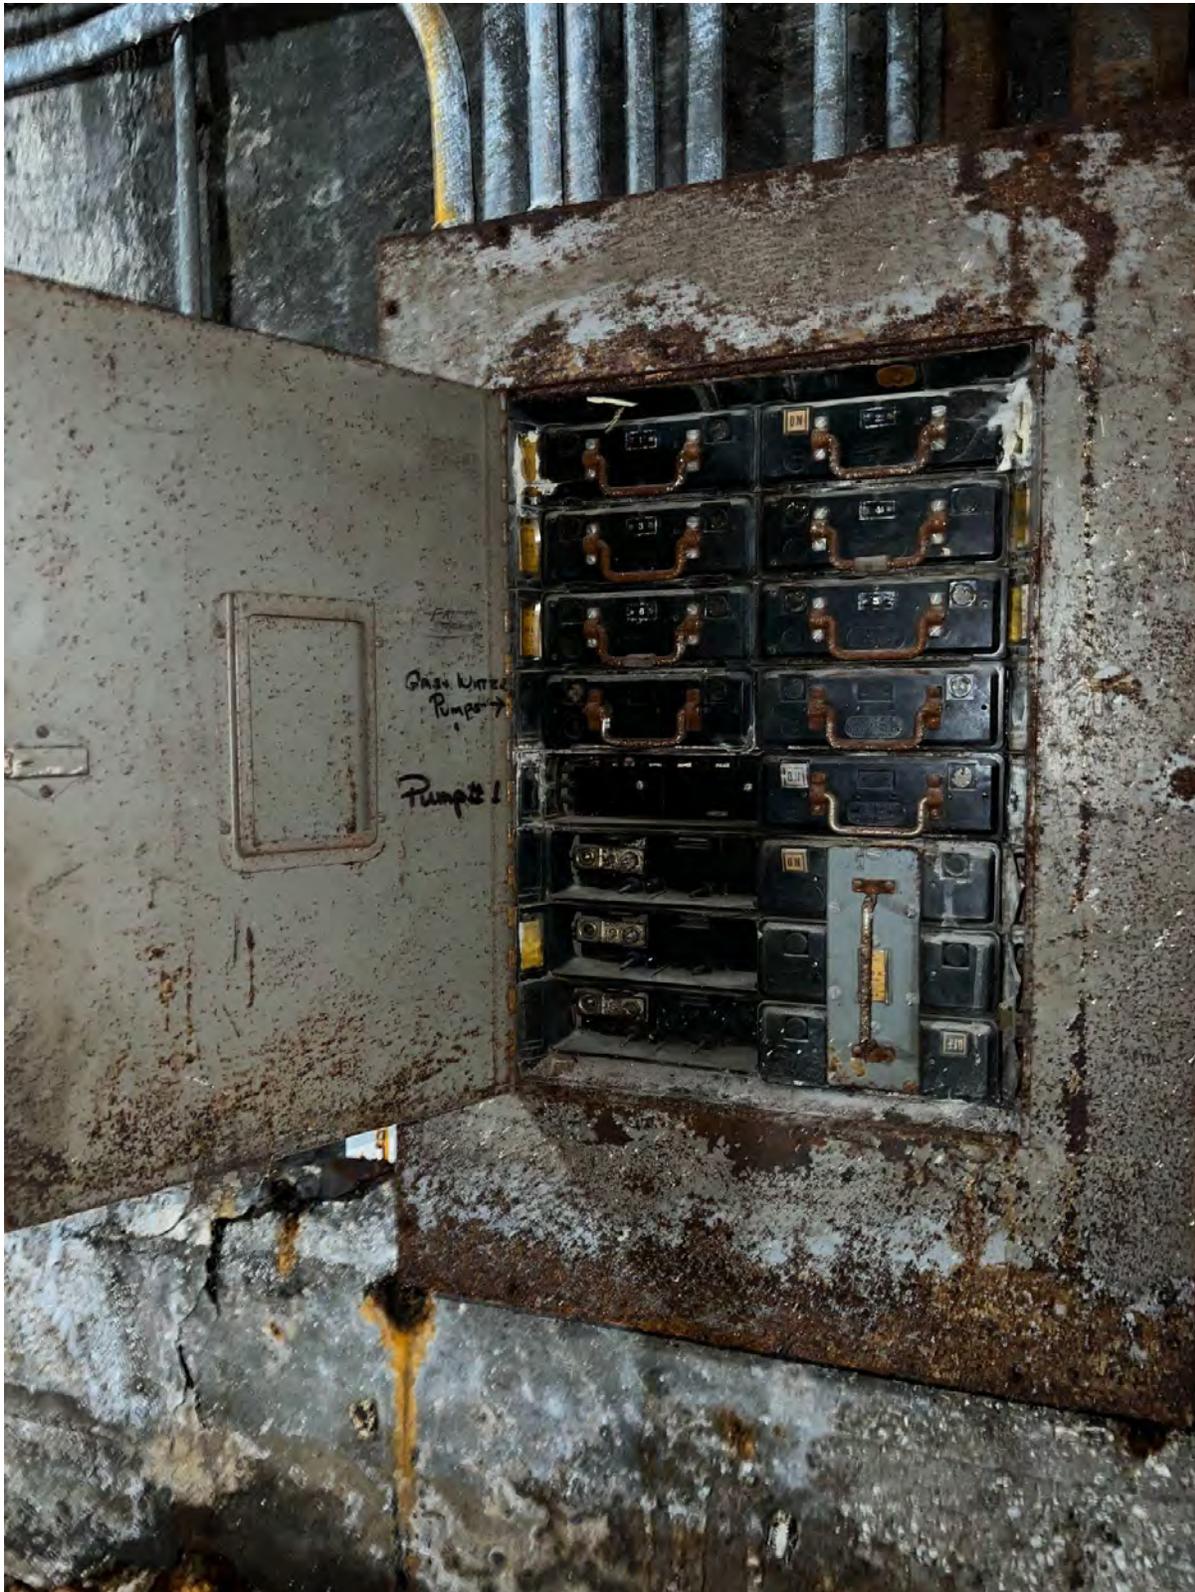
Sub-Basement: House panel with outdated style breakers.

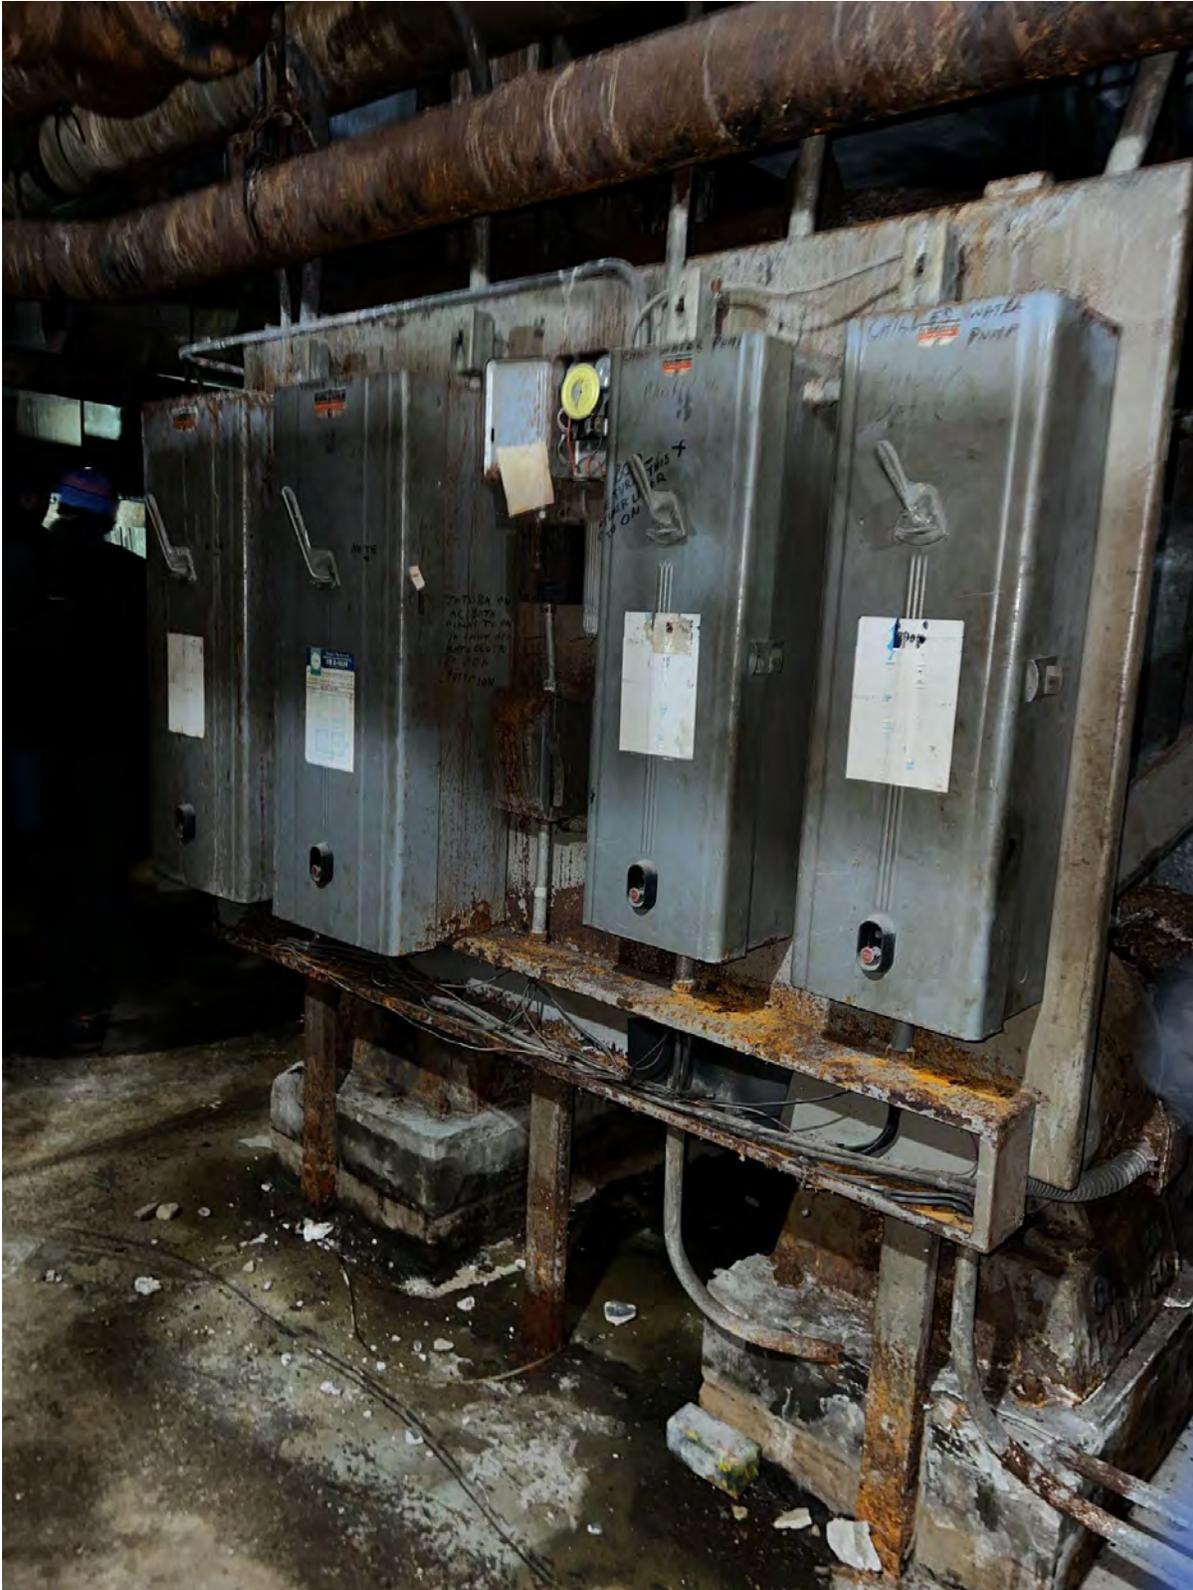
Sub-Basement: Outdated mechanical equipment disconnects

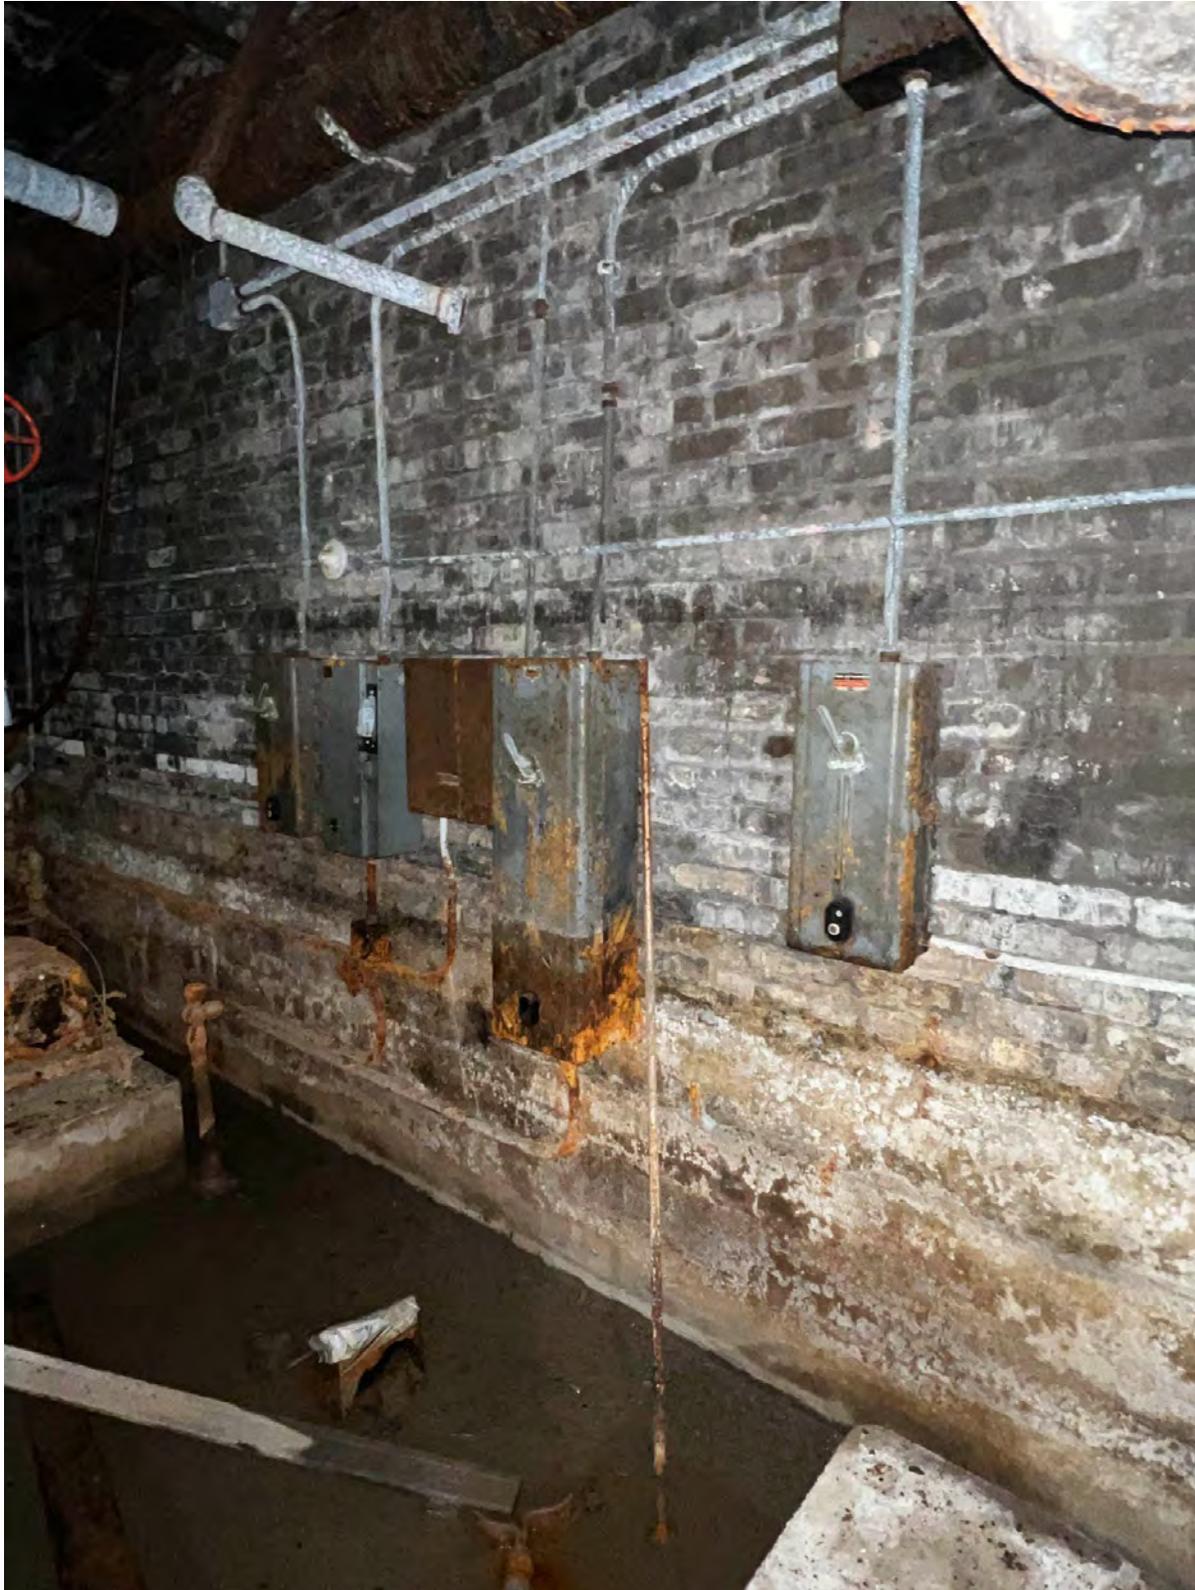
Sub-Basement: Equipment Disconnects degraded by water damage.

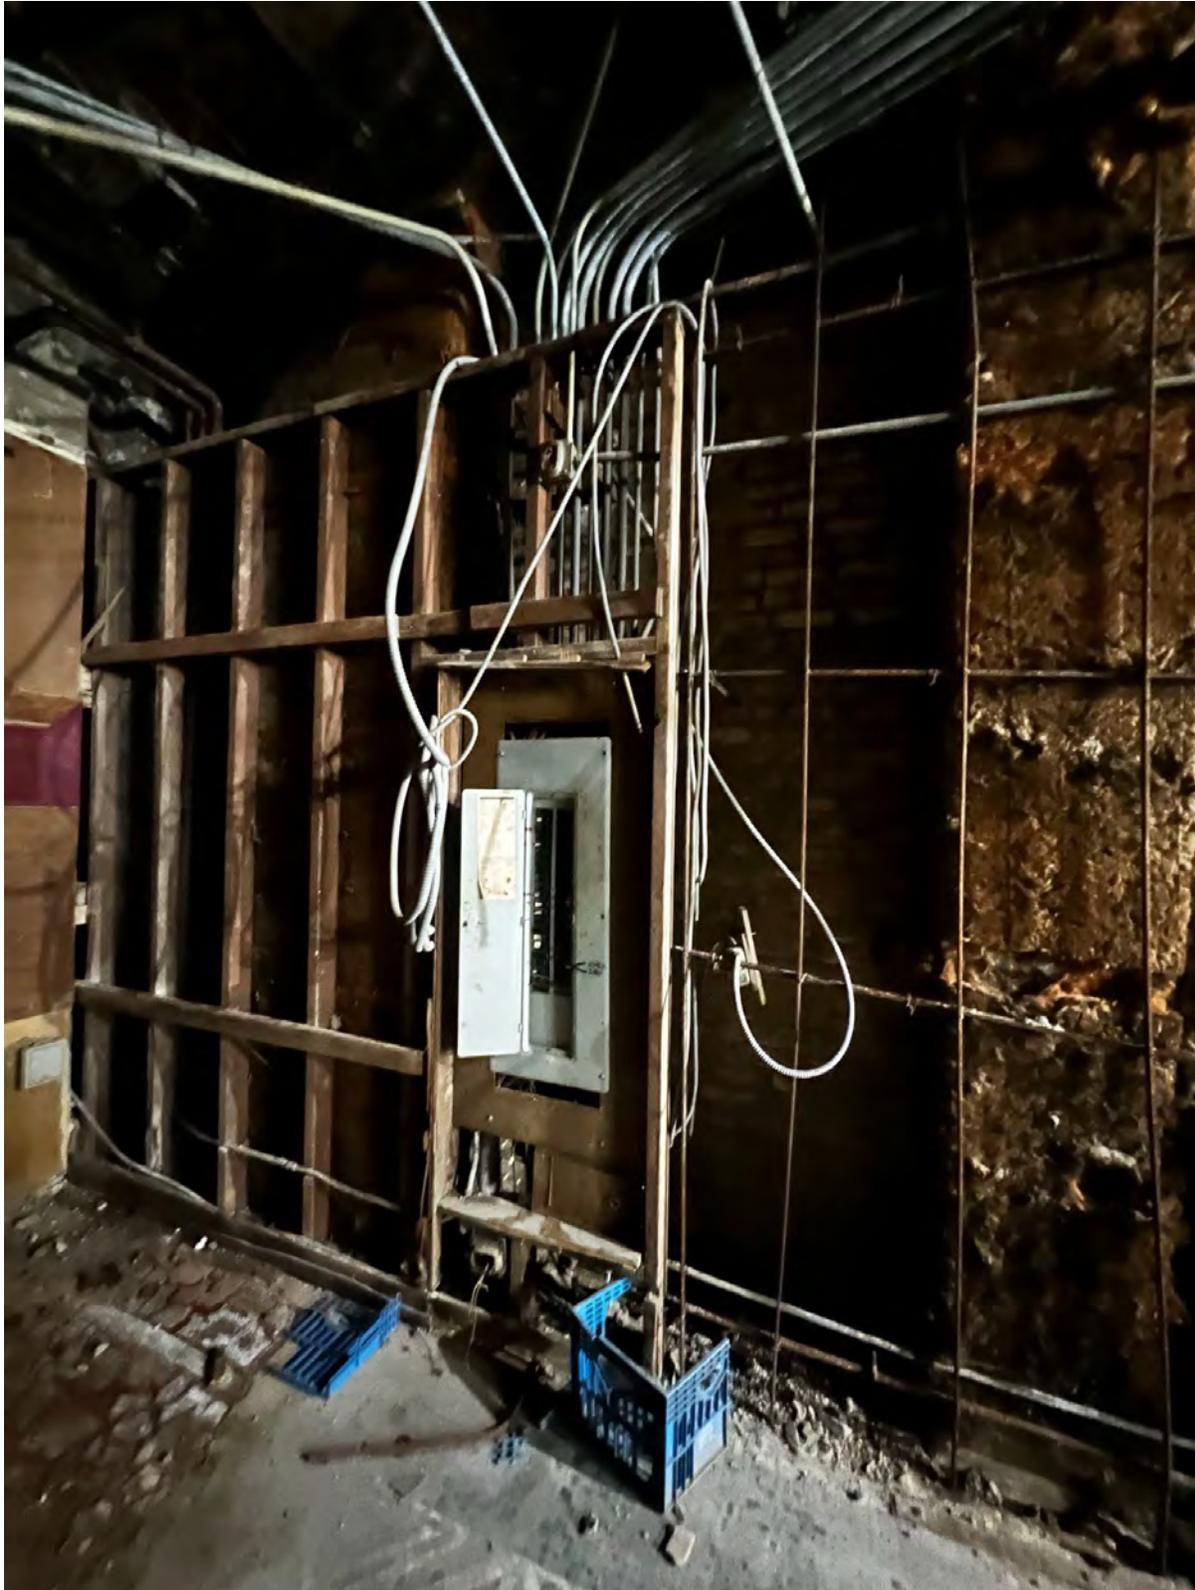
Basement: Non-code compliant house panel

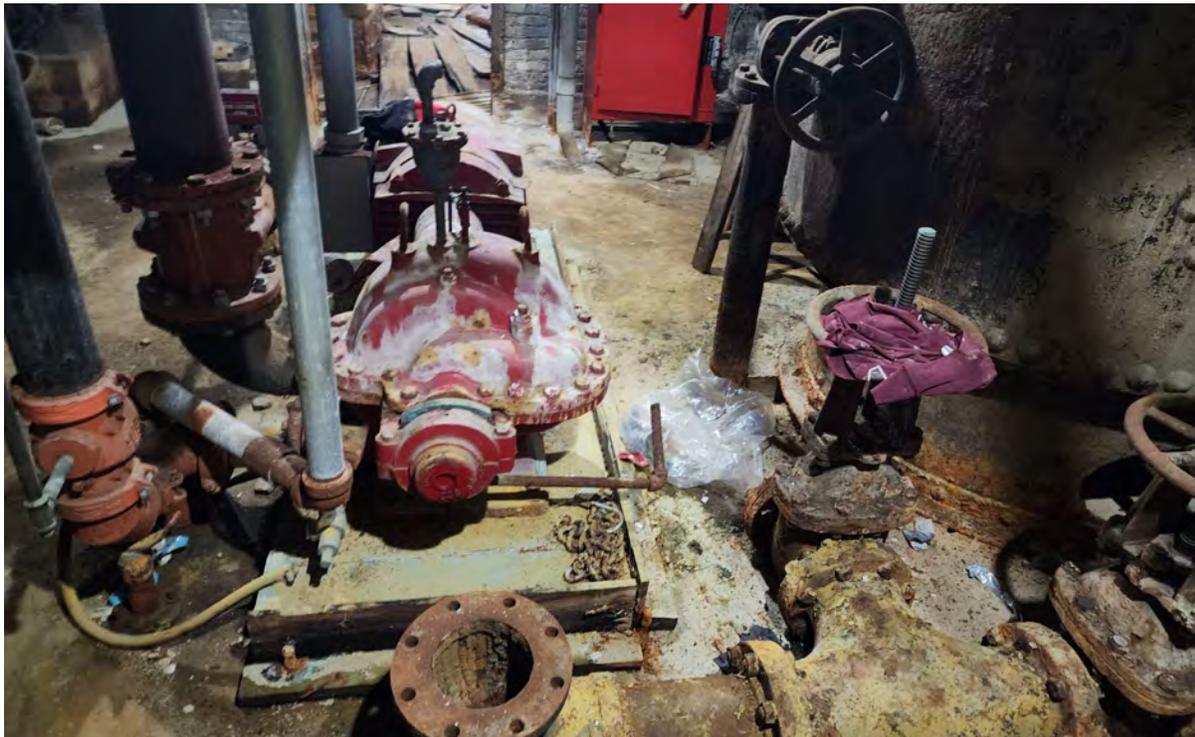
Basement Level: Fire pump, fire pump controller, and damaged abandoned FP piping

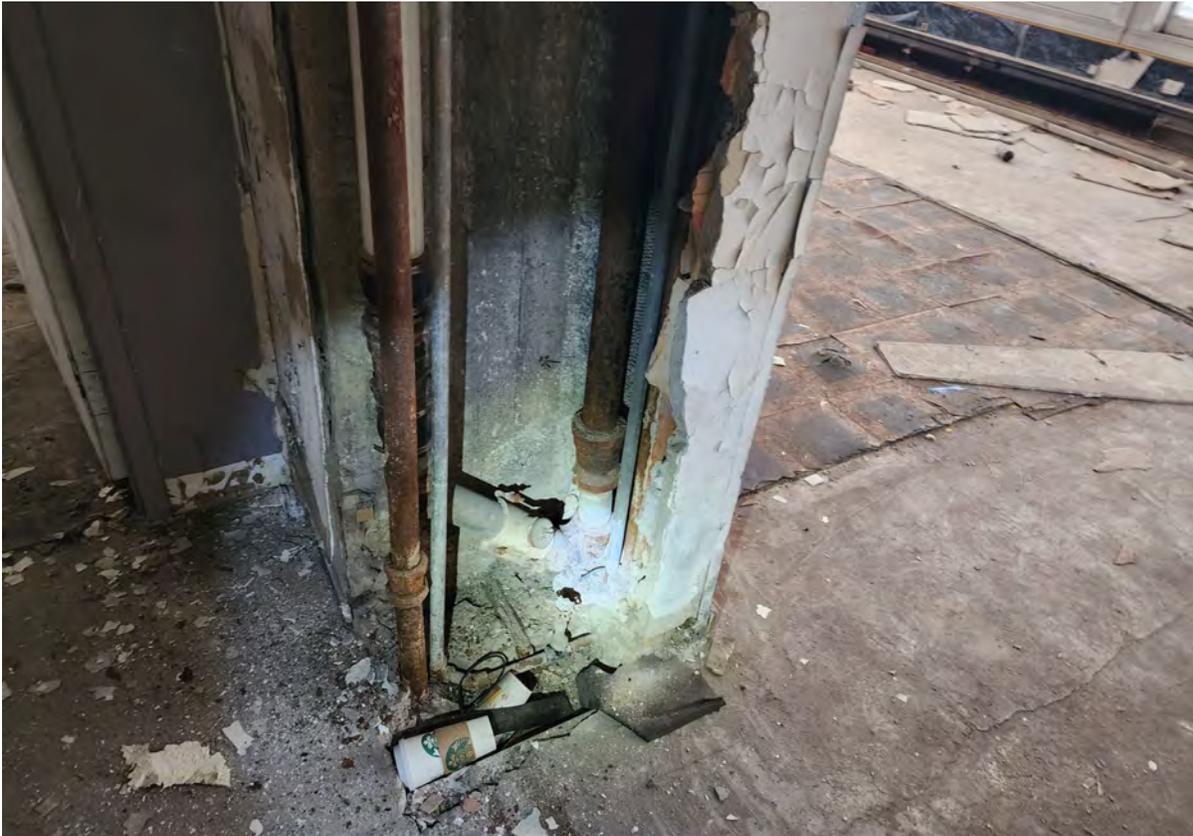
3rd Floor: Storm stack. Portions of the existing piping were replaced with PVC piping as part of emergency repairs performed to alleviate building flooding.
