GSA Great Lakes Region

# **202 State Street Evaluation Report**

**202 S State Street**

Report Issuance 6.1.23

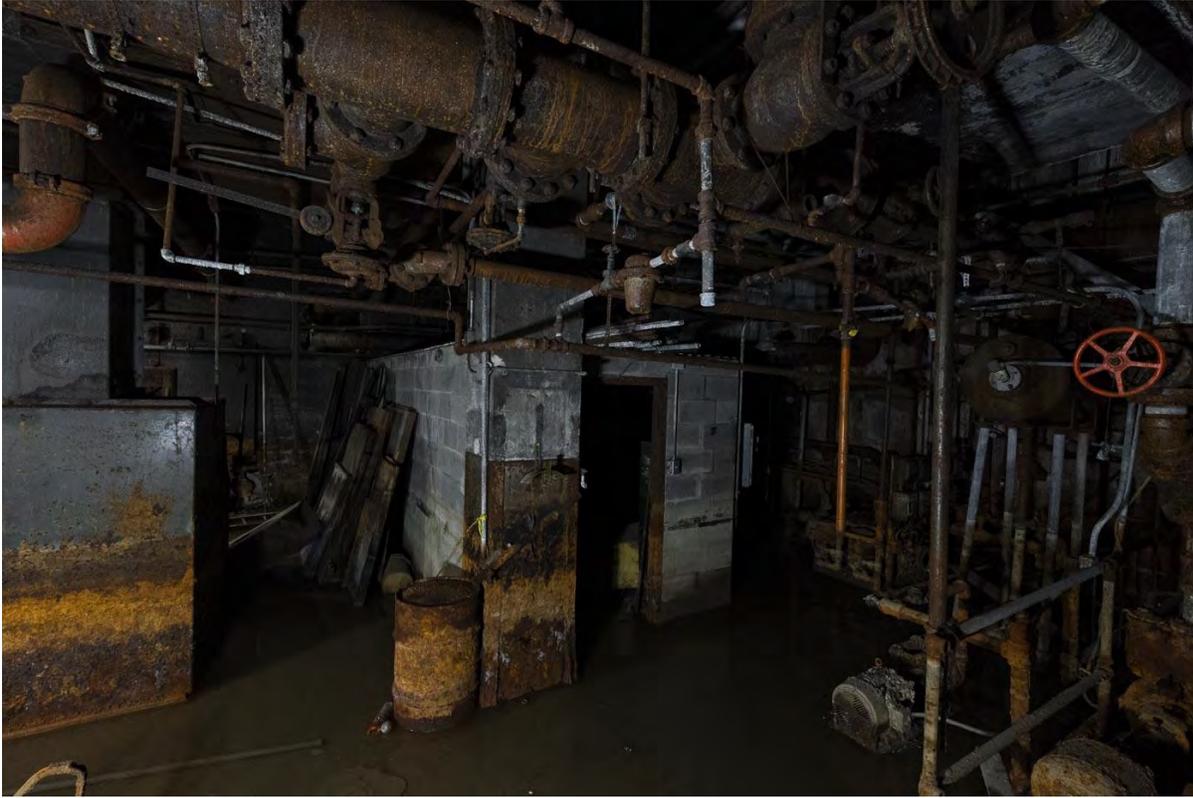
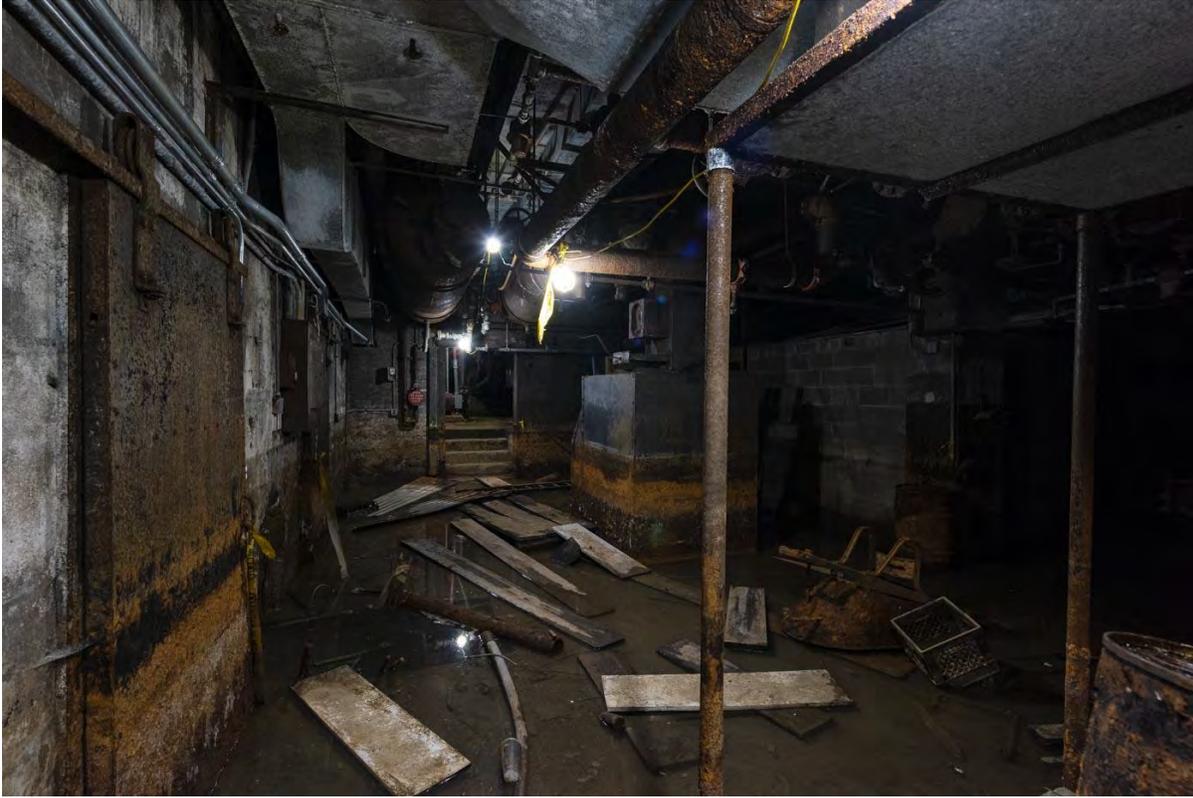
Lower Level 3 - Flooded

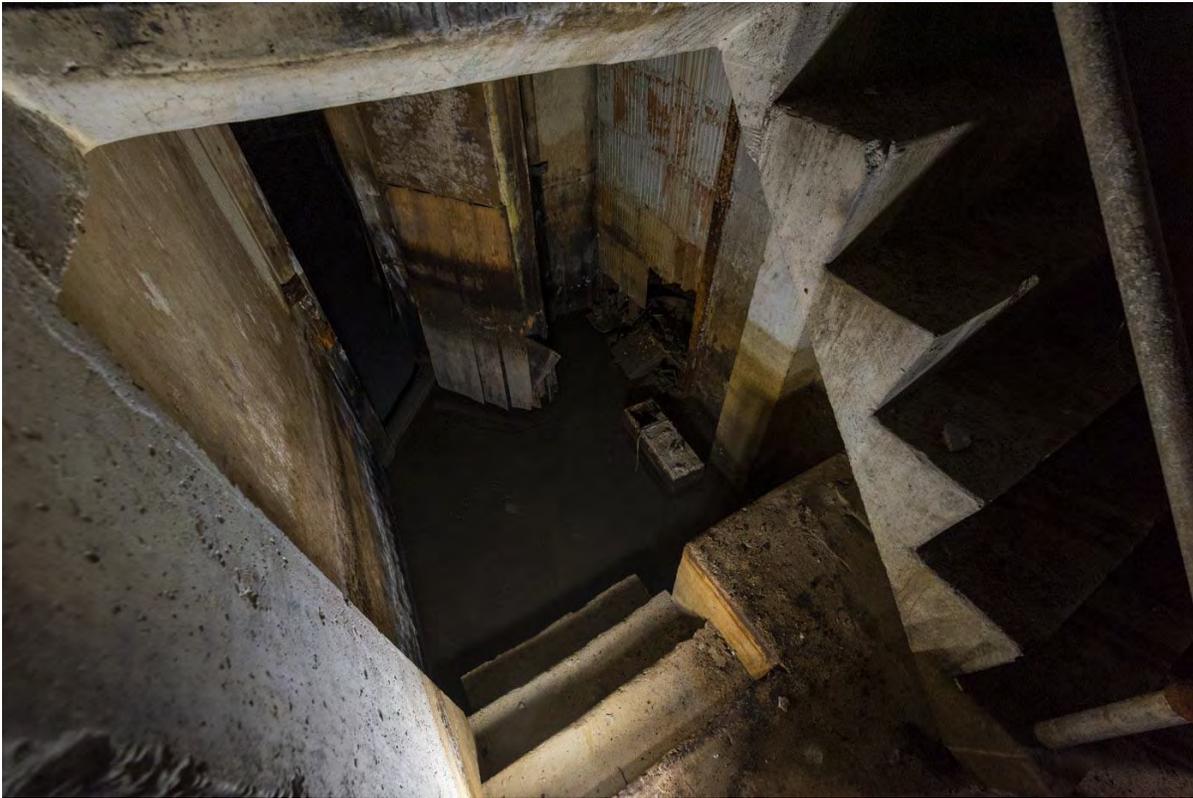
Stair between Lower Level 2 and 3 - Flooded
