GSA Great Lakes Region

# **202 State Street Evaluation Report**

**202 S State Street**

Report Issuance 6.1.23

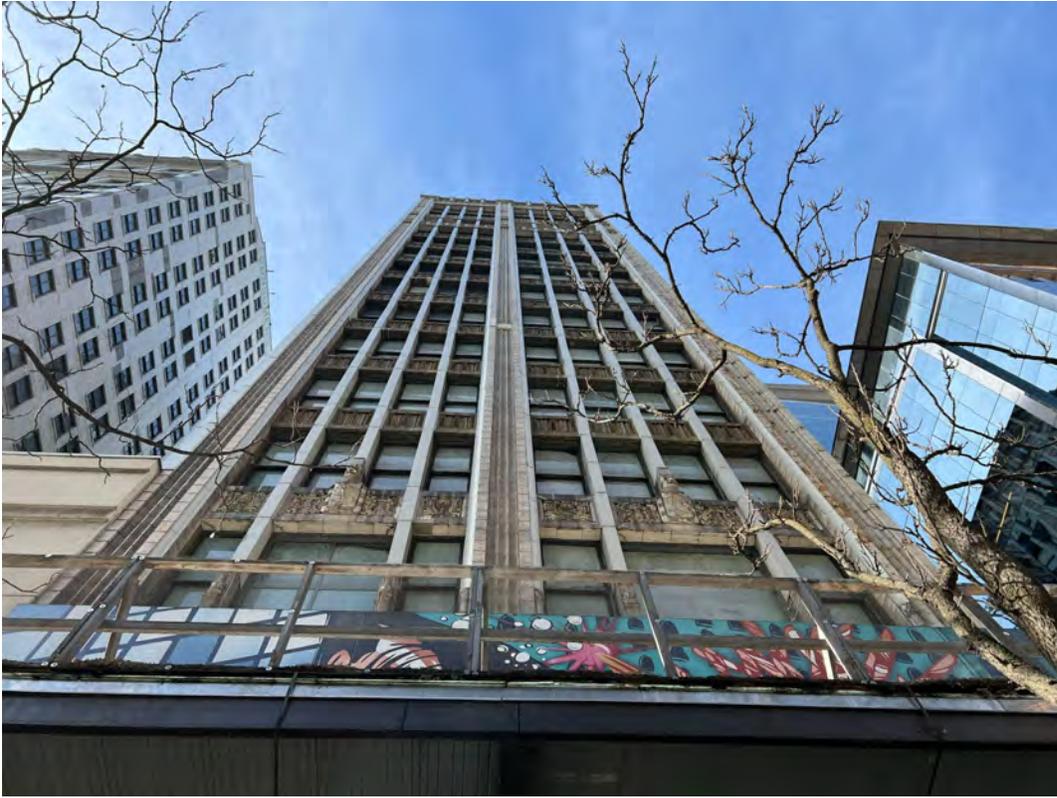
Exterior East elevation

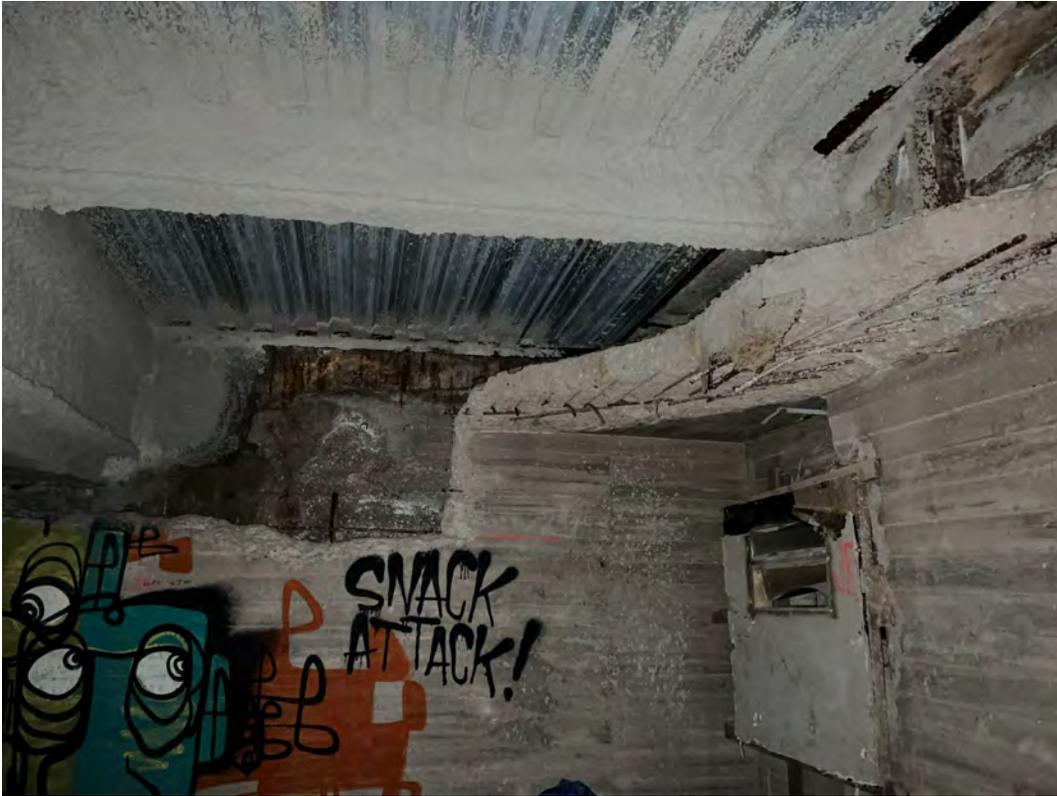
Ground Level slab from below: Vaulted slab on deck at east sidewalk

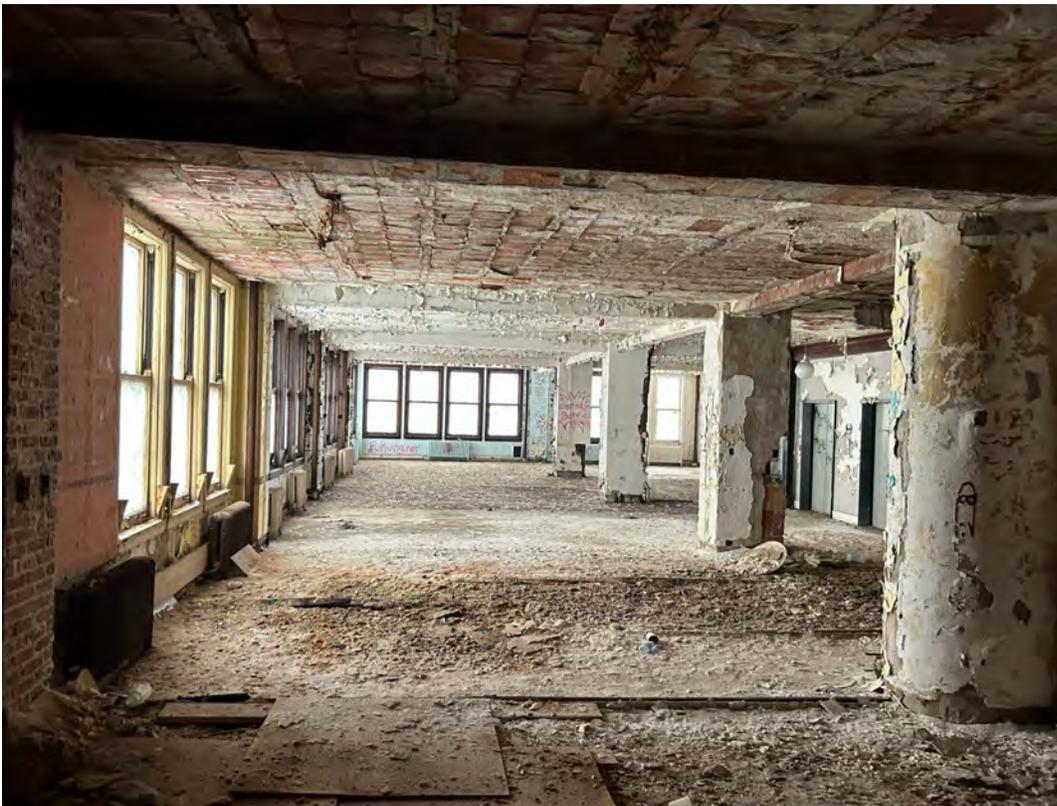
Superstructure: Typical upper floor layout and clay tile arch floor system, looking east

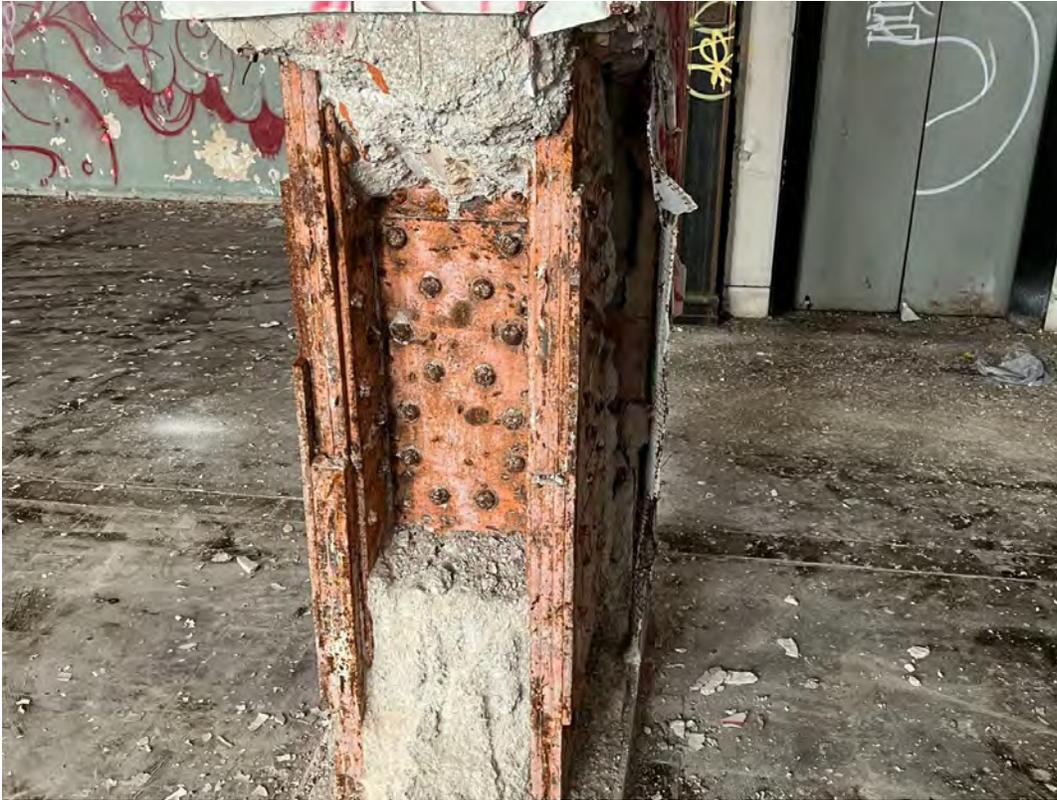
Superstructure: Previously removed concrete encasement on steel column

Similarly, several areas have been exposed presumably for investigative purposes. Exposed columns and various connections of steel framing members were observed. At these locations, reinstatement of the concrete or masonry encasement will be required.

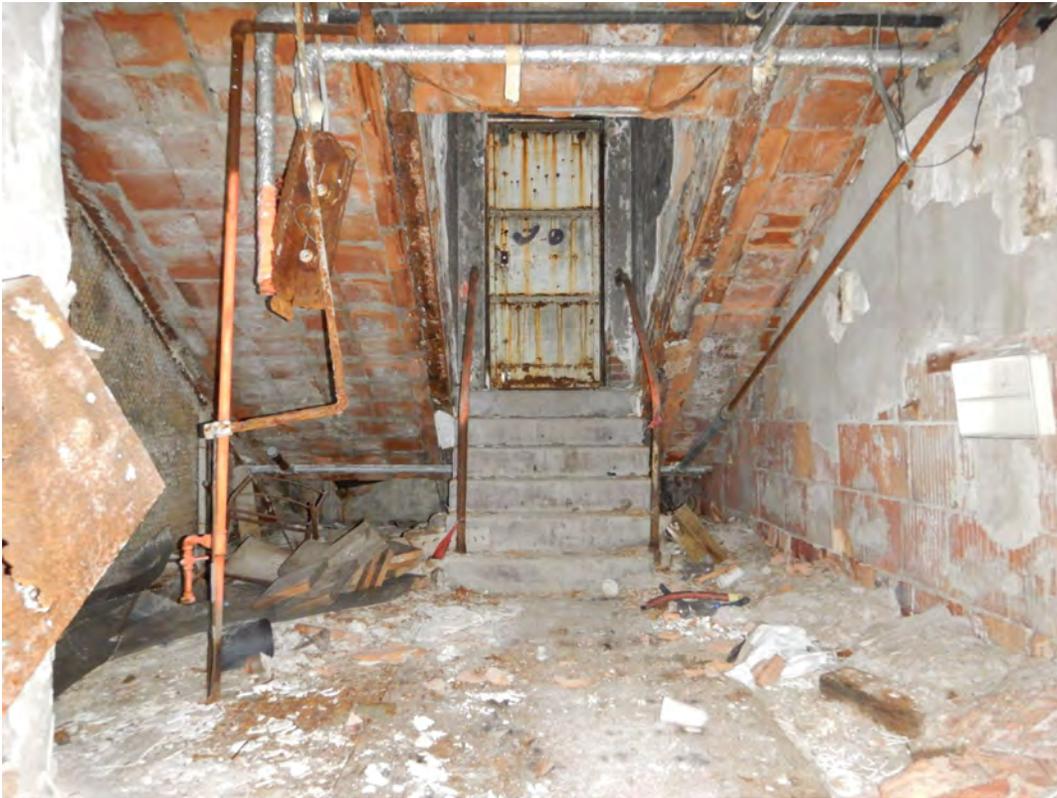
Roof framing: Clay tile encased roof framing, photo take from attic

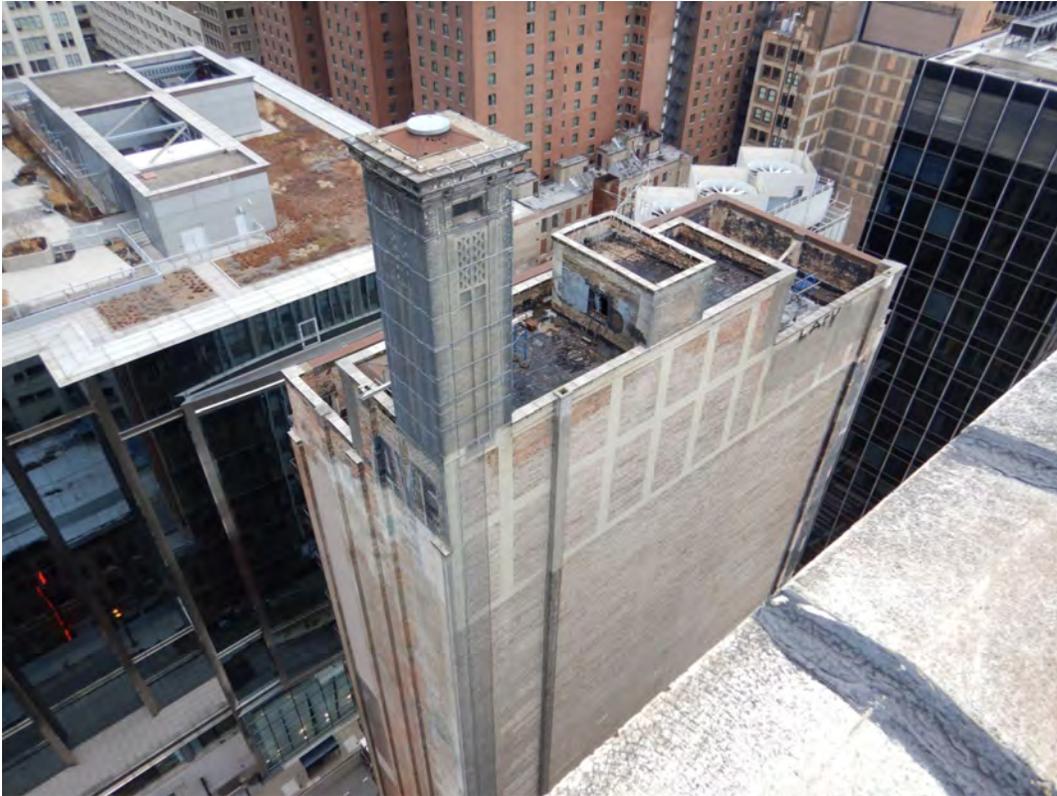
Overall roof from 220 S. State St. looking north

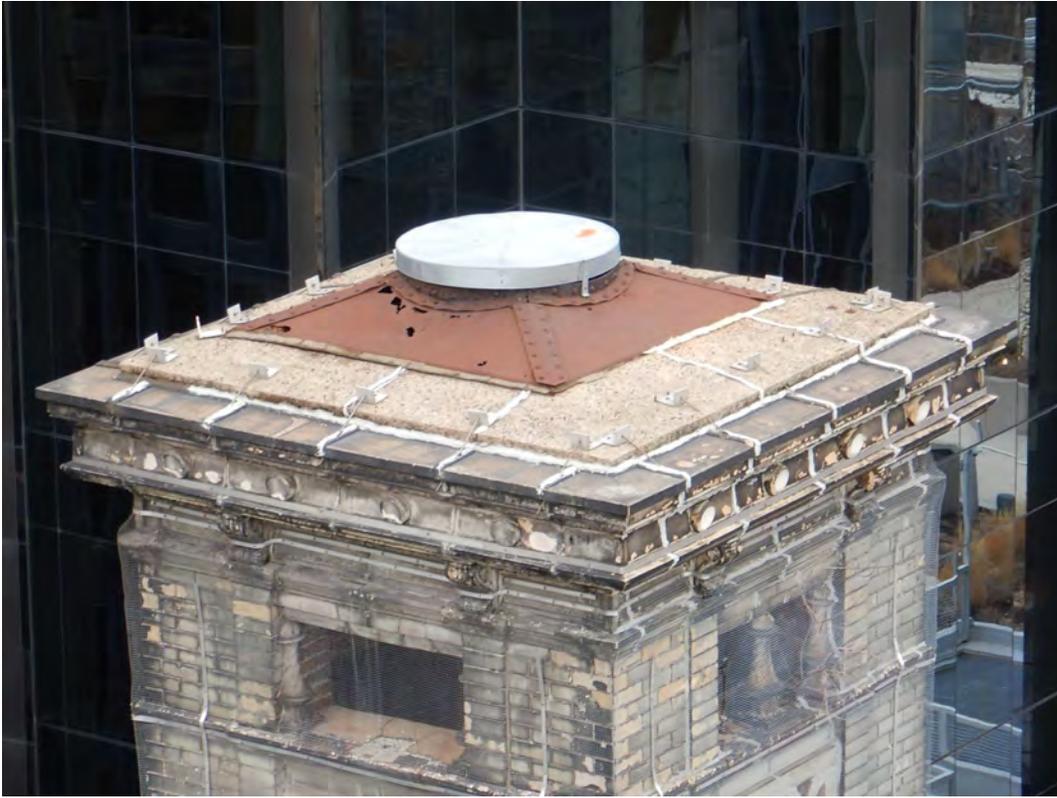
Roof of the tower

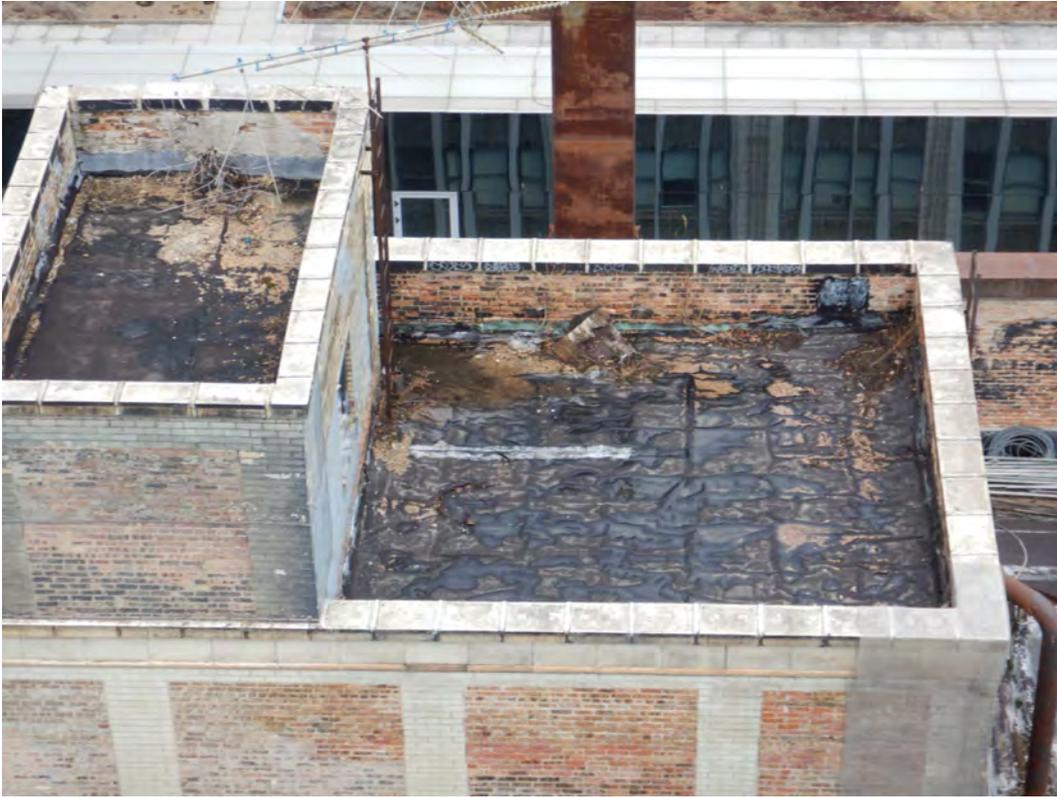
Center and east sections of the penthouse roof

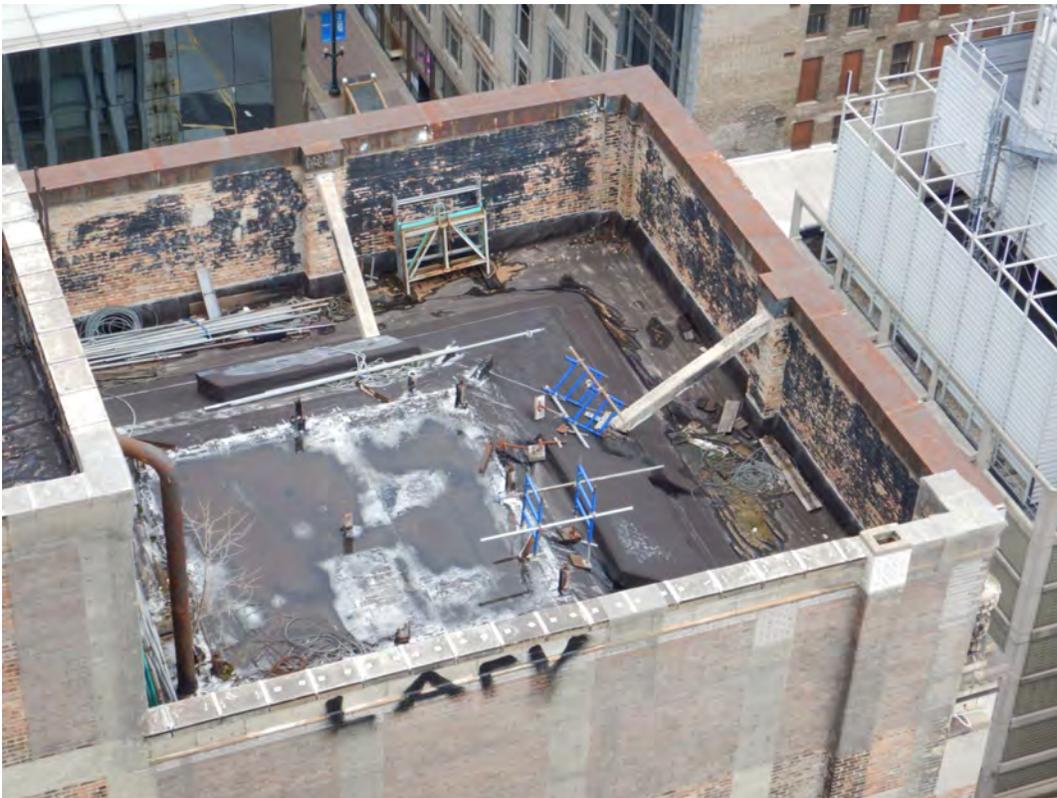
East section of the penthouse roof

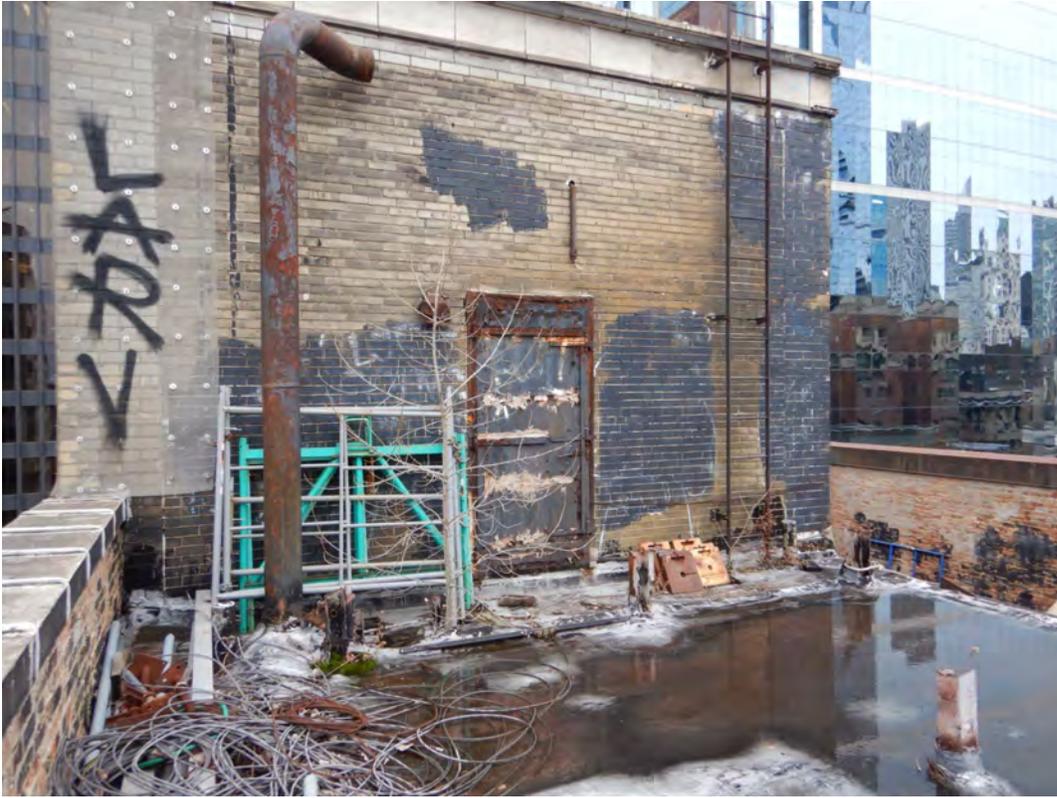
Upper flat roof with ponding water and vegetation growing from roof

3. New roof drainage design with proper slope to drains and overflow drains to meet current building code requirements.
4. New doghouse structure for roof access.
5. Repair all deteriorated and damaged terra cotta and brick on the penthouse structures.
6. Replace all doors and windows.
7. Replace all access ladders to various roof levels.

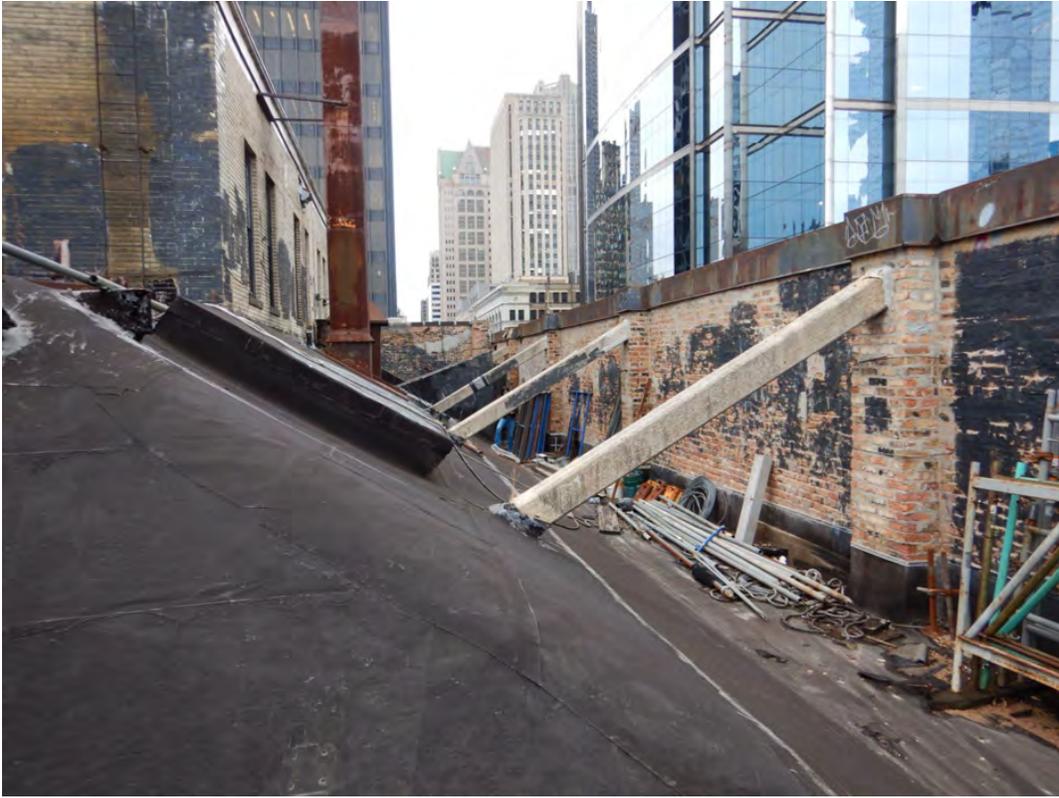
Sloped roof looking west

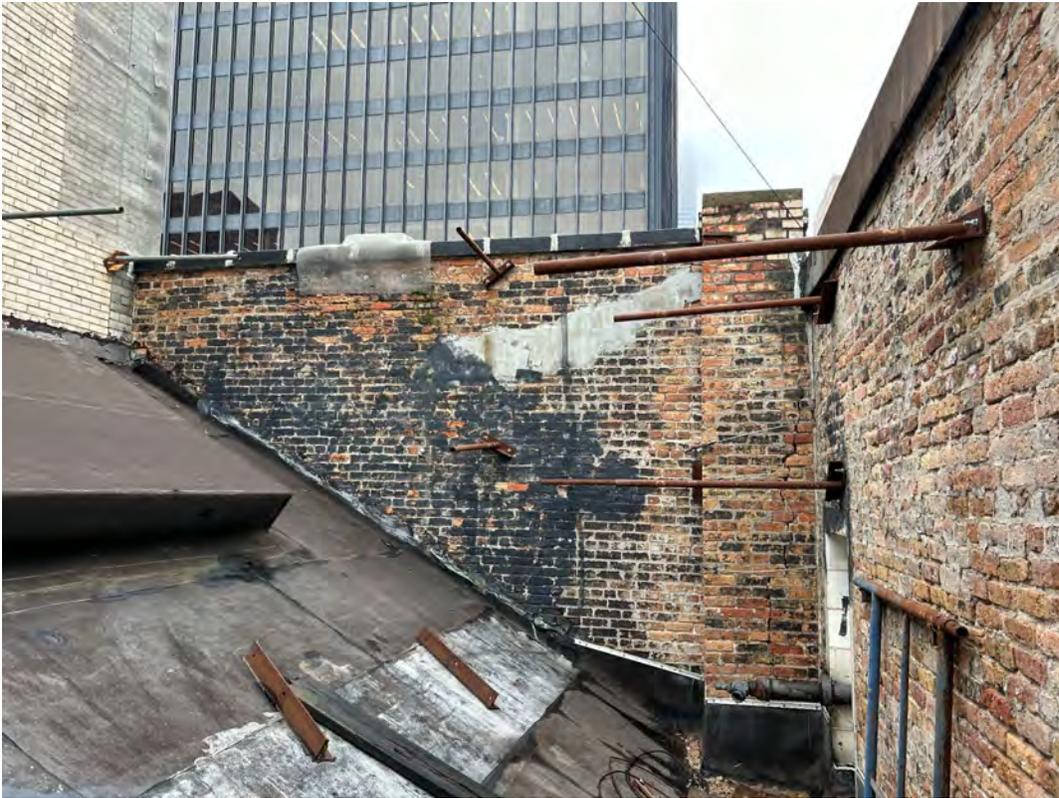
Sloped roof at west parapet wall

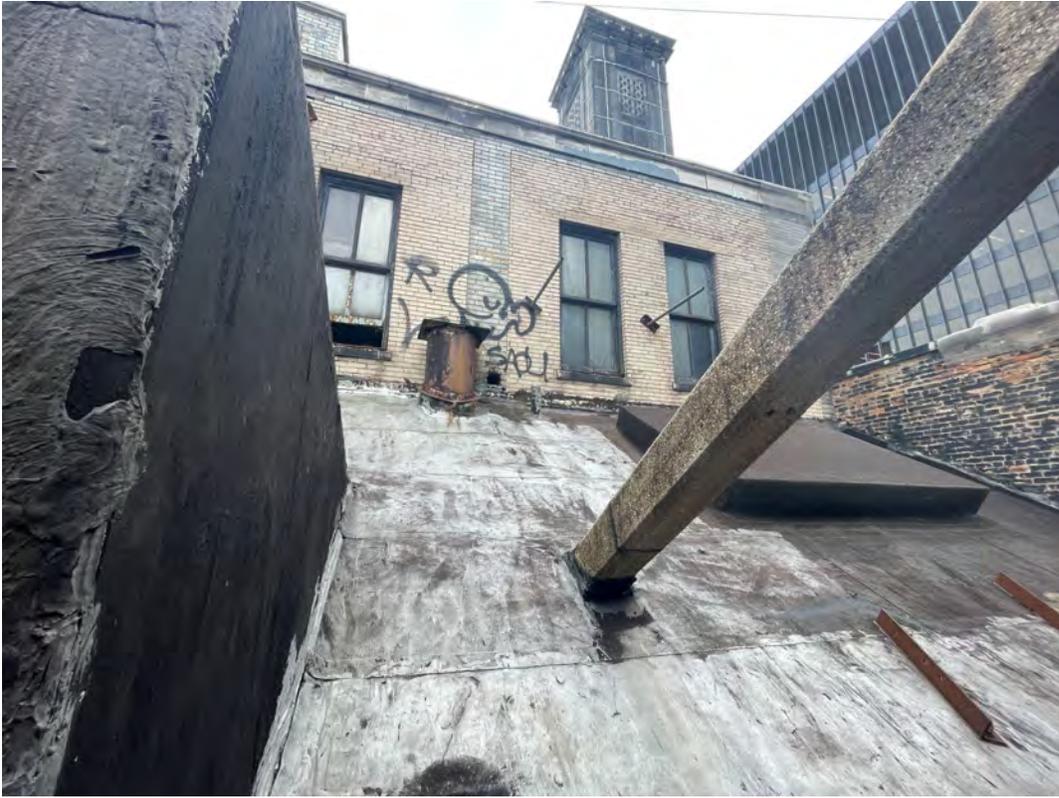
West section of roof, north elevation of penthouse

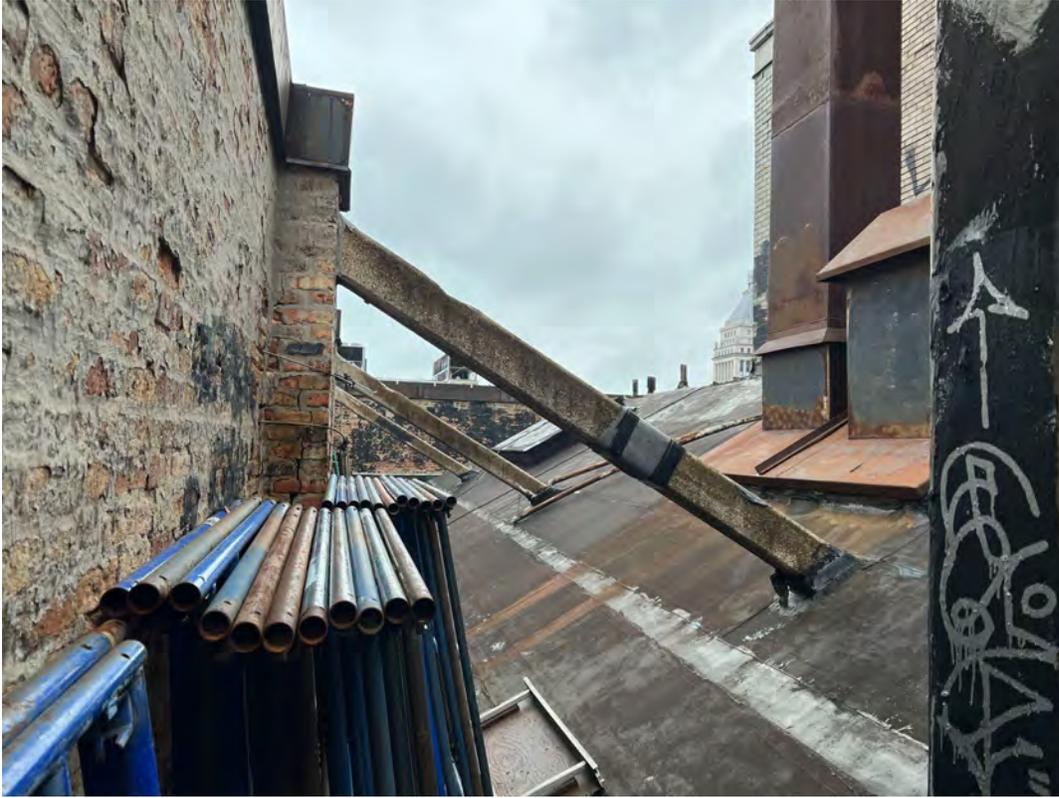
North side of sloped roof

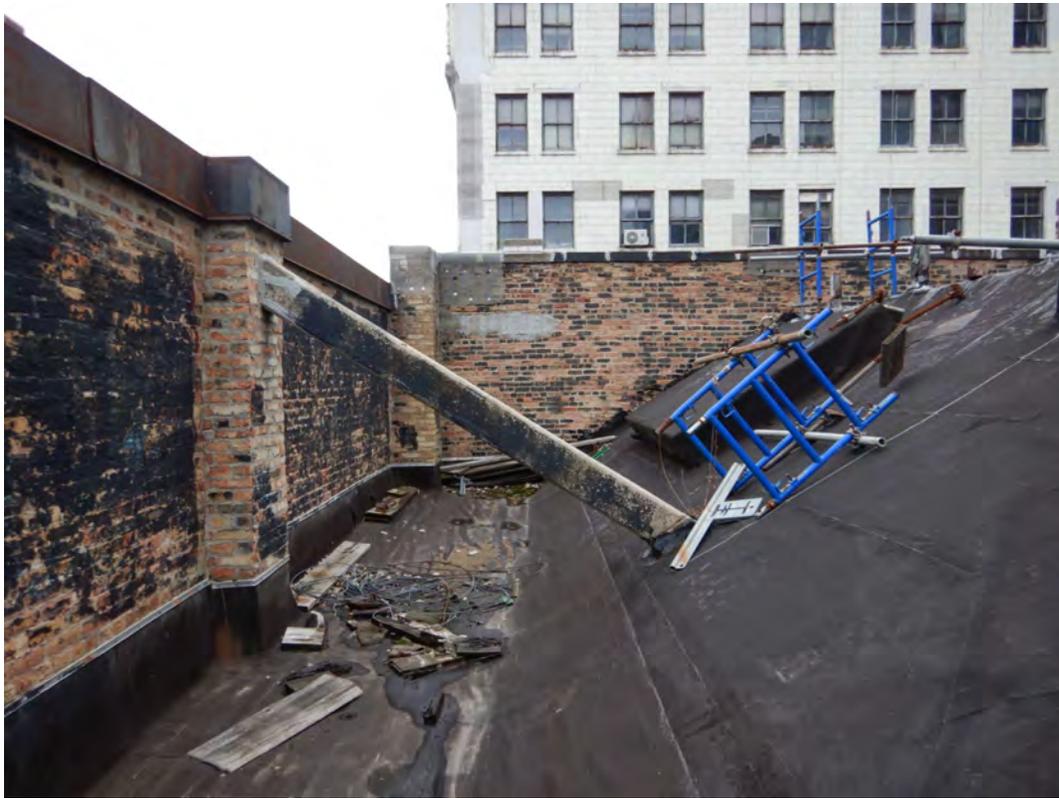
Southeast corner of roof

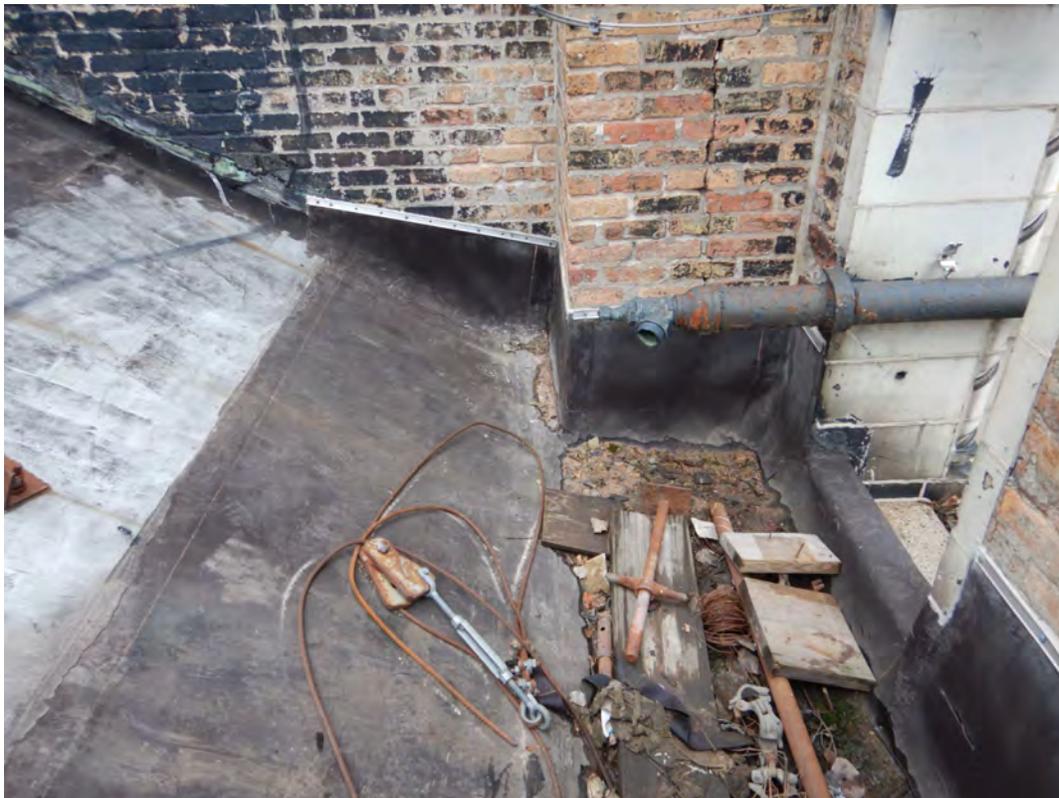
Northwest corner of roof, the only roof drain was buried under debris

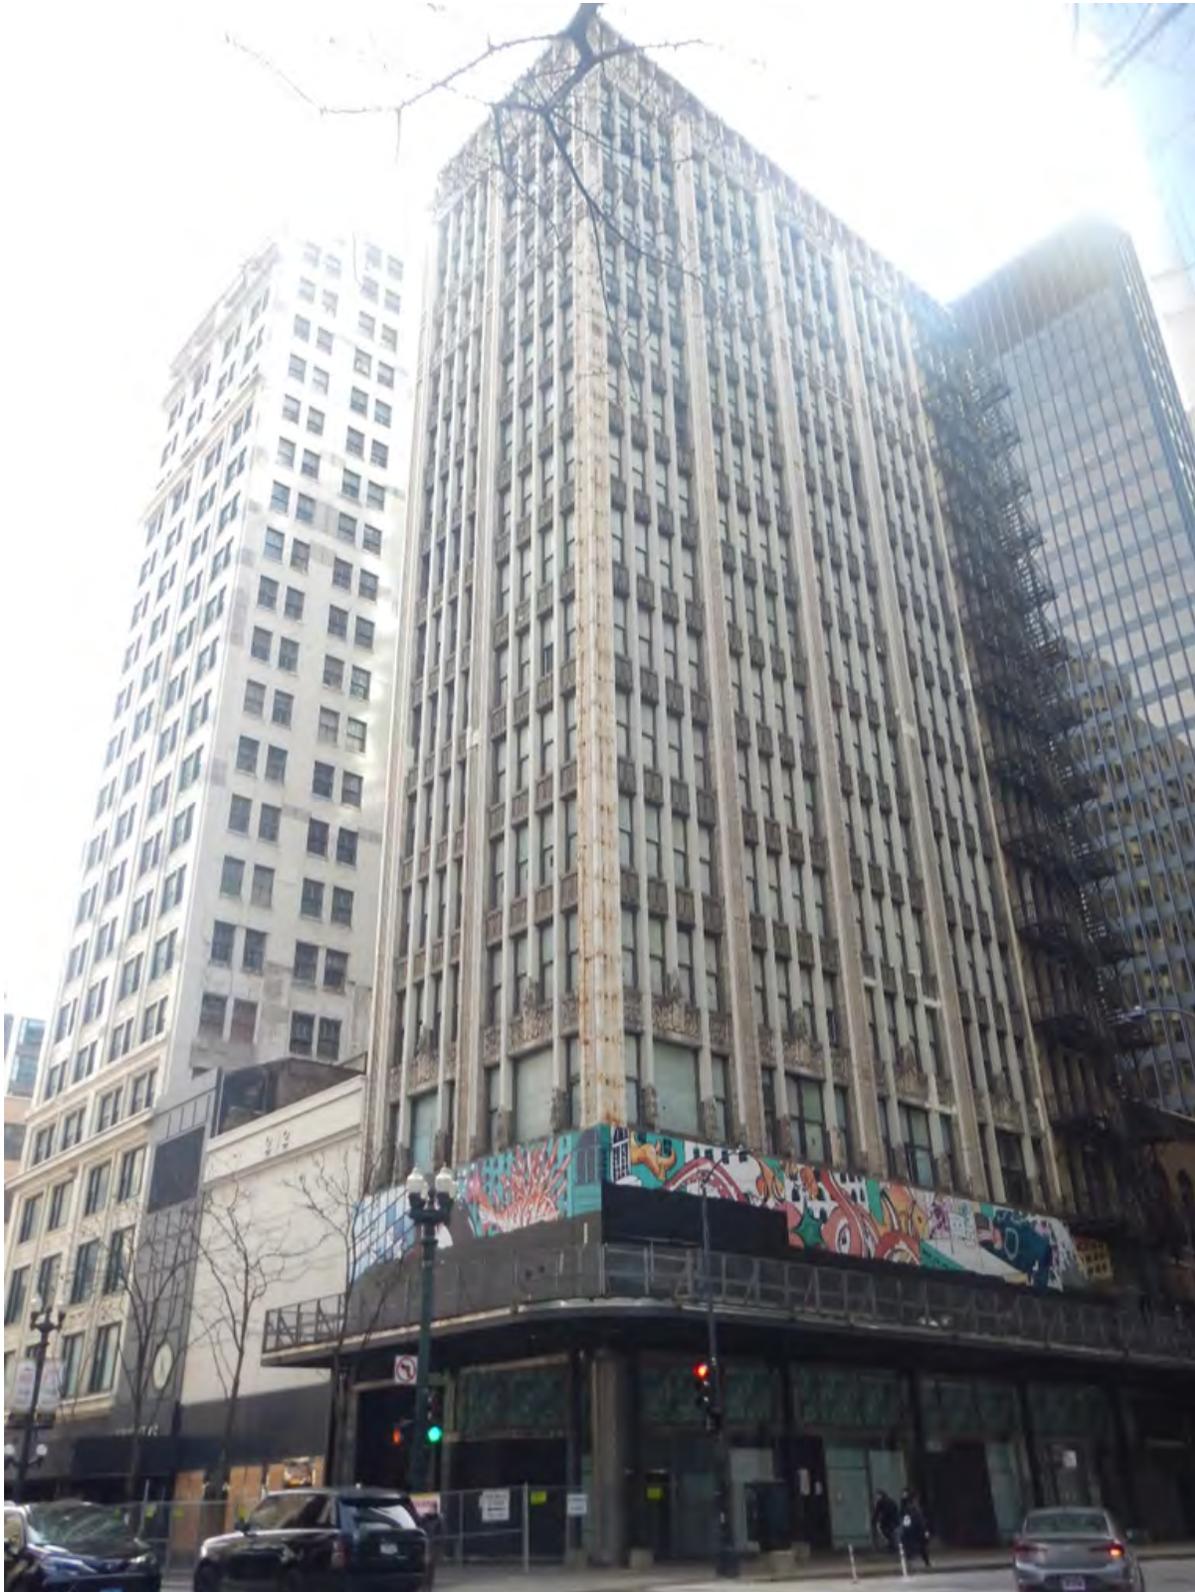
Overview of north and east elevations.

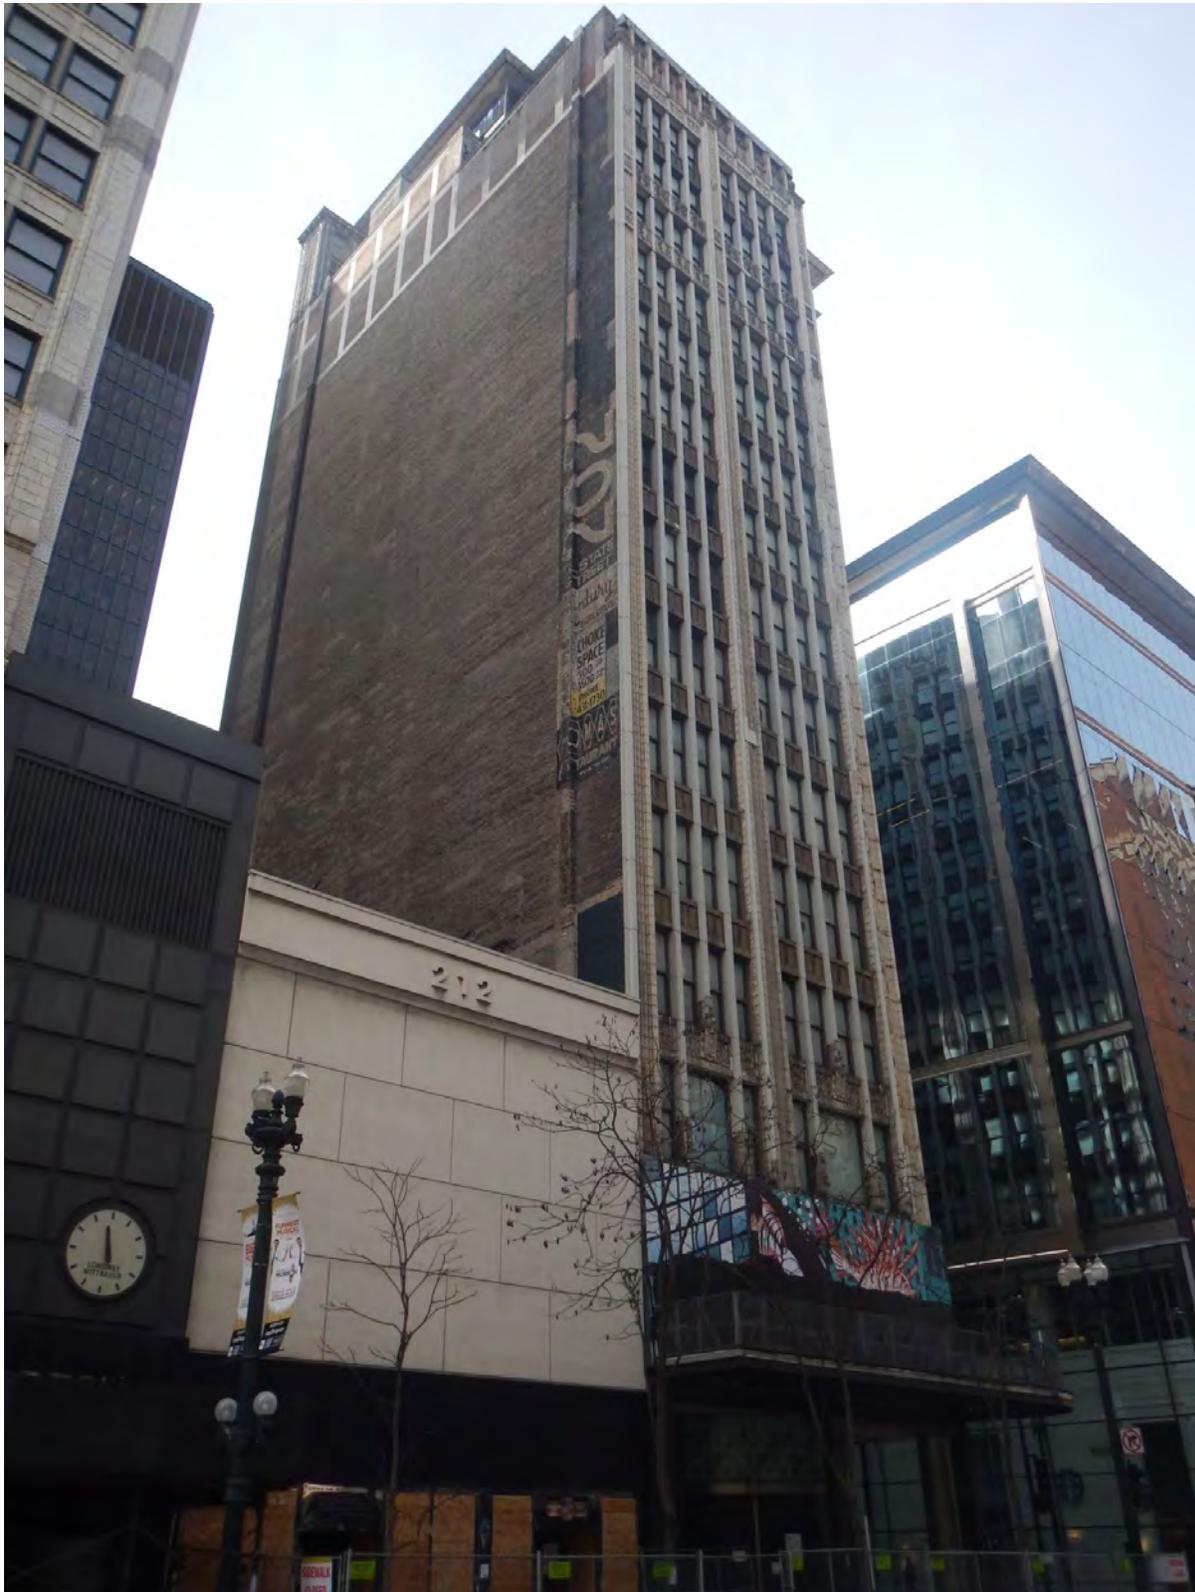
Overview of east and south elevations.

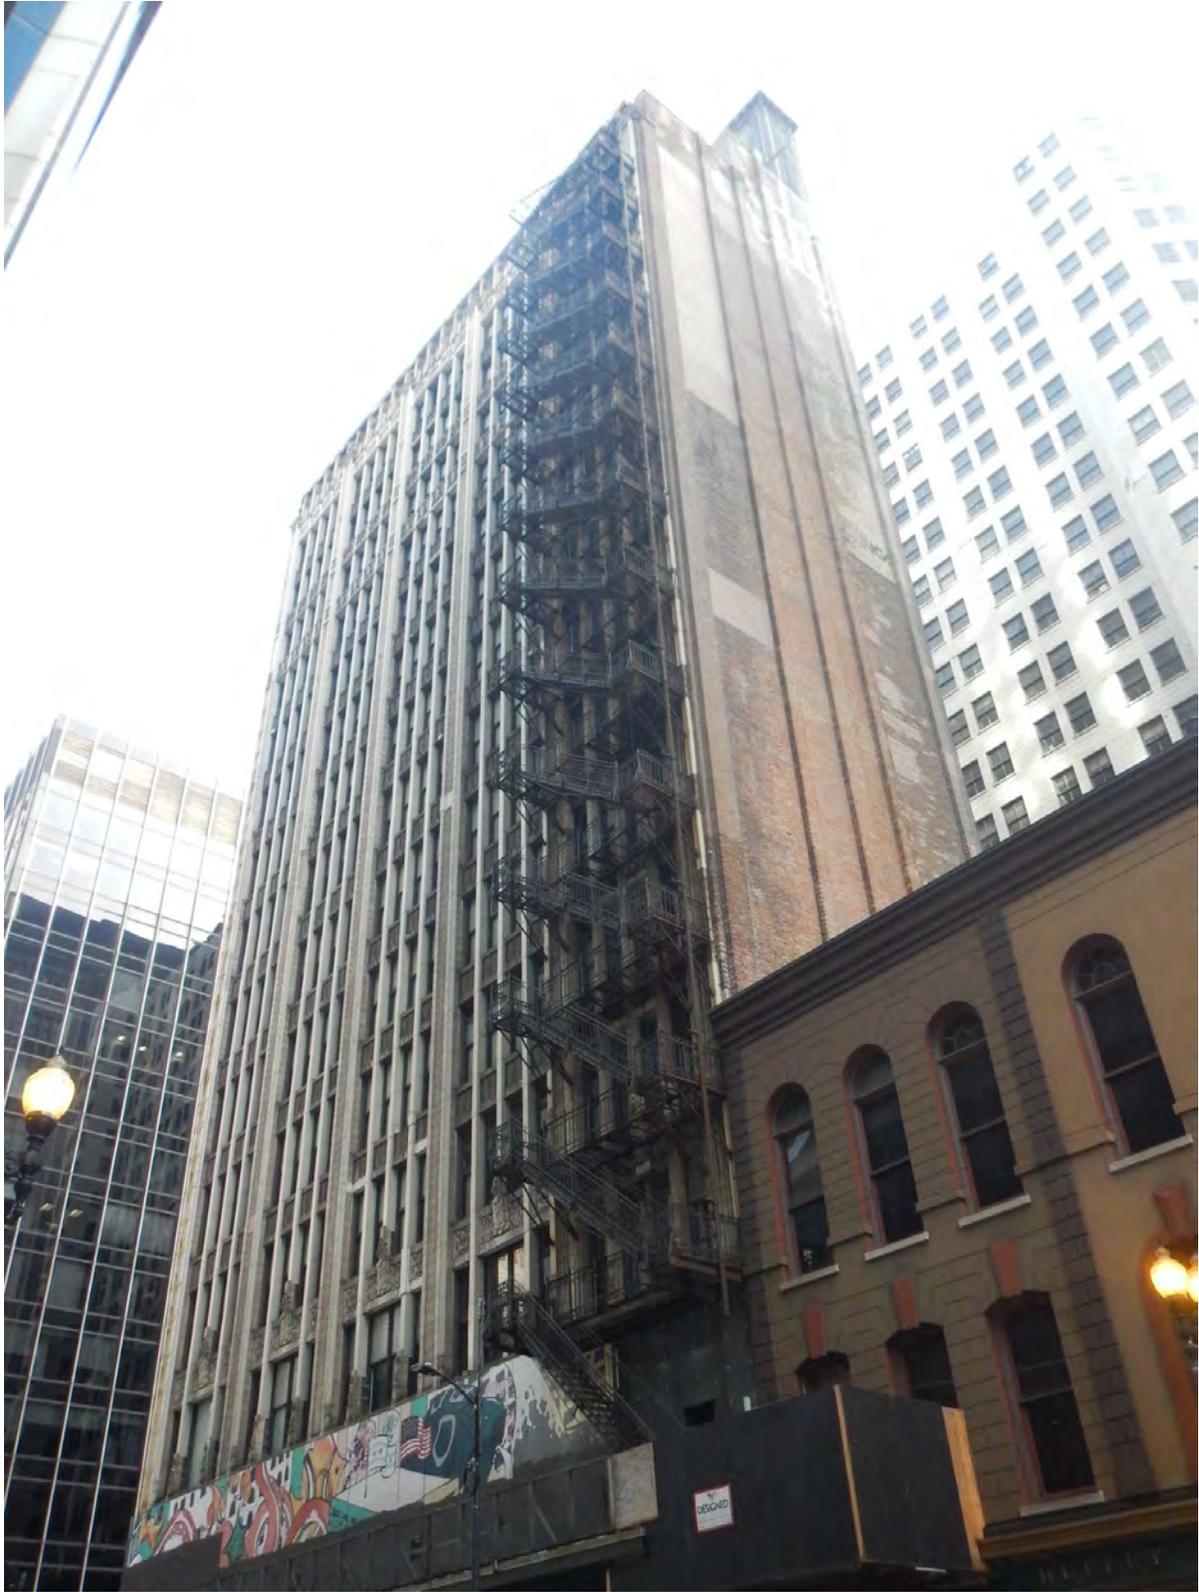
Overview of west and north elevations.

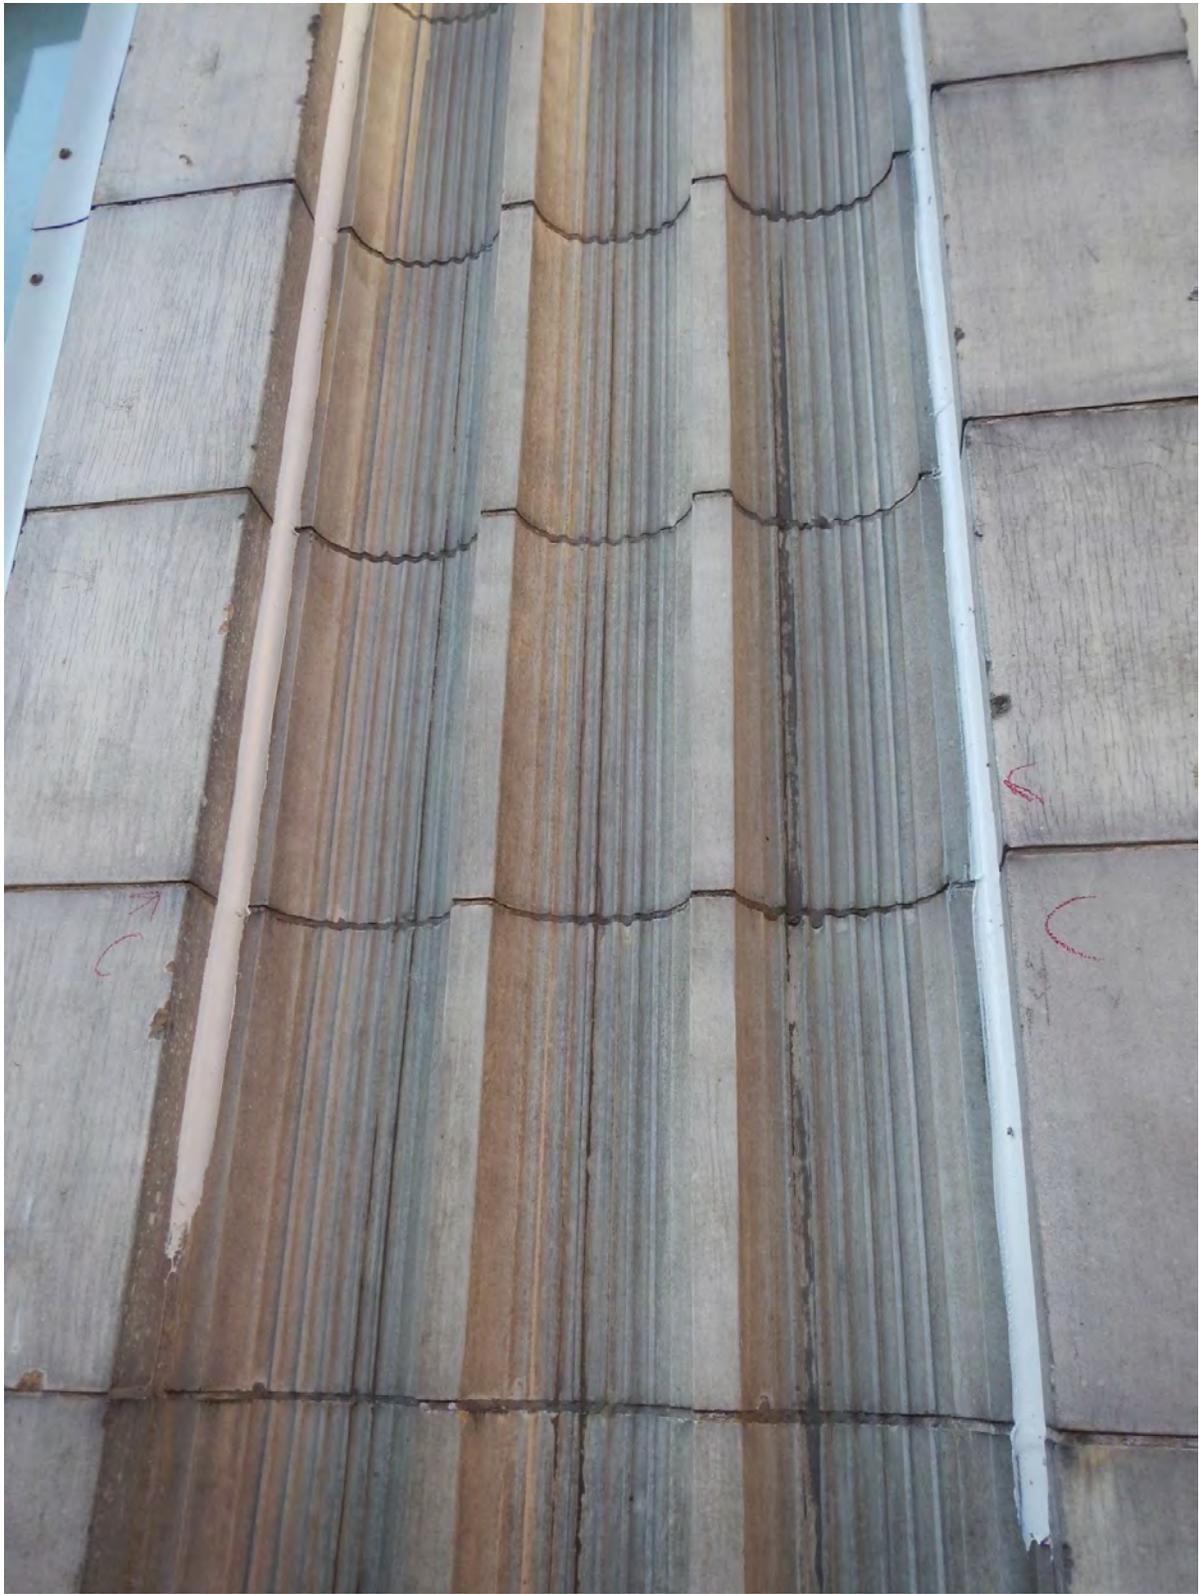
Typical terra cotta column detail

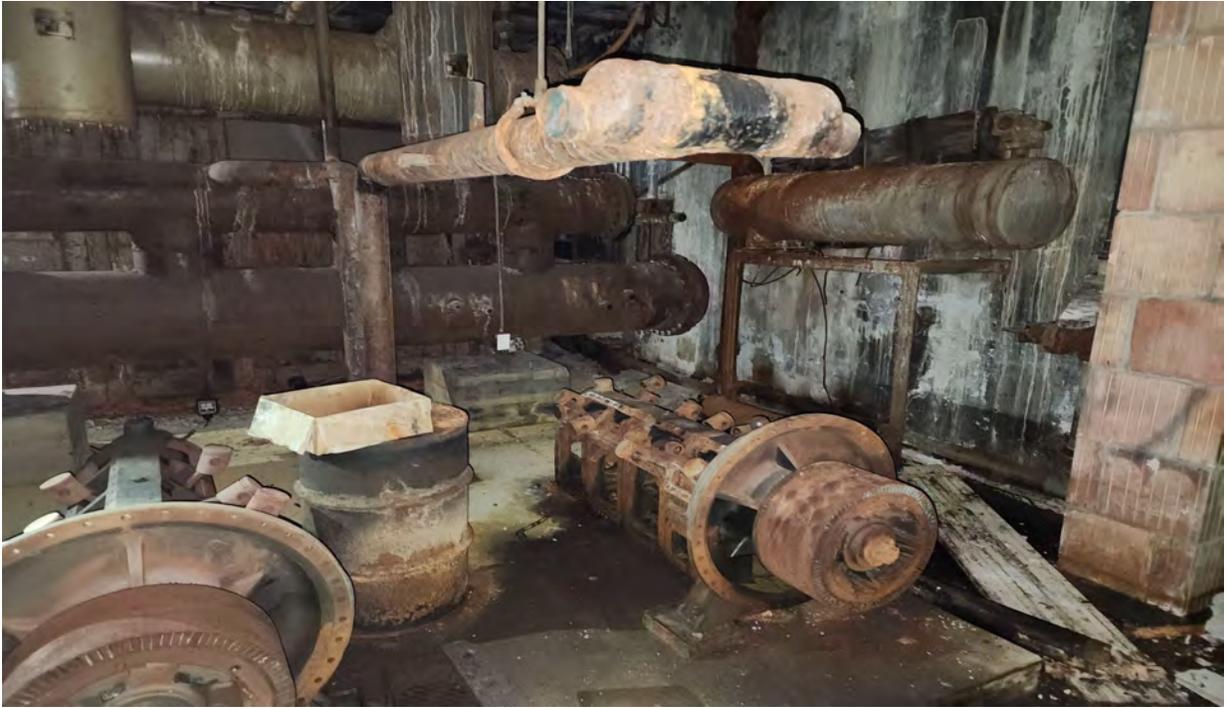
Lower Level 2-Existing Water cooled chillers

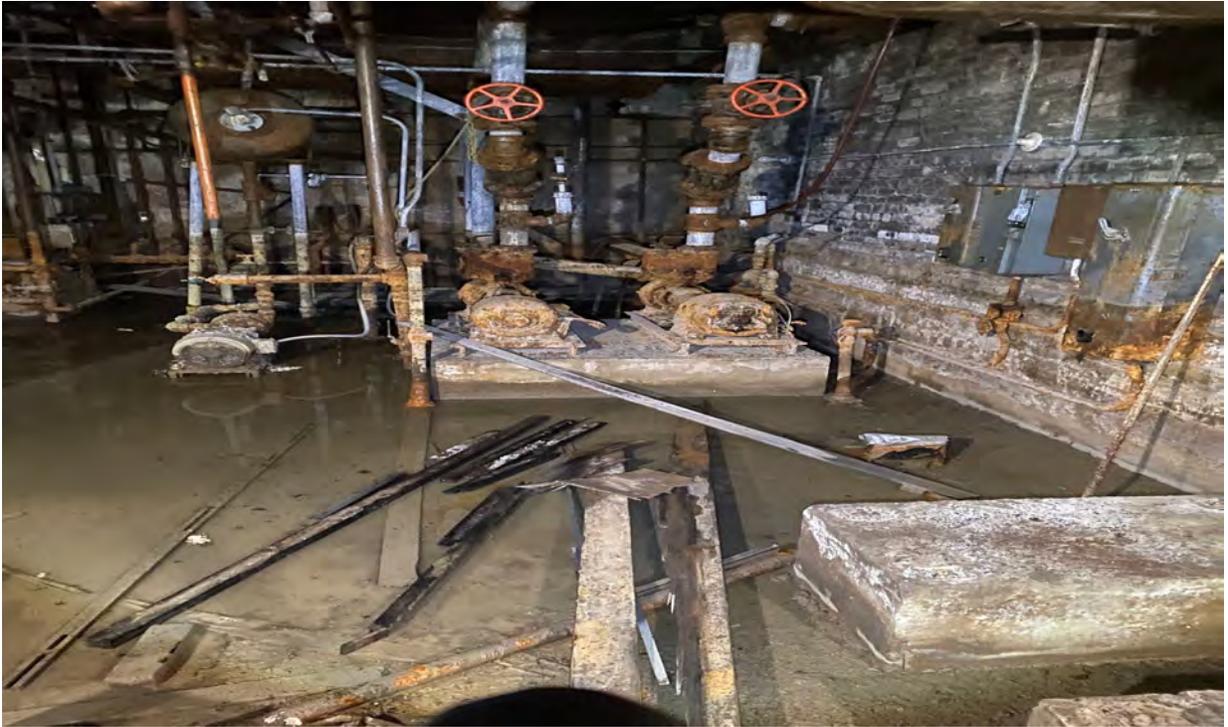
Lower Level 2-Existing Chilled water pumps
