GSA Great Lakes Region

# **202 State Street Evaluation Report**

**202 S State Street**

Report Issuance 6.1.23

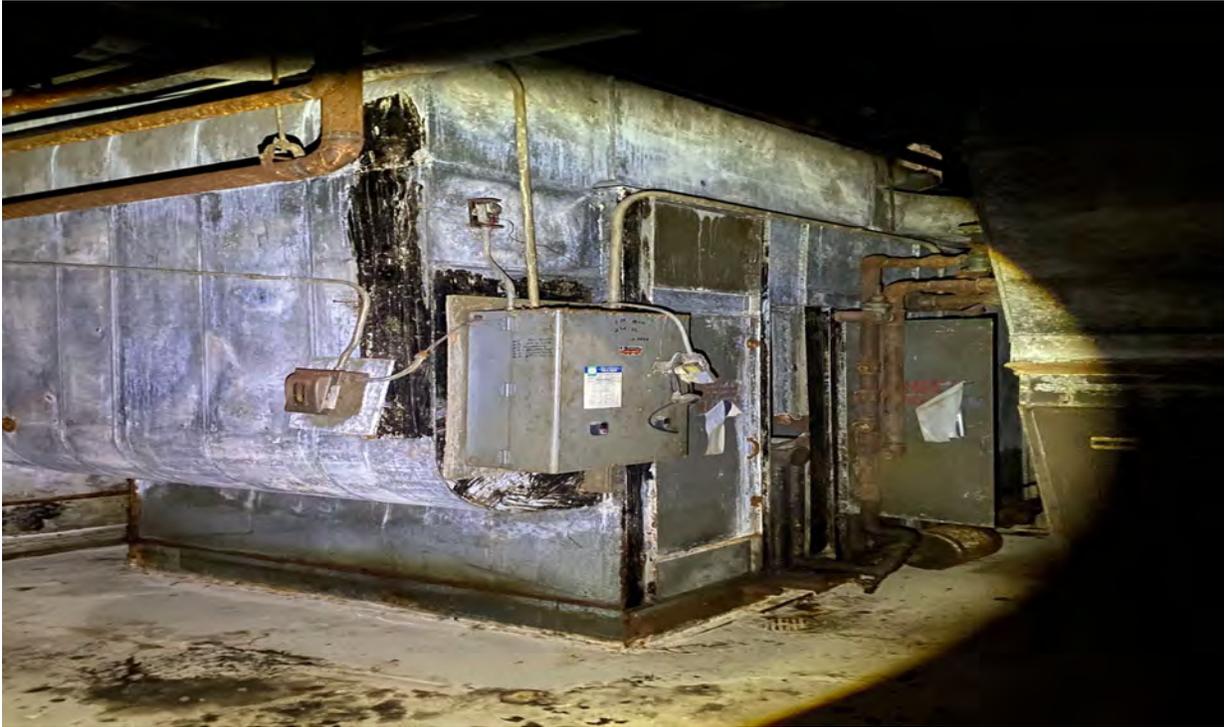
Lower Level 2-Existing AHU

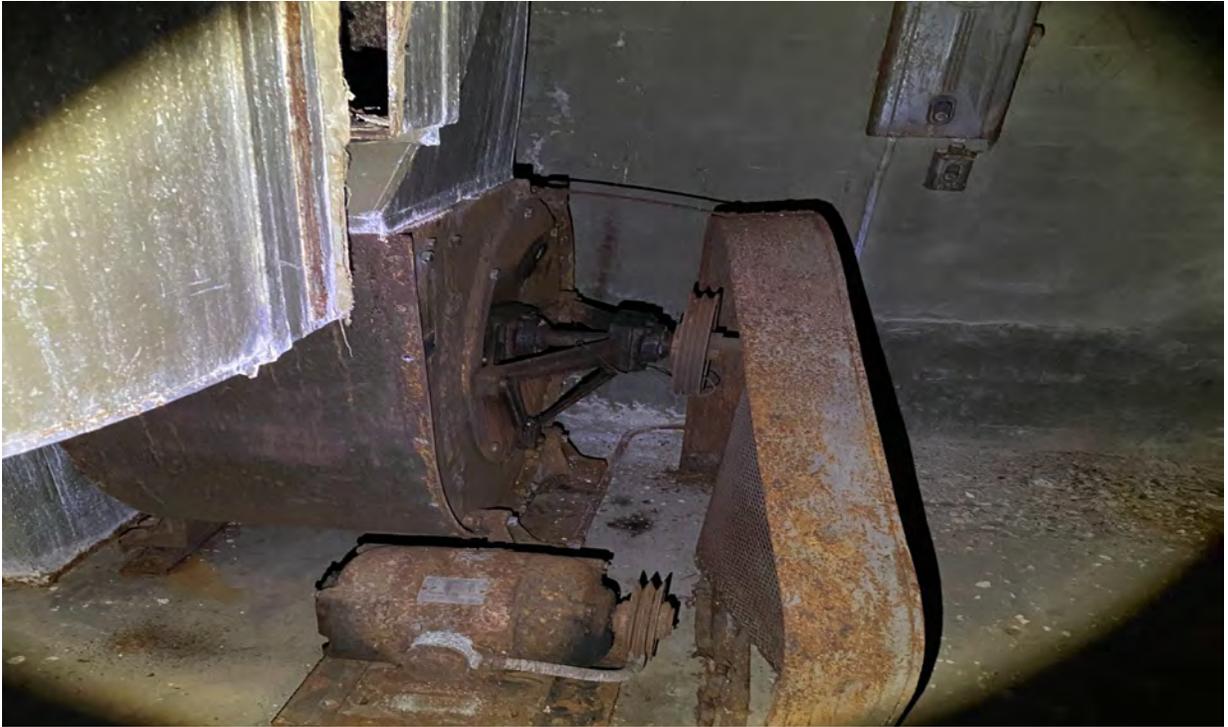
Lower Level 2-Existing Fan

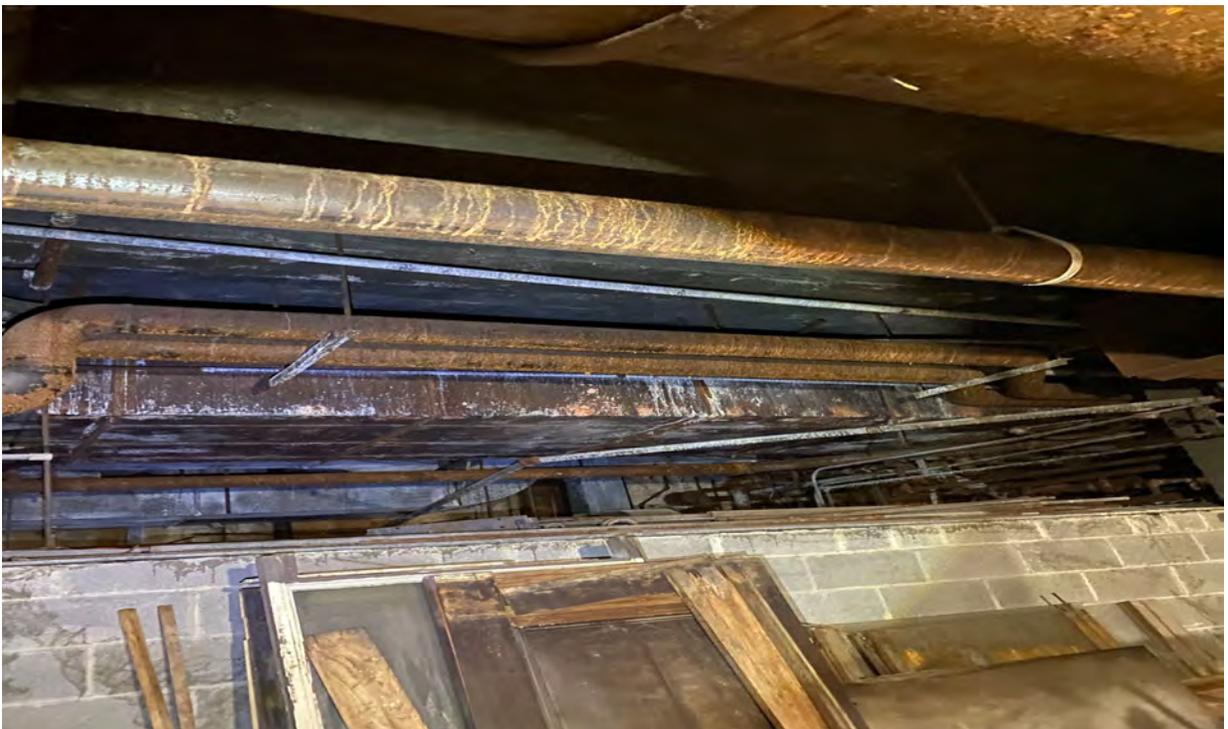
Lower Level 2-Existing Pipes and ductwork

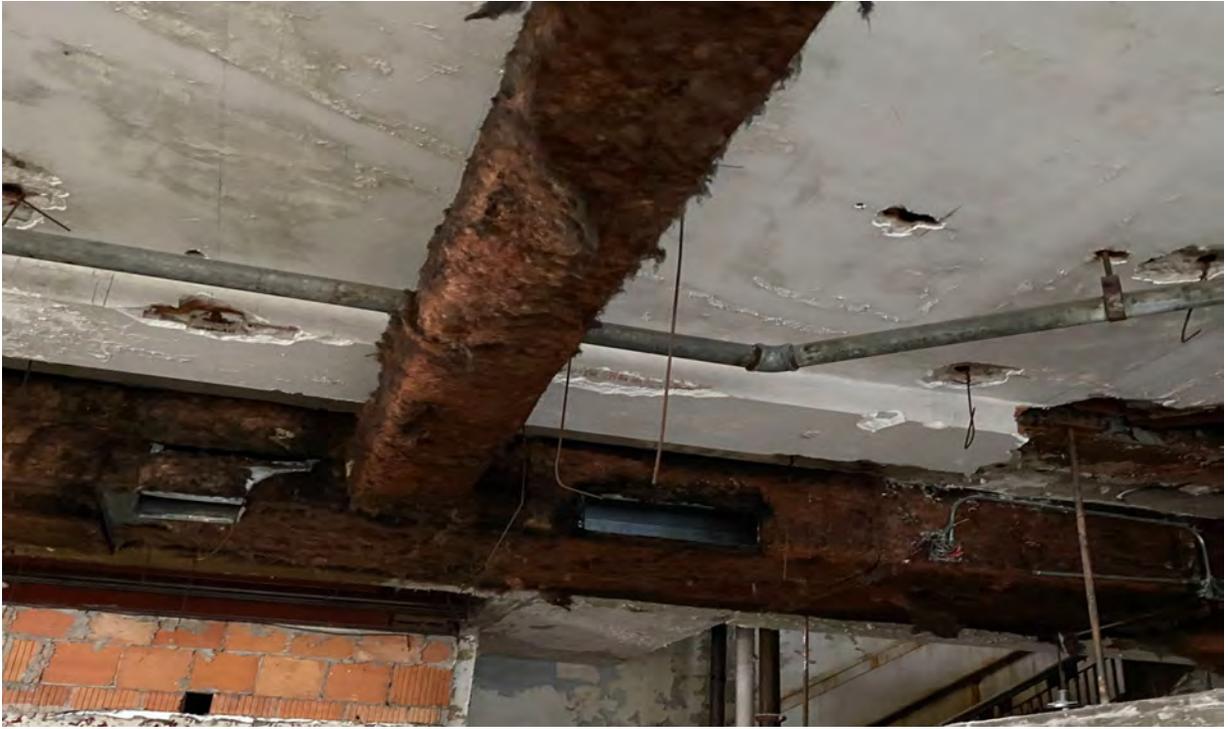
Level 2-Existing ductwork

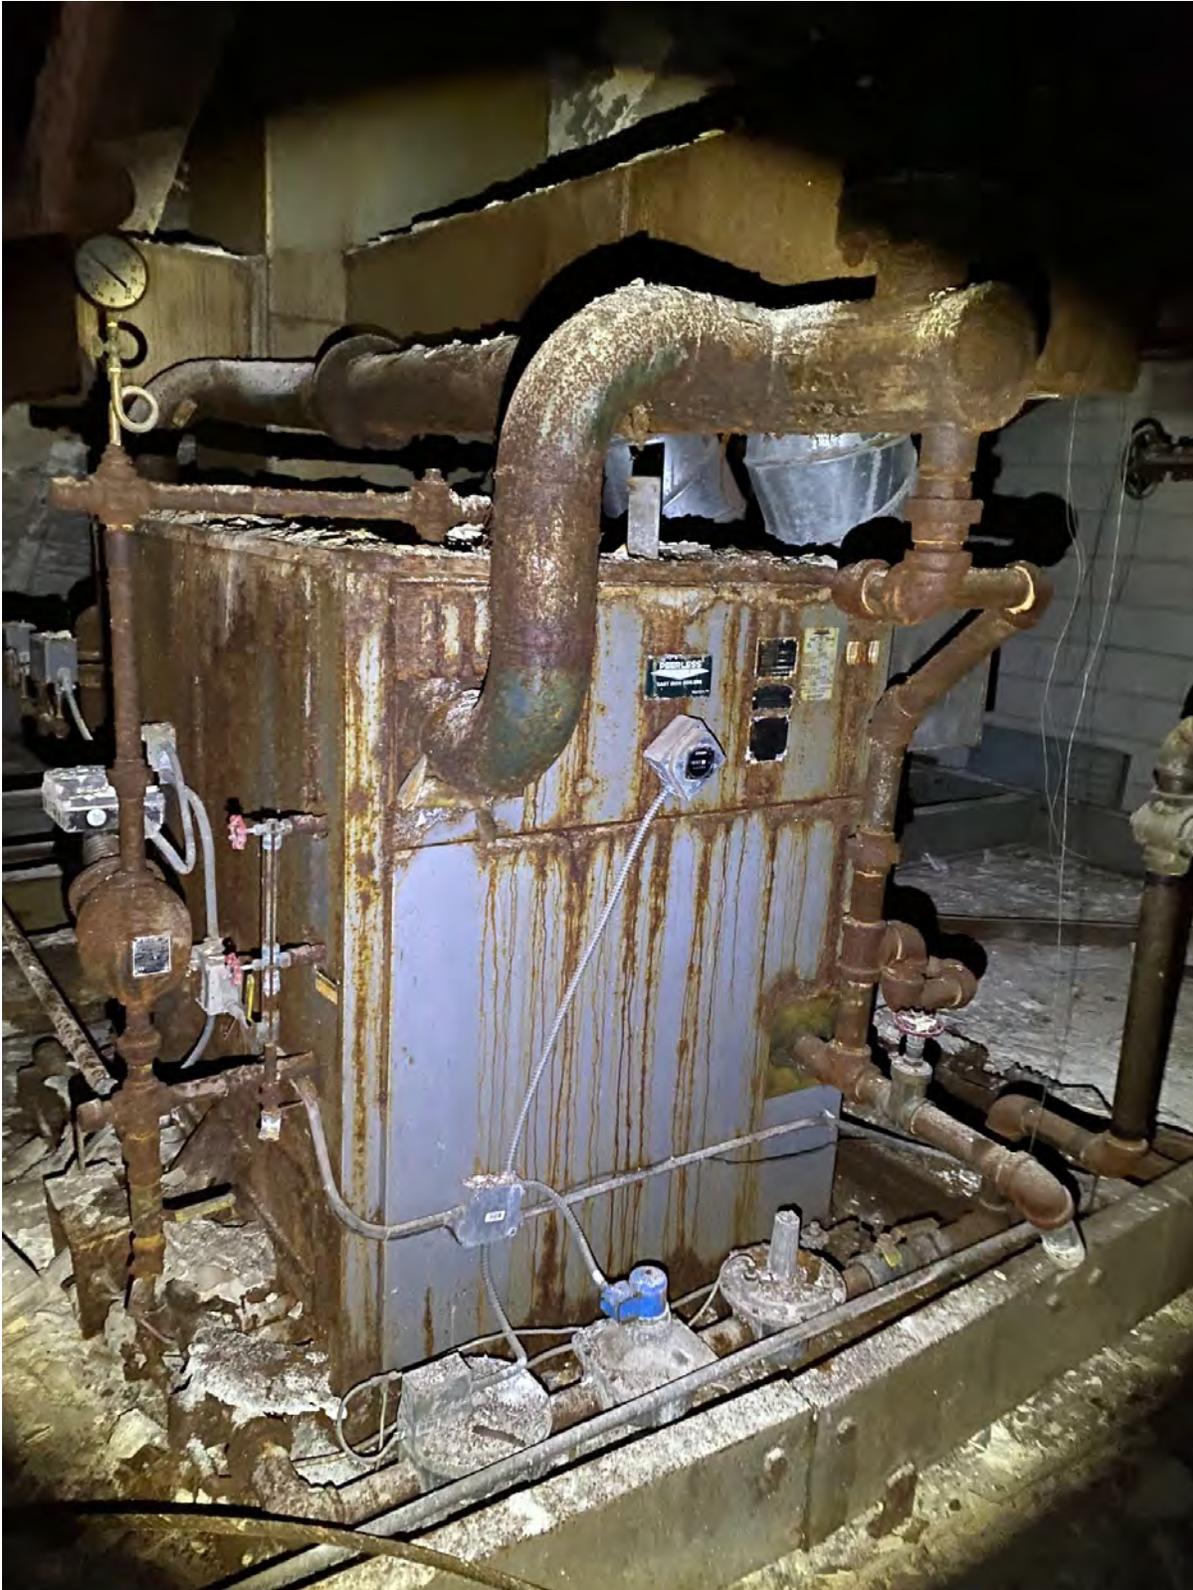
Upper mechanical room -Existing boiler

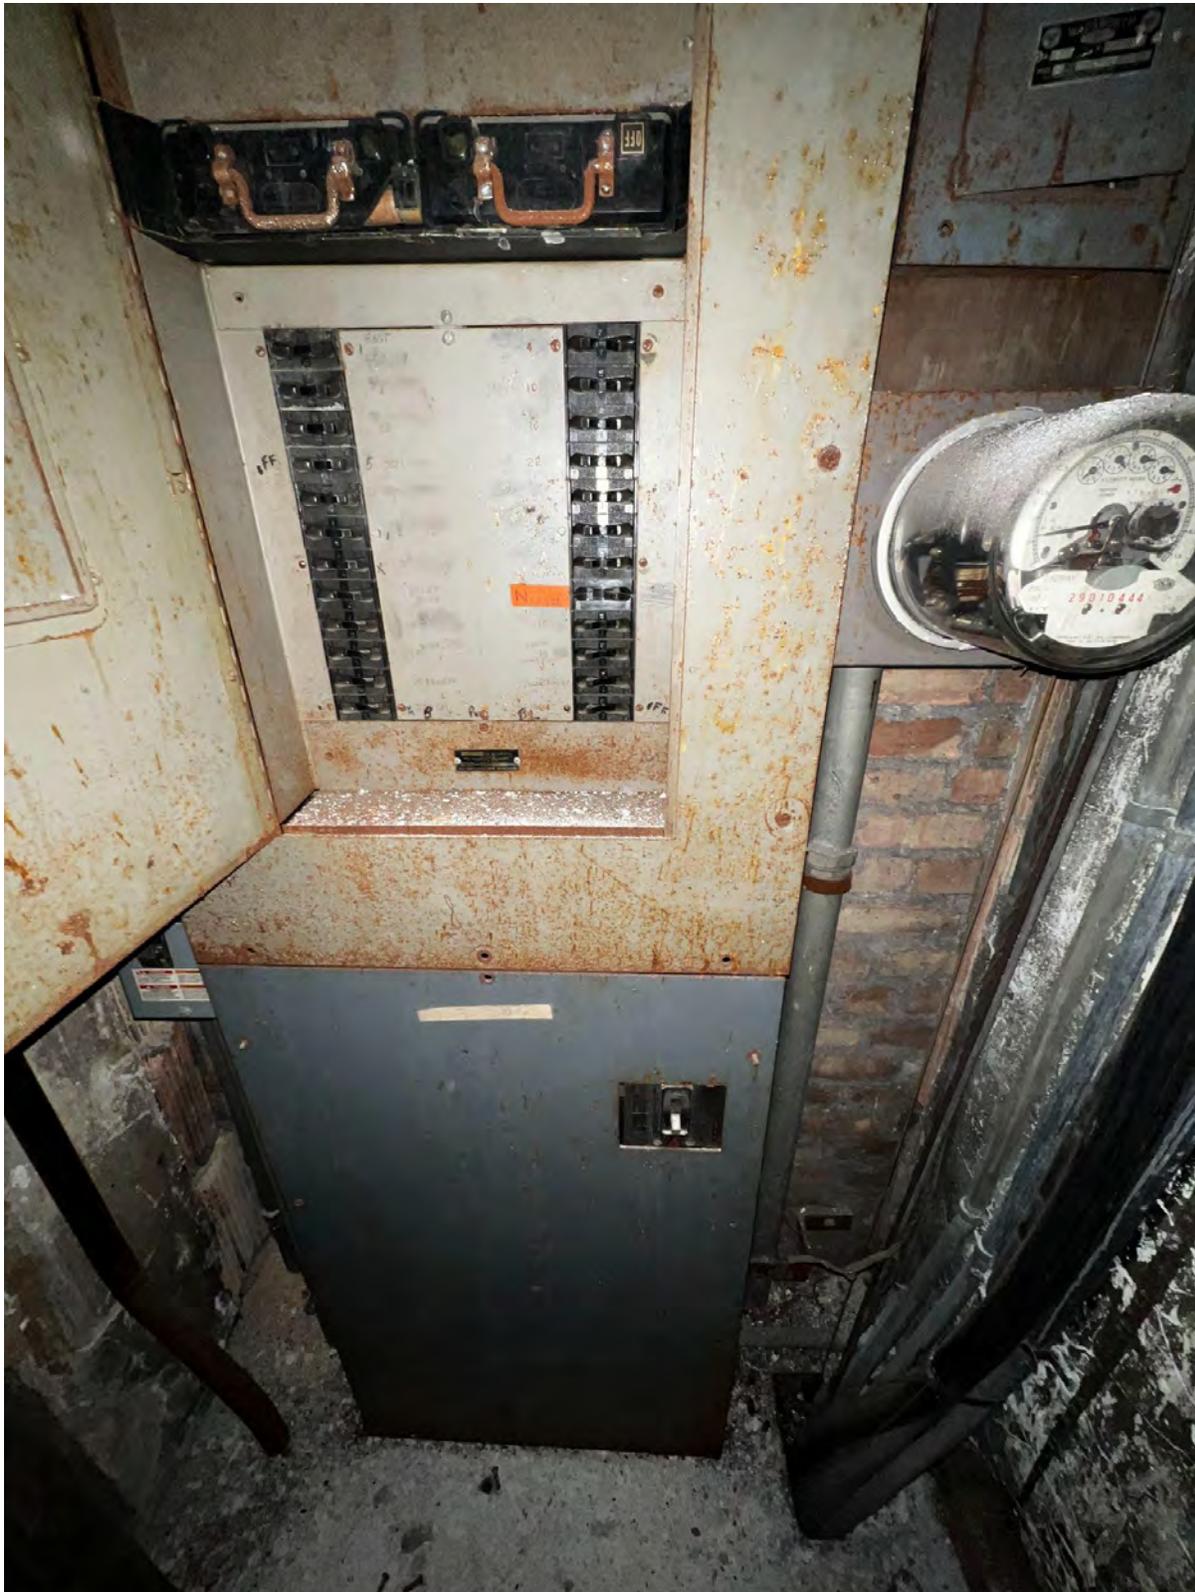
Upper floors bus duct disconnect, panel, and separate tenant metering

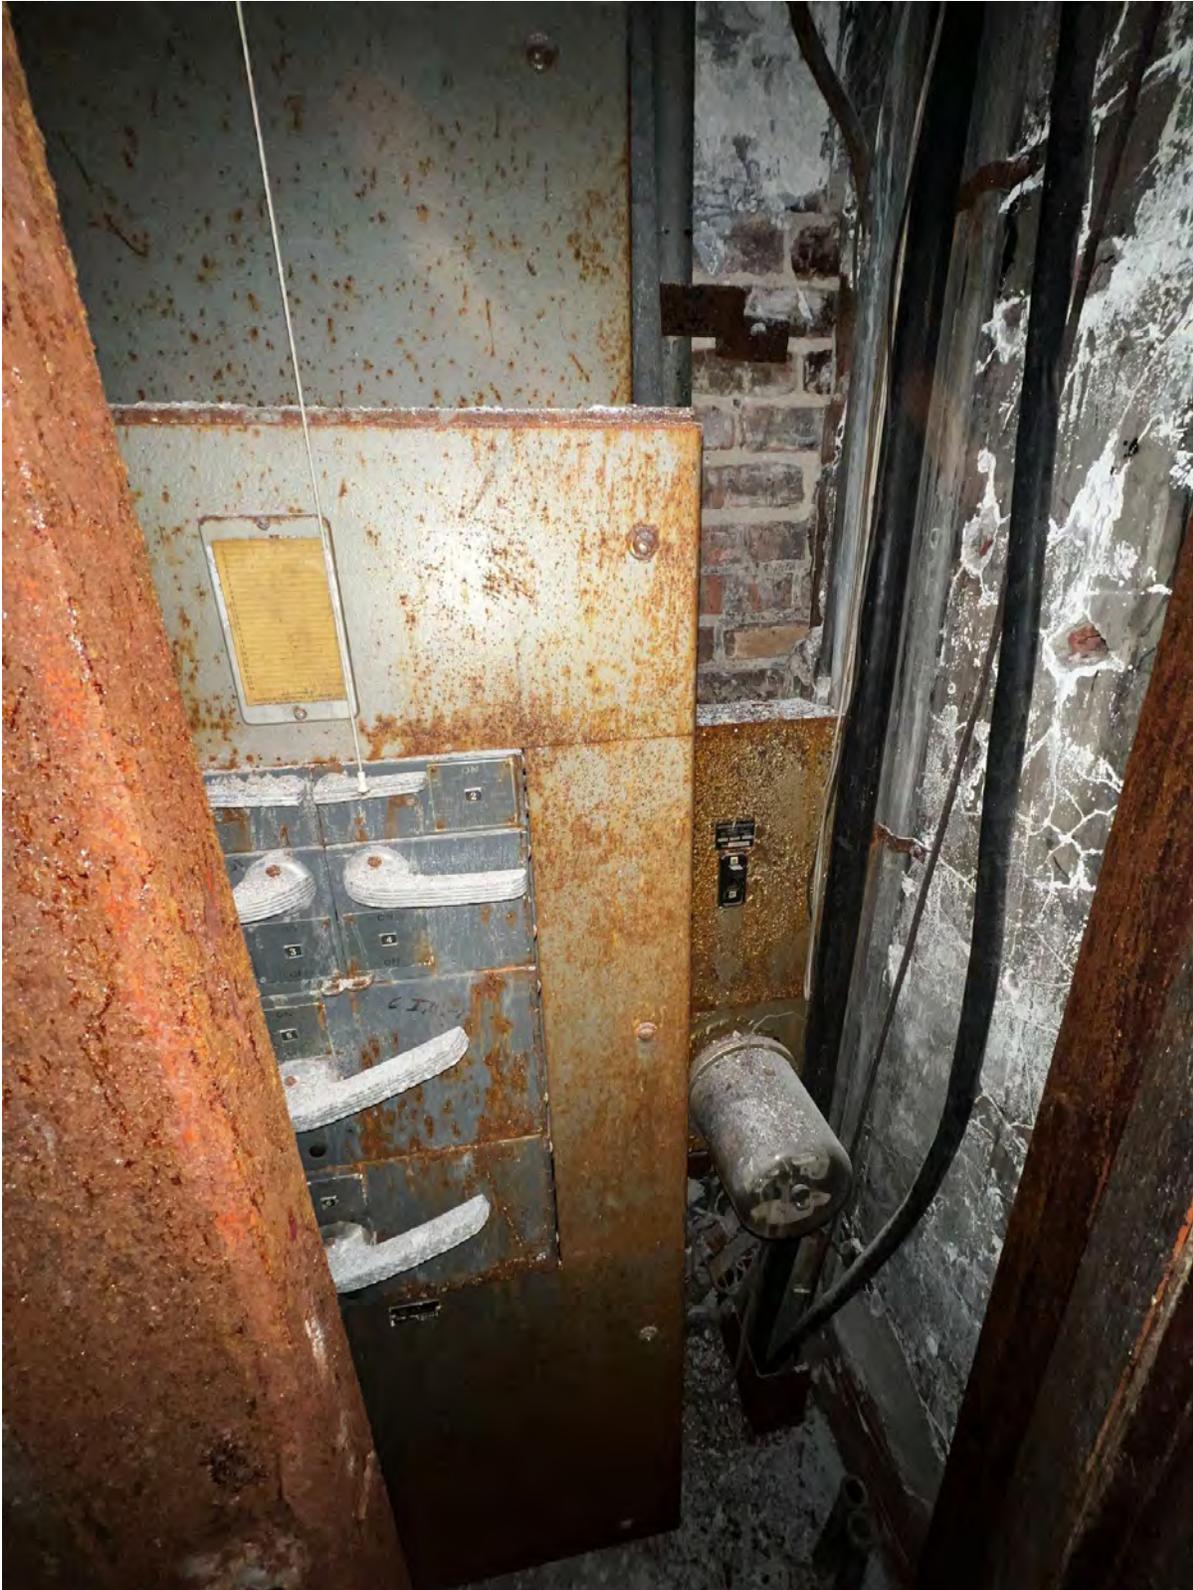
Upper floors distribution panel and separate tenant metering

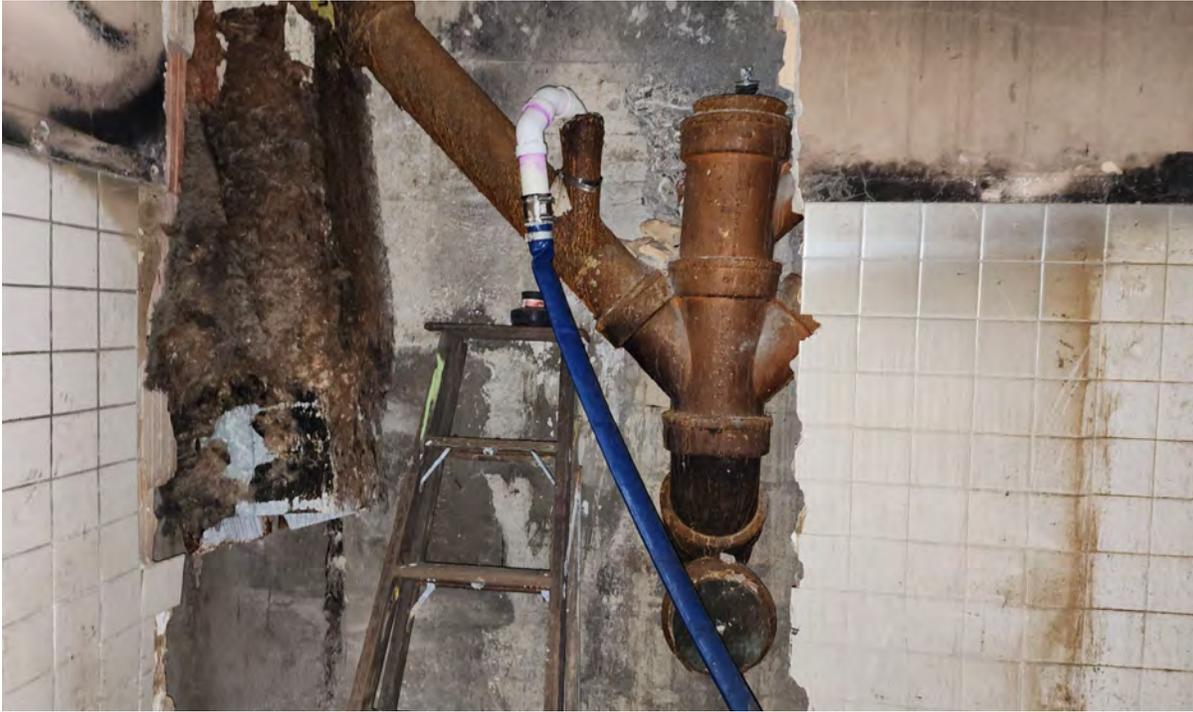
Basement Level: Existing storm service leaving the building. Discharge hose from the temporary sump pump shown discharging into an open pipe fitting.

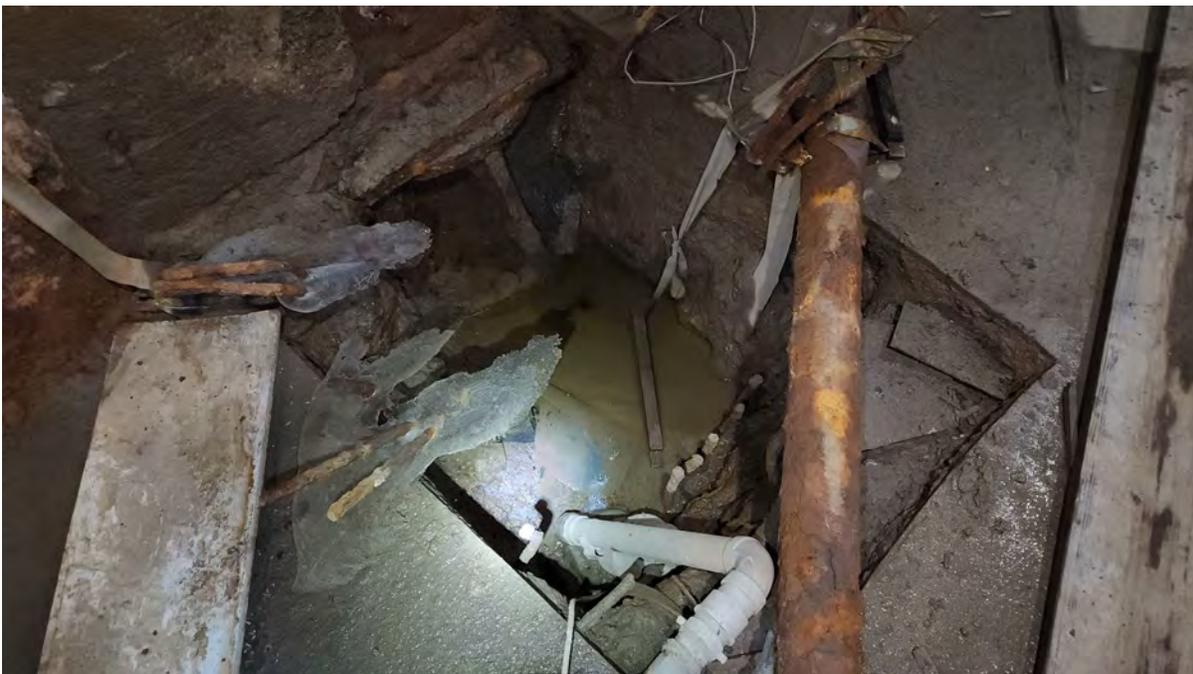
Basement Level: Floor slab has been cut and a temporary pump pit has been created to mitigate basement flooding by collecting water. A simplex pump was put into the pit to pump out the water.

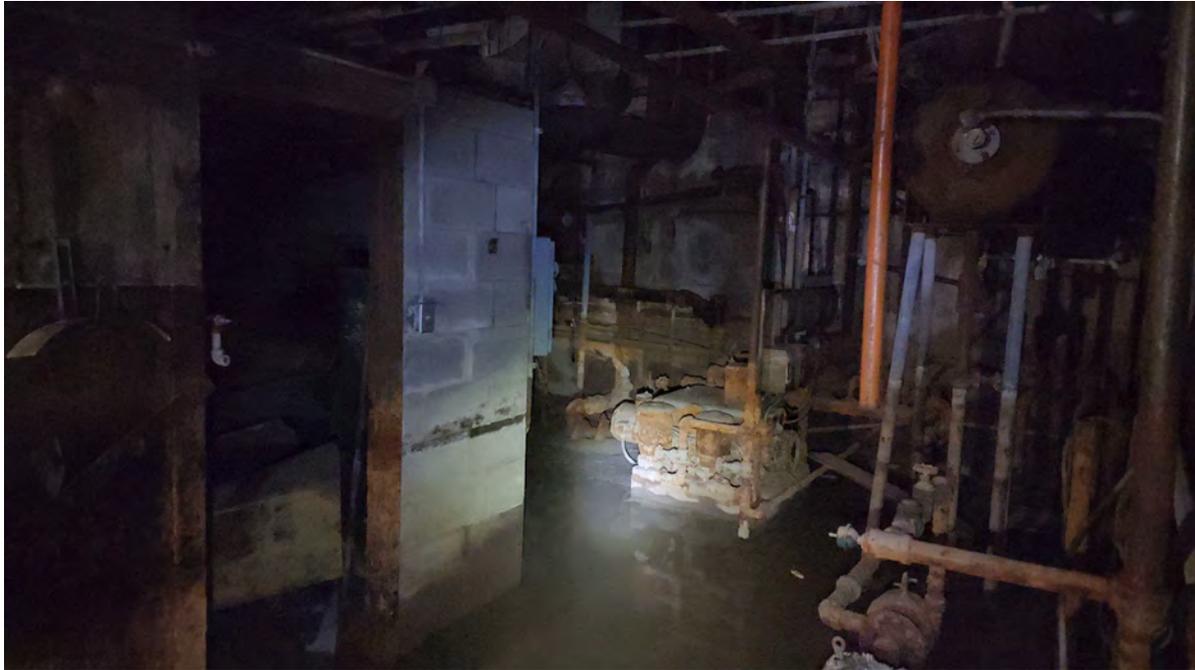
Basement Level: Mechanical and Plumbing equipment in flooded area of the basement. The water ponding is several inches deep.

- Demolish or abandon in place the existing underground drain tile system. Demolish the associated sump pump serving the existing drain tile system.
- Provide an all new drain tile system below the basement floor. Provide associated floor slab trenching and repair required for installation of the new underground piping system.

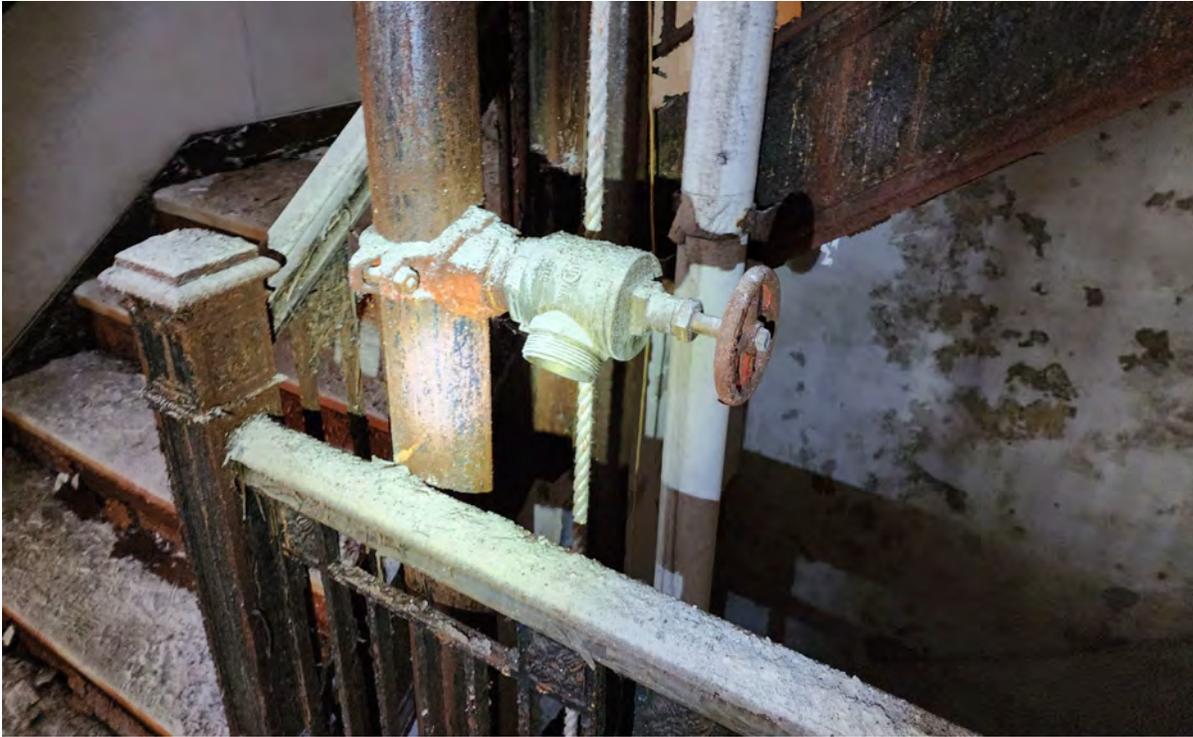
2nd Floor stairwell: Fire Protection Standpipe and hose connection valve.

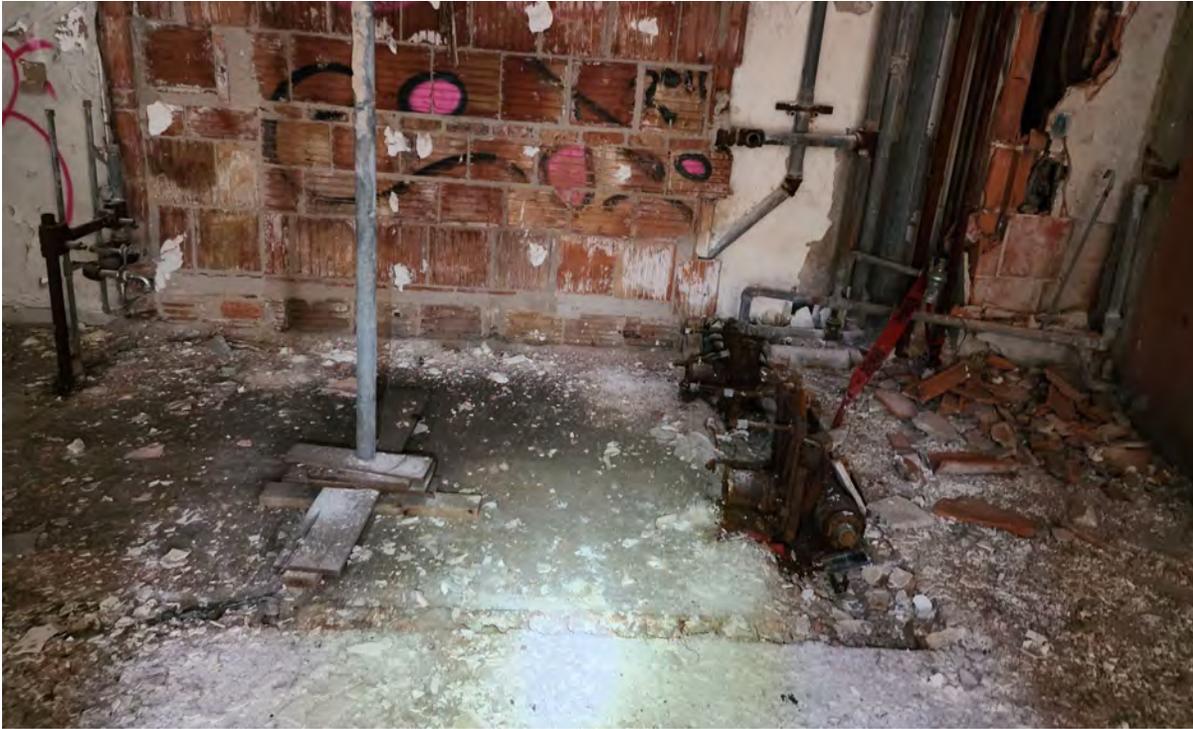
3rd Floor: Plumbing rough-ins from demolished multi-user toilet room.

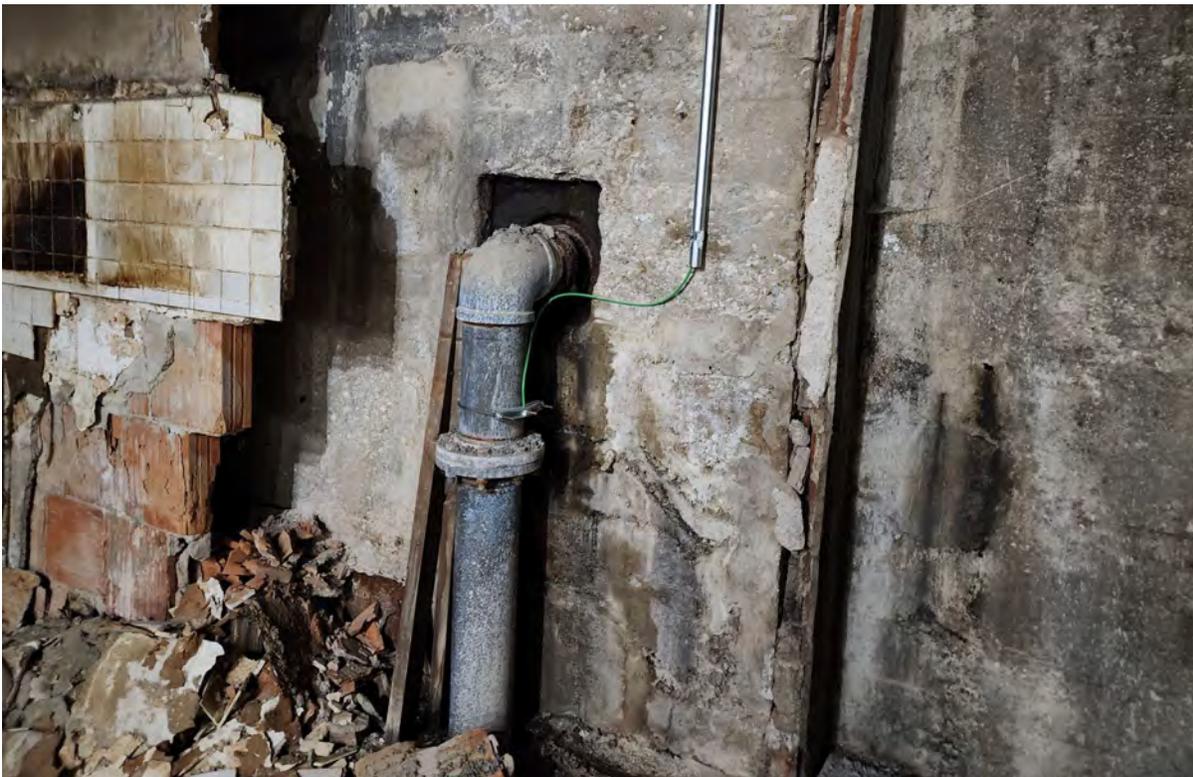
Basement Level: Incoming Domestic water service. Approximate size: 8".

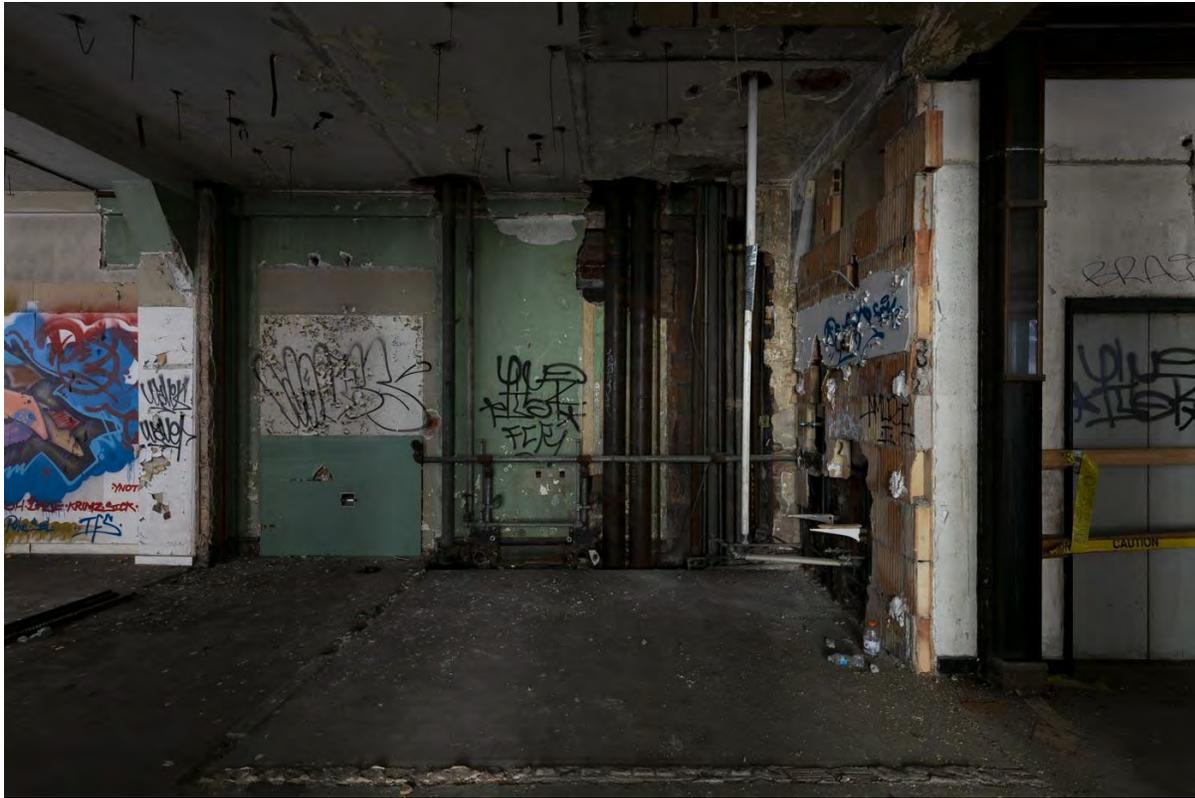
3rd Floor Location of the Former Restrooms (typically removed on all floors)

5. Replace doors, frames and hardware.
6. New core toilet rooms on each floor. (Levels - Lower Level 1 to 15)
7. Create one new fire rated stair from Lower level 2 to 15. Include floor penetrations, stair, etc

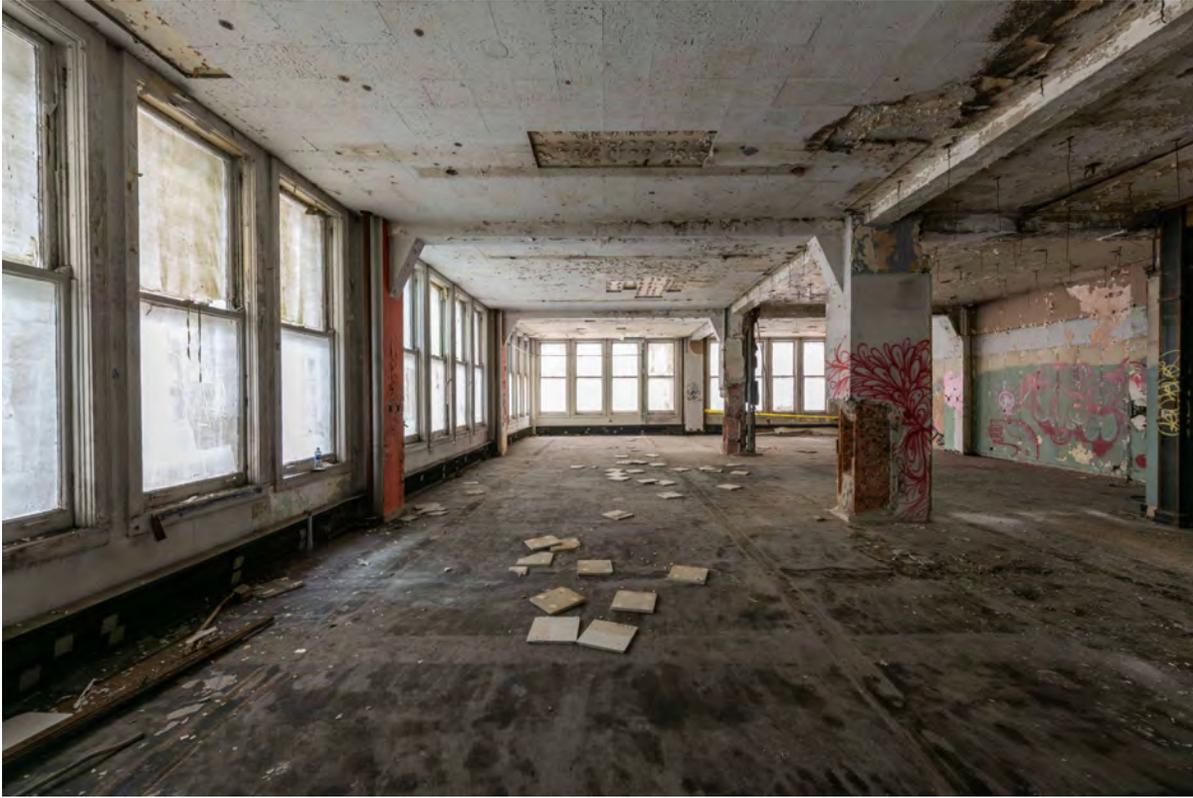
6th Floor at Stairwell

**Stairs** - Only one stair exists in the building above the mezzanine. The stair is typically open to all floors vertically up the building with doors only on the first and Lower Level 1. As a result no acceptable paths of egress exist in the building. The existing stair is steep and would most likely require AHJ approval to utilize as a means of egress. The open stair provides no fire separation and as such would be considered an atrium. No appropriate mechanical/fire suppression/alarm systems are in place to address this condition. Stair has stone treads and ornamental metal railings with a wood cap. Generally undamaged except in localized places with broken treads. The metal has overall

corrosion throughout. The underside soffit is plaster in poor condition. The structural condition of the stair is unknown.

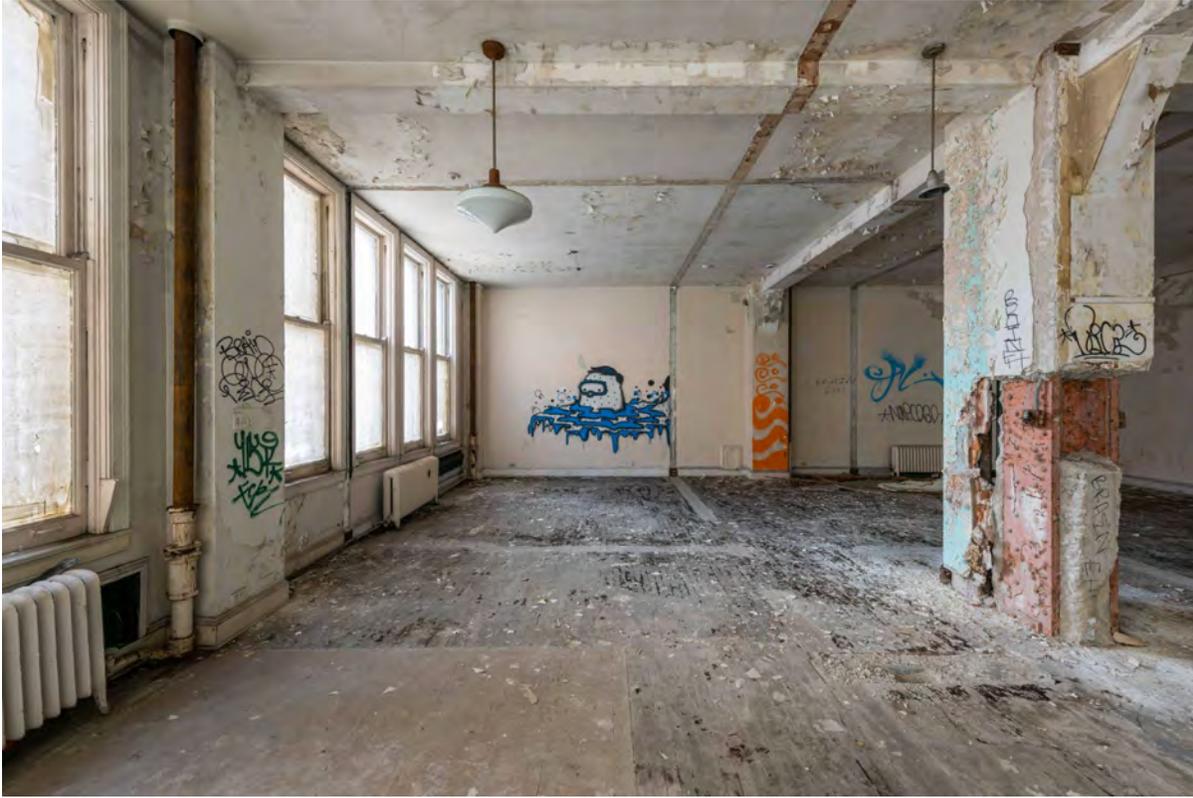
7th Floor Prior Column Investigation

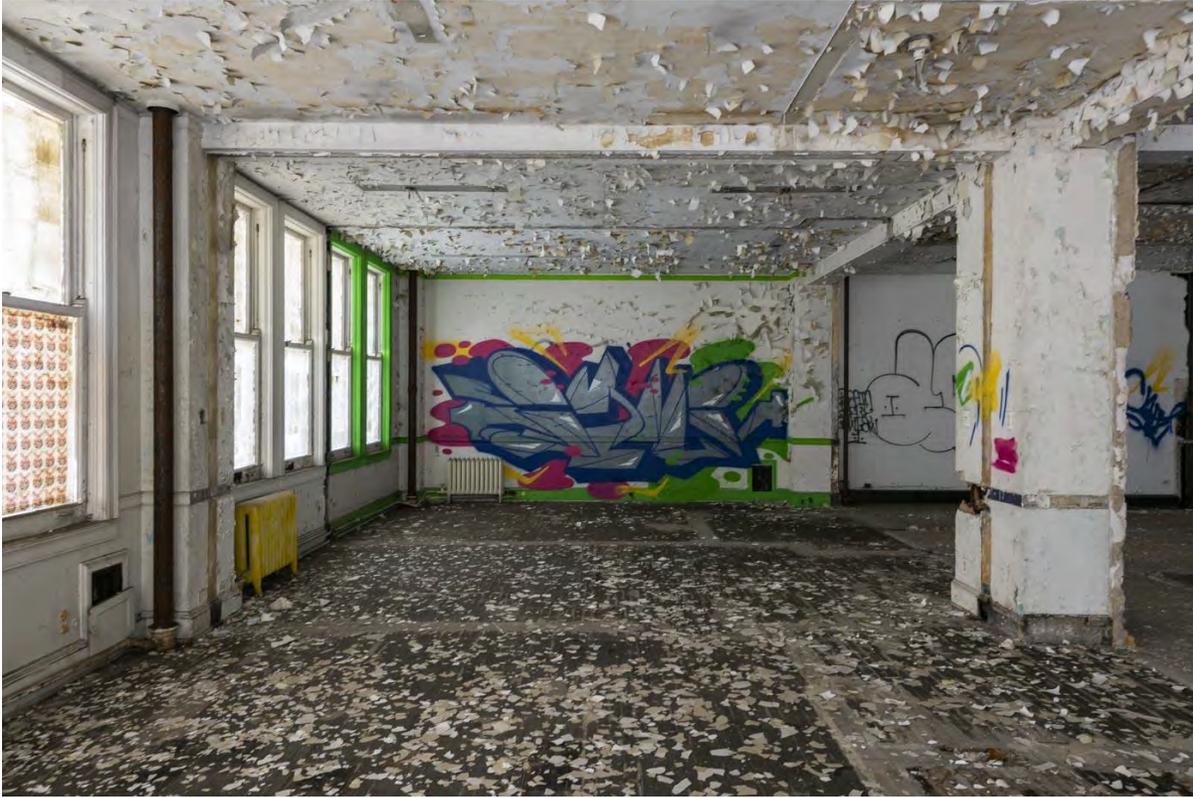
12th Floor Ceiling/Slab

The interior wall and ceiling finishes are predominantly plaster. The building's condition of being unheated for more than 15 years, has resulted in freeze thaw damage to virtually all surfaces. A significant portion of the plaster ceilings have already fallen to the floor exposing the structure. Very little if any in our estimation is able to be reused.

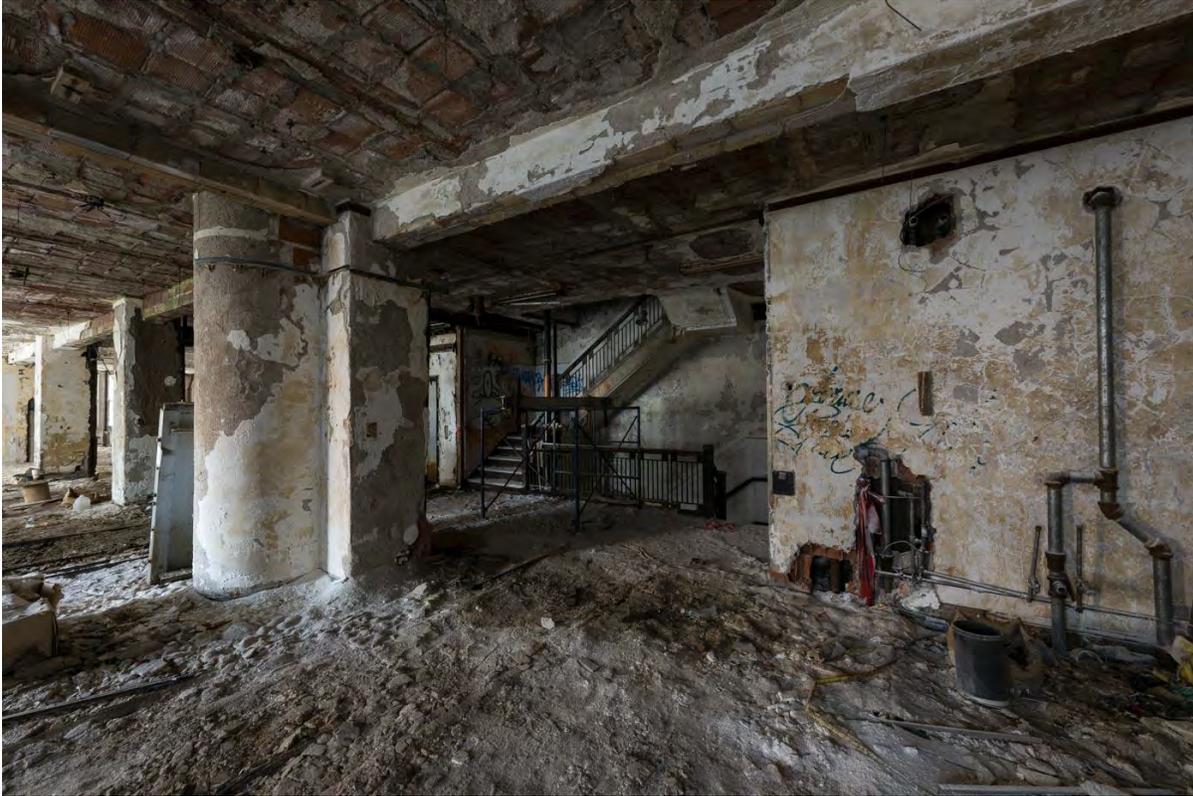
The non heated conditions have significantly damaged the typical wood floors throughout the building. In most conditions where they remain they are not only damaged but have additionally buckled and are therefore not able to be reused.

15th Floor Flooring

4. New carpet flooring in tenants and common areas. Included with this will be lightweight concrete topping slabs to correct floor elevations damaged in the existing building. (Levels - Lower Level 1 to 15)

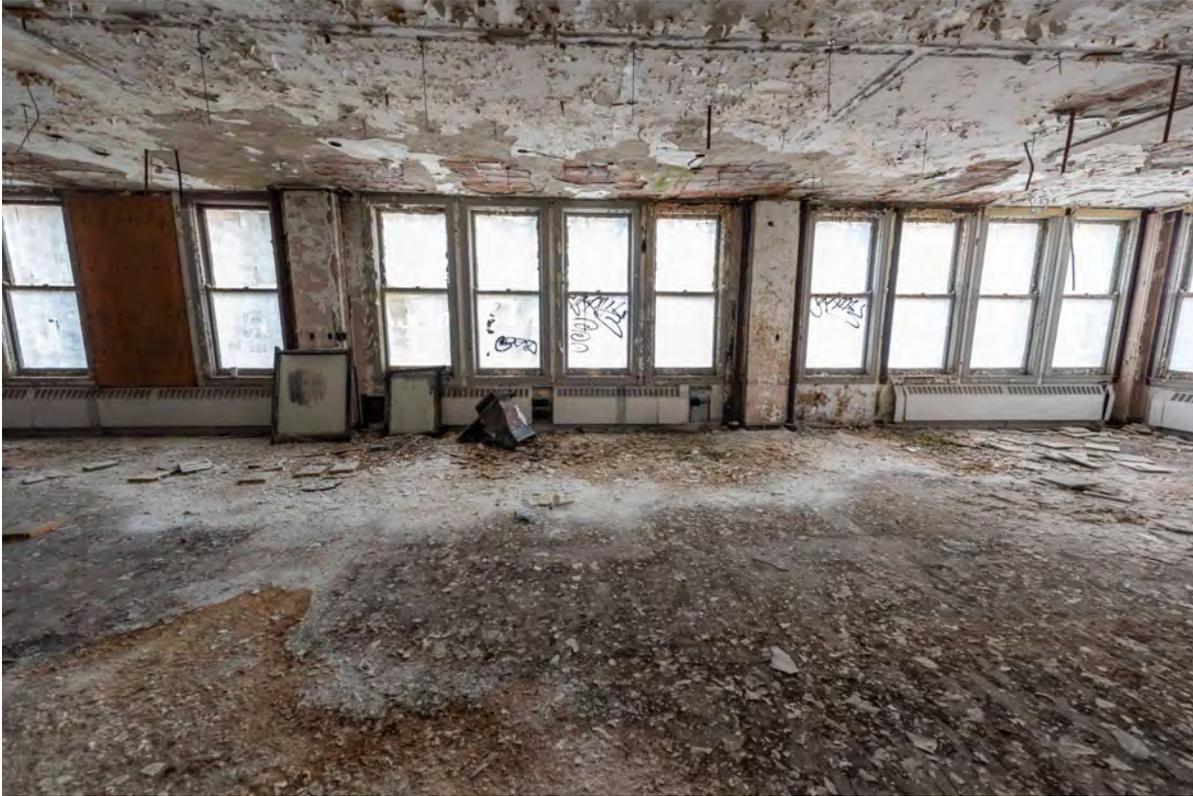
15th Floor Looking at Stairwell

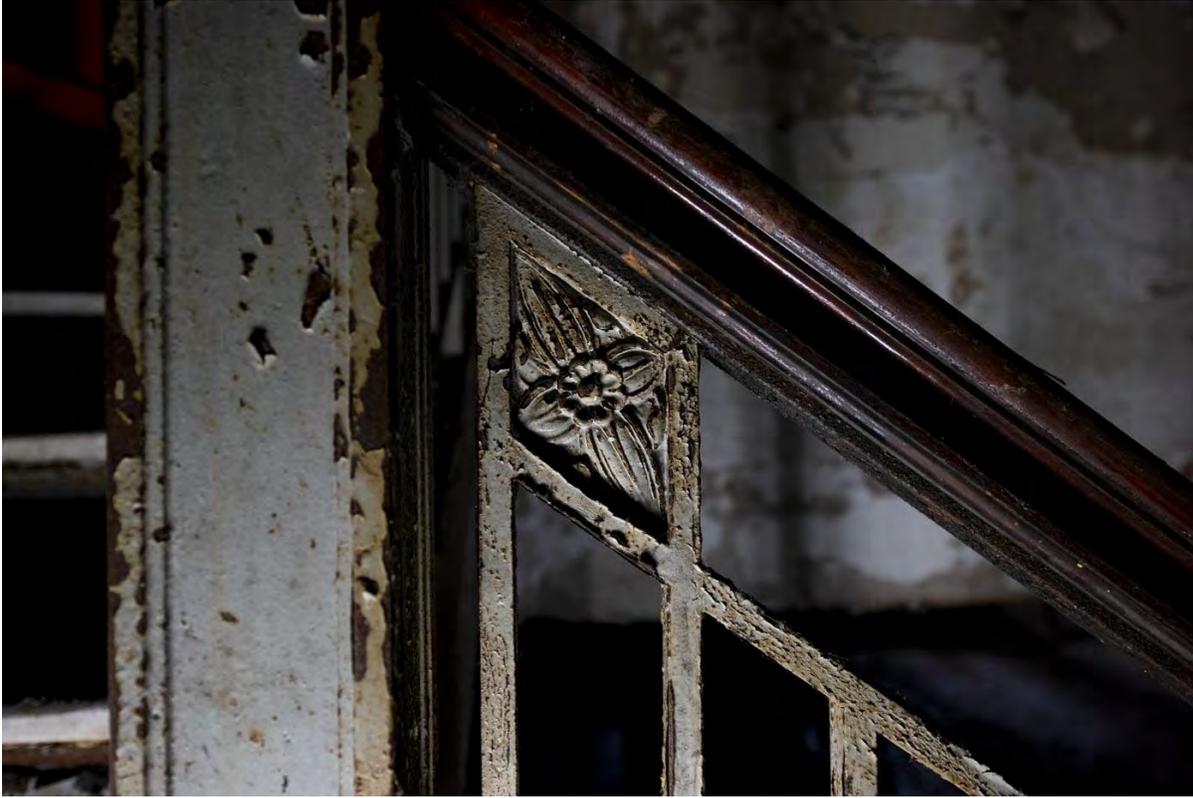
Stairwell Iron Handrail

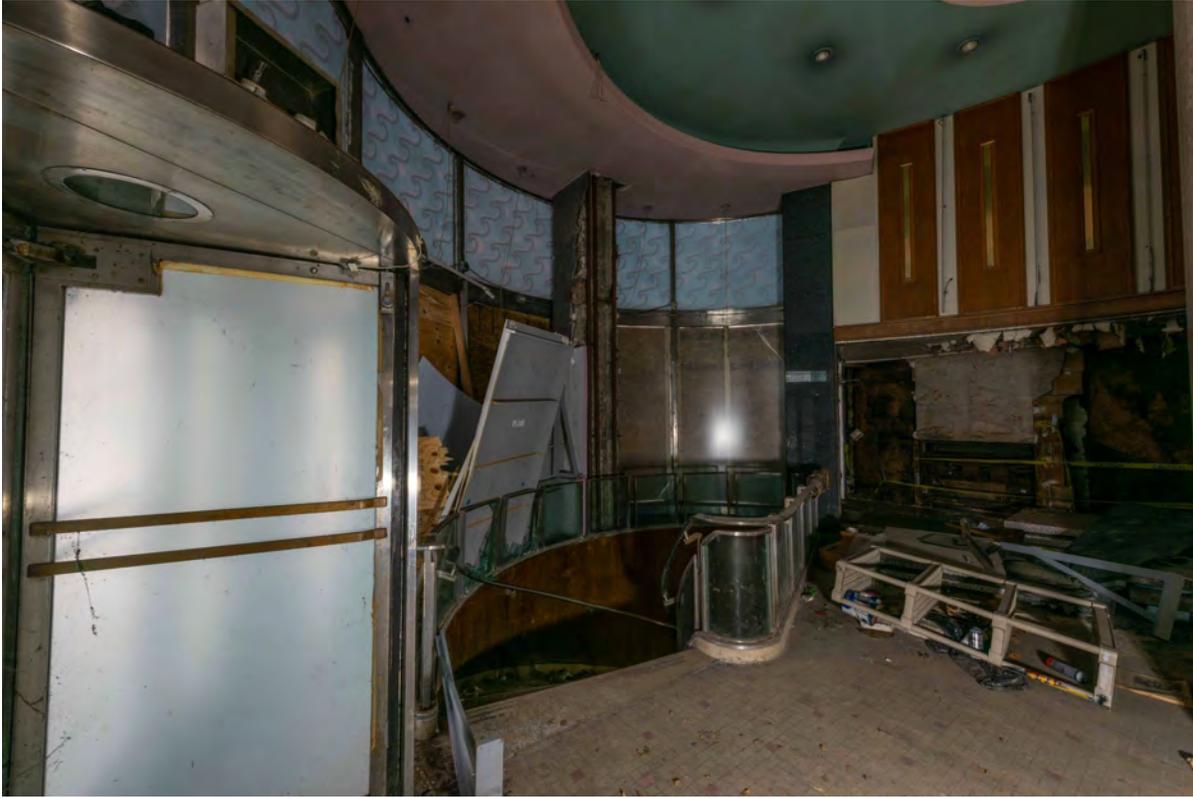
Glass Handrail and Stair to Lower Level 1
