GSA Great Lakes Region

# **202 State Street Evaluation Report**

**202 S State Street**

Report Issuance 6.1.23

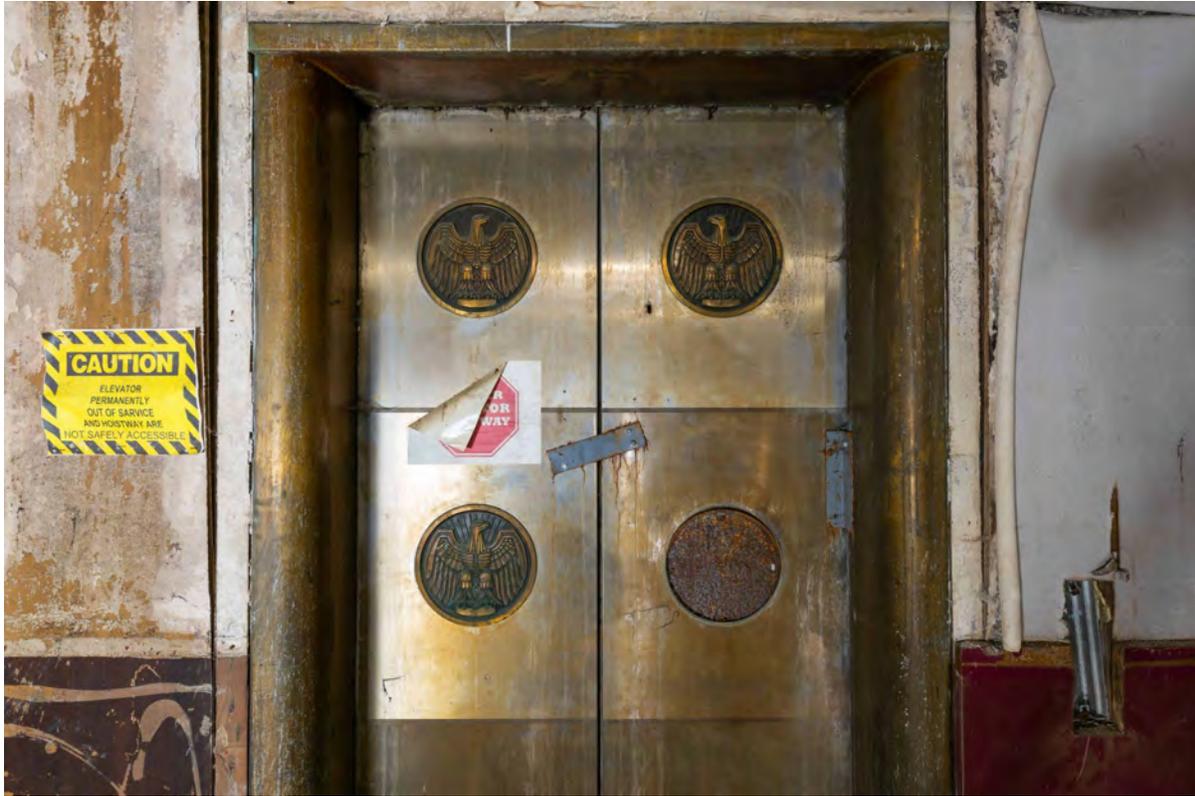
Lower Level 1 Elevator doors with eagle medallions
